Editorial

REPORTS ...

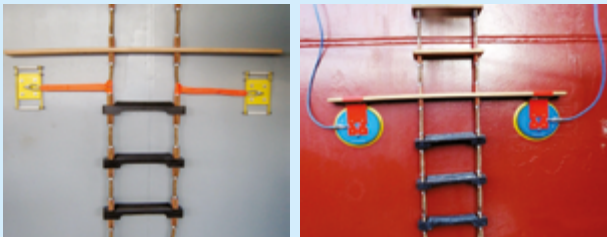
Examples of compliant fitting – magnetic (left) and vacuum (right). Any boarding arrangements for pilots must be in accordance with SOLAS Regulation V/23 & IMO Resolution A.1045(27) as amended by A.1108(29).
