### DEATH OF THIRD ENGINEER DUE TO BURN INJURIES

THE THIRD ENGINEER (3/E) ON BOARD A CAPE-SIZE BULK CARRIER WAS SPLASHED BY HOT SLUDGE WHILE OPENING THE MANHOLE COVER OF A SETTLING TANK. ALTHOUGH HE WAS SUBSEQUENTLY EVACUATED TO A SHORESIDE HOSPITAL BY HELICOPTER, HE TRAGICALLY DIED 12 DAYS LATER.

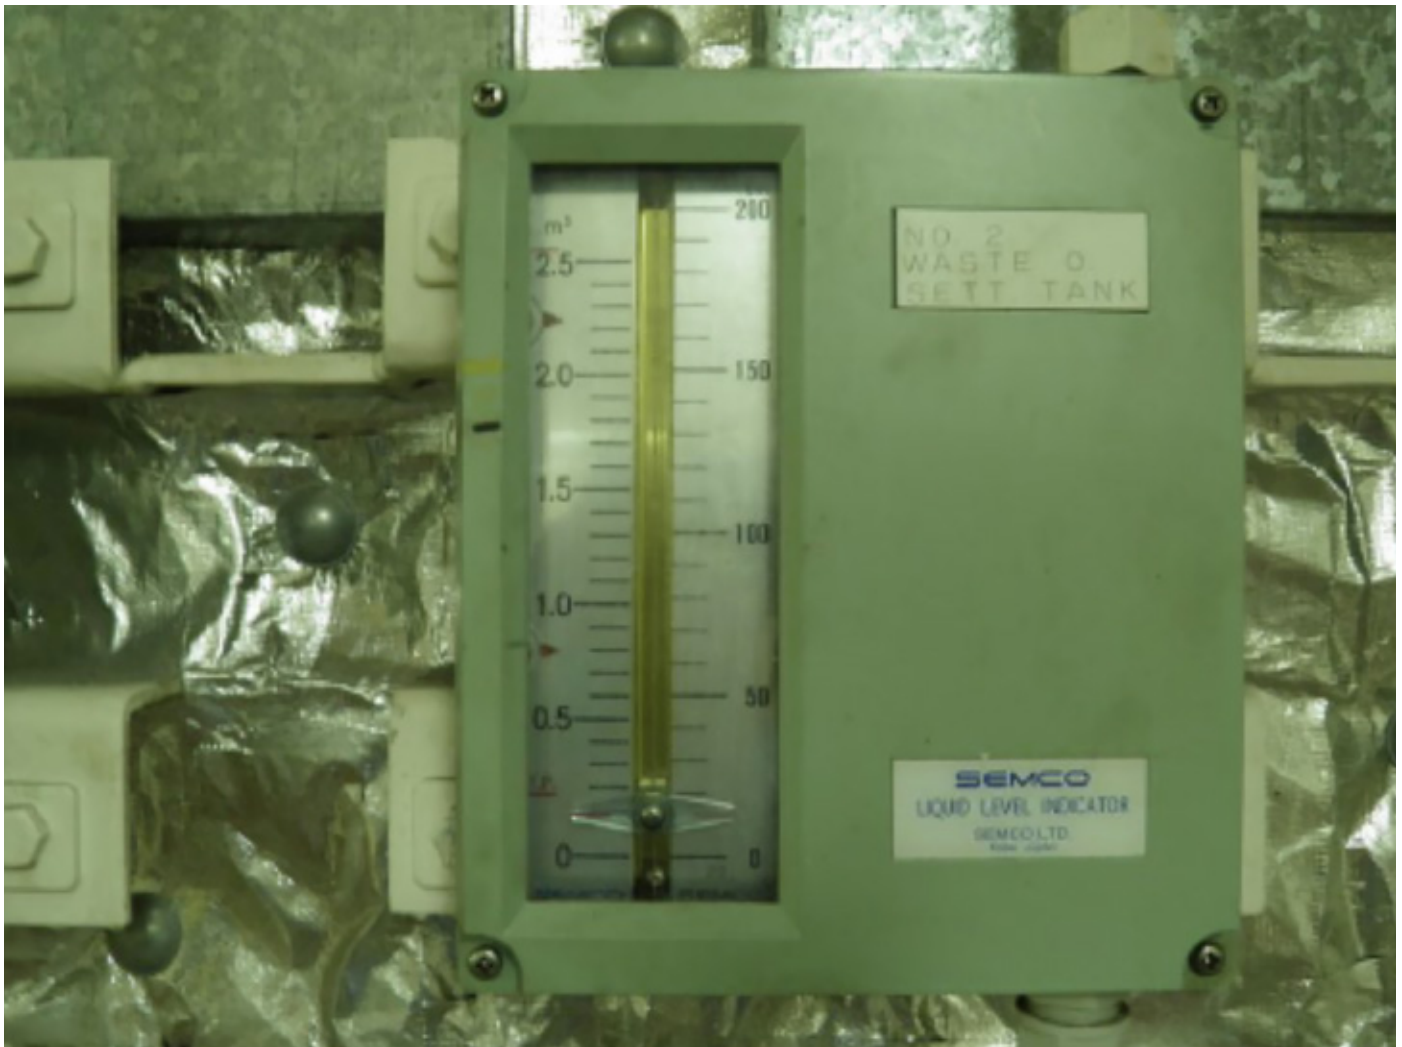
**FIGURE 1** THE LEVEL GAUGE OF NO.2 WASTE OIL SETTLING TANK. SOURCE: HBMCI

The vessel, built in 2010, was anchored off a Brazilian port waiting to enter and commence loading. While at the anchorage, the Second Engineer (2/E) transferred about 1.8 m<sup>3</sup> of sludge from the “Bilge Separator Oil Tank” (BSO Tank) to No.2 “Waste Oil Settling Tank” (No.2 WOS Tank) using the sludge pump. After the transfer, it was observed that the level gauge of the No.2 WOS Tank was not indicating the correct quantity. The transferred quantity was then confirmed by sounding the BSO Tank, and it was concluded the level gauge in No.2 WOS Tank had malfunctioned.

The vessel's Planned Maintenance System (PMS) did not address the foreseeable and preventable jamming of the level gauges with sludge oil by providing guidelines for periodic routine maintenance/tank cleaning. The provision of an appropriate and regular regime for cleaning the tank would have helped avoid the need for this unplanned and hazardous task.

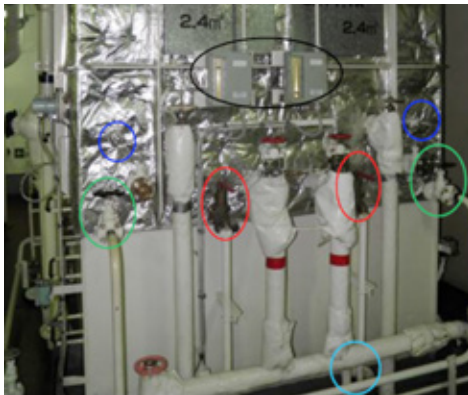
**FIGURE 2 THE TWO WASTE OIL SETTLING TANKS.**  
BLUE: THERMOMETER GREEN: DRAIN TO BSO TANK  
RED: SELF-CLOSING VALVE LIGHT BLUE: SCUPPER  
BLACK: LEVEL GAUGES SOURCE: HBMC I

The WOS Tank was not fitted with a sounding pipe as an alternative means when the level gauge malfunctioned. Although not a requirement, had a sounding pipe been fitted, this would have allowed the two engineers to verify the contents of the tank.

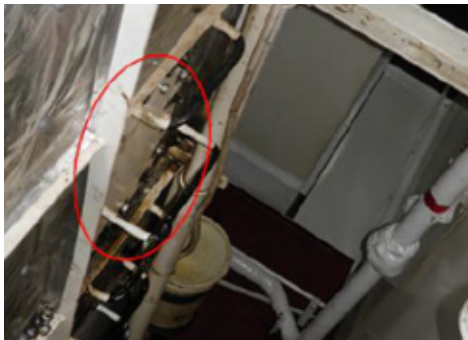
**FIGURE 3 THE MANHOLE AT THE AFT SIDE OF THE TANK ALMOST ONE METER FROM THE BULKHEAD AND TWO METERS FROM THE FLOOR. SOURCE: HBMC I**

Based on the above, the 2/E was convinced that the tank was empty and told the 3/E to proceed with opening the manhole. The 3/E used a small folding ladder to reach the manhole cover, located about two metres above the floorplates, and started removing the cover nuts using an air impact wrench. The 3/E removed most of the nuts from the manhole apart from four, which he then loosened by a half turn. As he did not observe any oil leakage from the cover seat, he loosened the remaining nuts further. Then, without removing the nuts, he pulled the cover which detached from the seat. However, hot oil at a temperature of approximately 86°C started splashing from the manhole bottom onto the 3/E, standing on the ladder.

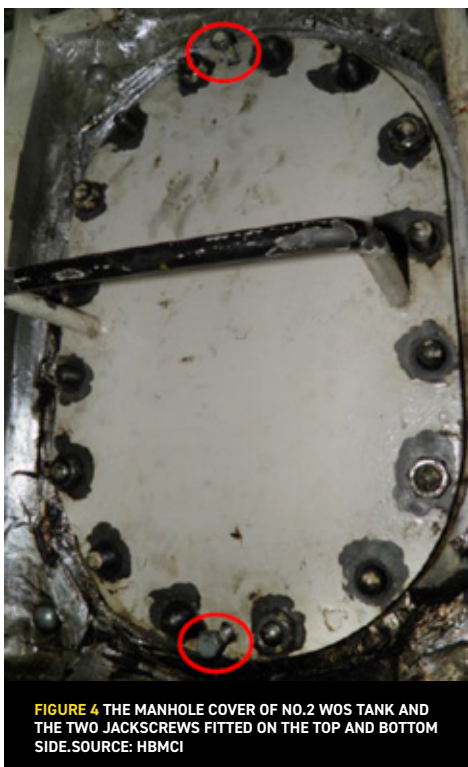
**FIGURE 4 THE MANHOLE COVER OF NO.2 WOS TANK AND THE TWO JACKSCREWS FITTED ON THE TOP AND BOTTOM SIDE. SOURCE: HBMC I**

Taking shortcuts from an established safe work procedure to save time and effort may be appealing, but can lead to undesirable and even tragic consequences. Other ways of confirming the tank had been drained could have been used, for example, by measuring the quantity of the BSO Tank; this would have helped identify that it was not safe to open the manhole cover.
