Death of Third Engineer due to burn injuries

CASE STUDY

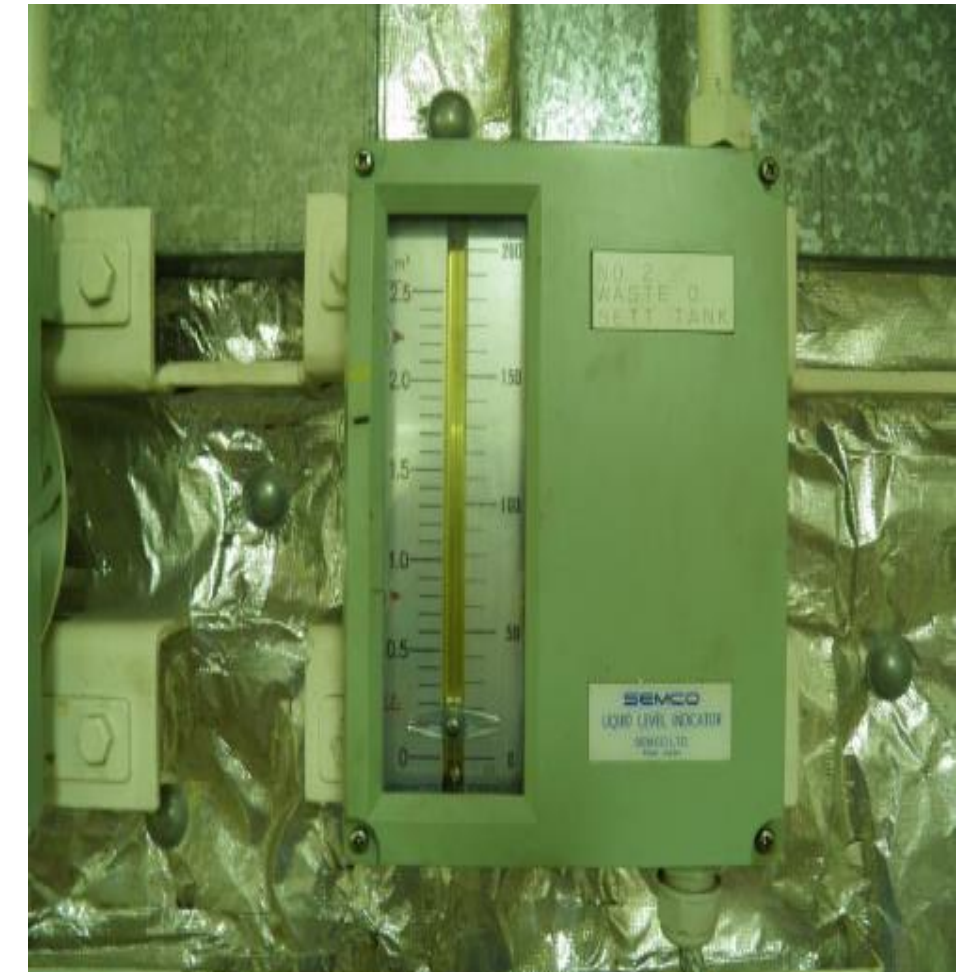
- During transfer of sludge to No. 2 “Waste Oil Settling Tank” (WOS) it was observed that the level gauge of the tank was malfunctioning
- The Chief Engineer (C/E) decided that the WOS should be cleaned the next day and the level indicator to be repaired
- The C/E prepared a “Job Hazard Analysis” (JHA) for the tank cleaning operation in accordance with the ship’s Safety Management System Manual, and the 2/E, assisted by the 3/E was assigned to the job

The malfunctioning level gauge

- **Planned Maintenance System (PMS)** – This did not address the foreseeable jamming of the level gauges with sludge oil. The provision of an appropriate and regular regime for cleaning the tank would have helped avoid the need for this unplanned and hazardous task

Implement a PMS requirement for periodic cleaning of the WOS tanks to avoid the jamming of level gauges

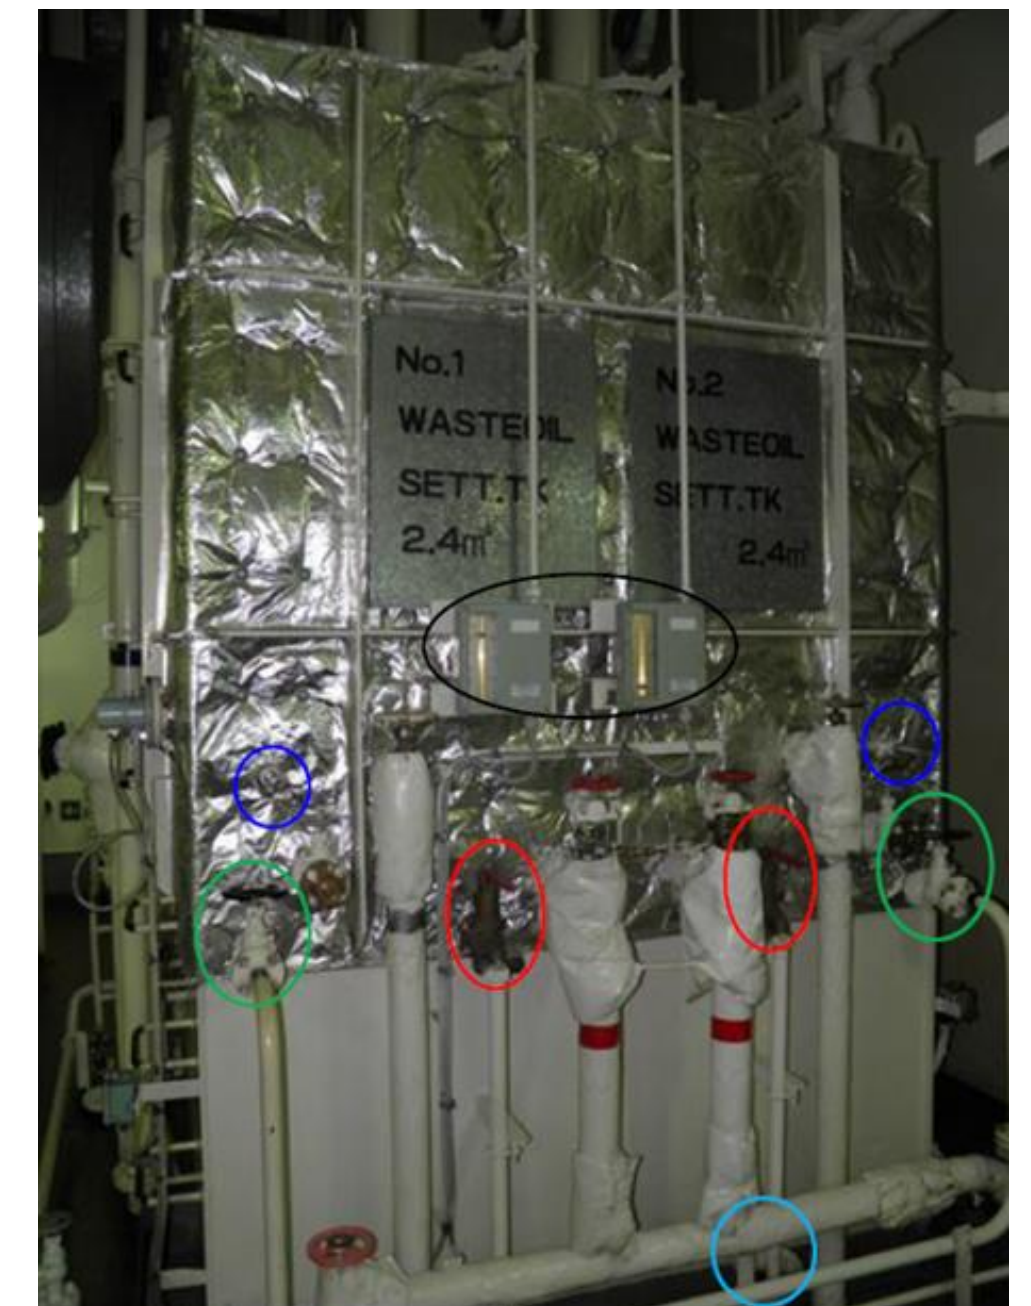
- The 2/E opened the WOS **drain valve** to drain off the sludge by gravity to the “Bilge Separator Oil Tank” (BSO tank) for about 10 minutes
- To confirm it was empty, the 3/E tried to turn the wire wheel of the scale reduction device on the top of the WOS and reported it was working
- Lastly, the 2/E opened the **self-closing water drain valve**, where Only a small quantity was observed before stopping
- Based on above the 2/E concluded that the WOS was empty

Blue: thermometer
Green: drain to BSO Tank
Red: self-closing valves
Light Blue: scupper
Black: level gauges

- **Sounding pipe** – The tank was not fitted with a sounding pipe as an alternative means when the level gauge malfunctioned. Although not a requirement, this would have allowed the two engineers to verify the contents of the tank

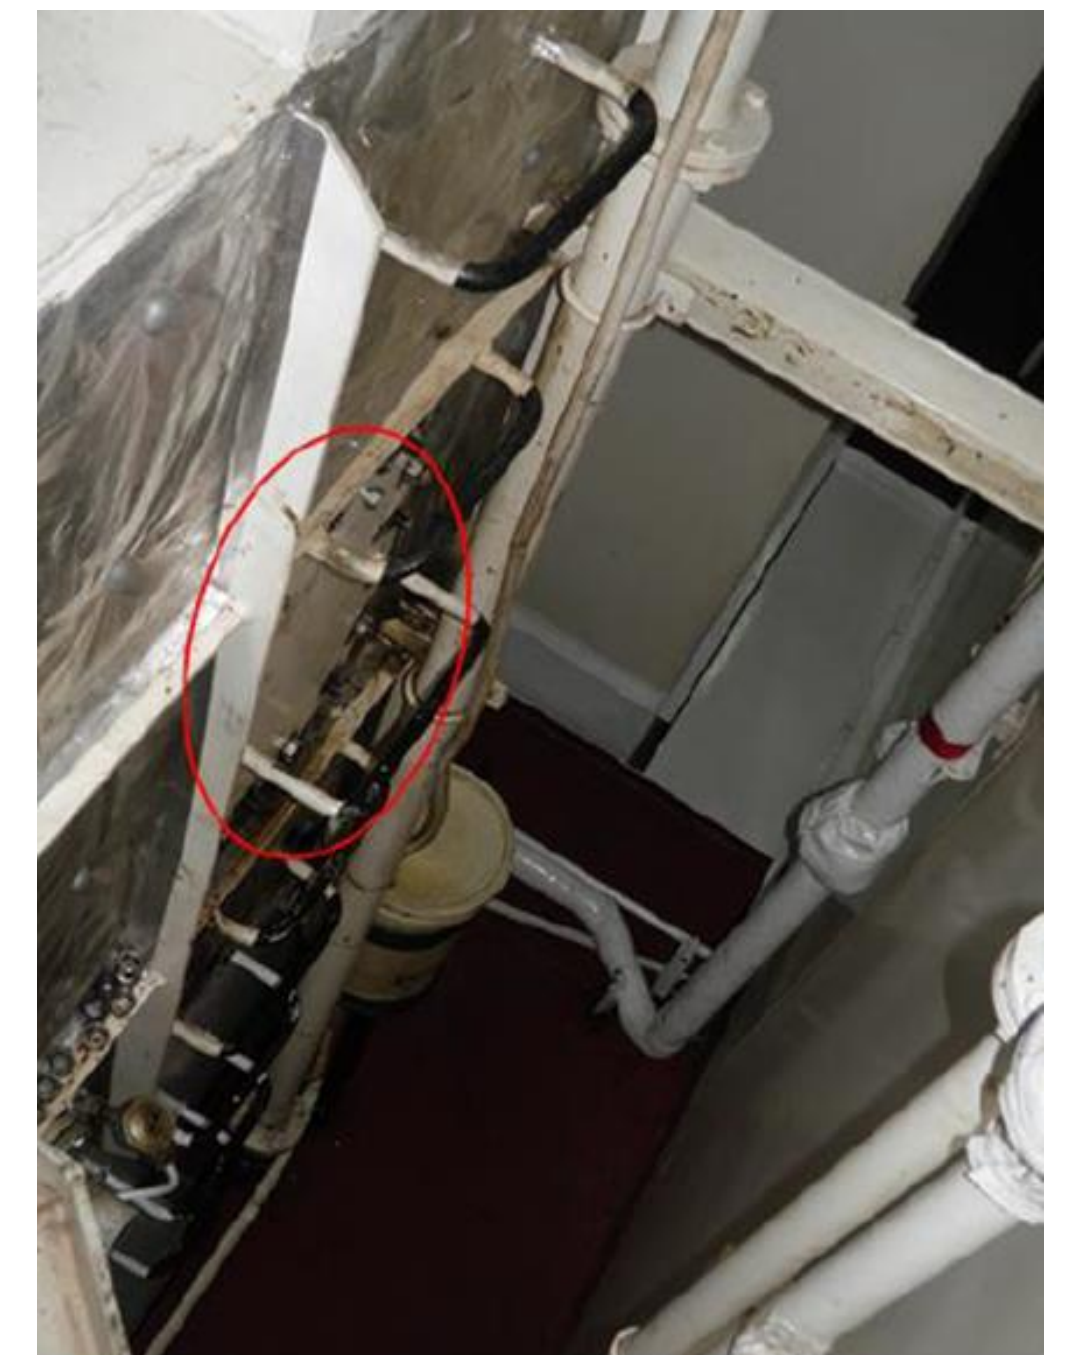
- Using a small folding ladder the 3/E started removing the manhole cover which was located about two metres above the floorplates
- Using an air impact wrench he removed most of the nuts from the manhole apart from four
- He loosened the last 4 bolts by a half turn. As no oil leakage from the was observed, he loosened the remaining nuts further
- Without removing the nuts, he pulled the cover which detached from the seat
- This resulted in hot oil of approx. 86°C splashing from the manhole bottom onto the 3/E

The manhole located two metres from the floor

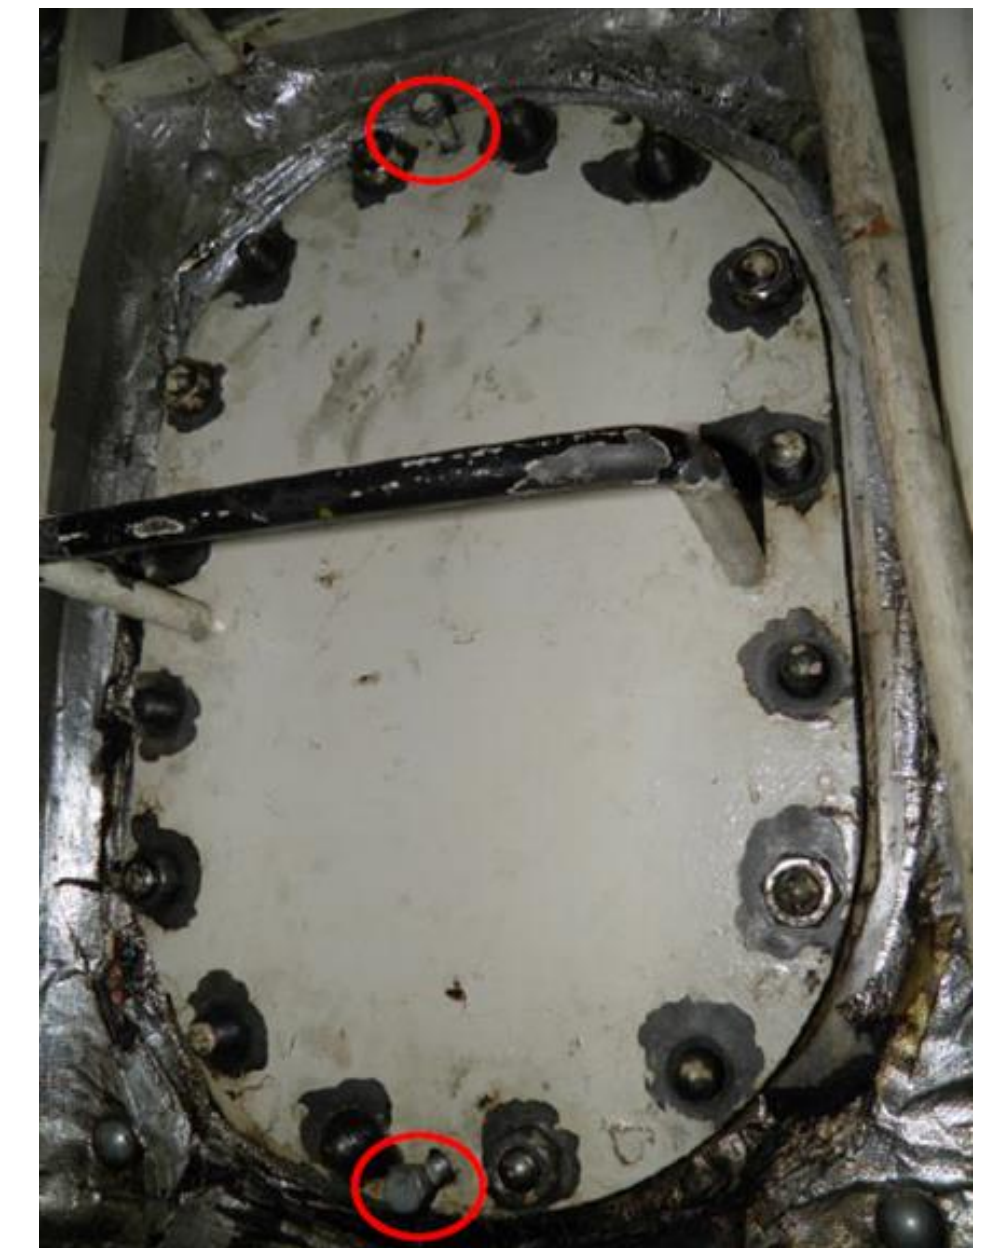
The manhole cover of the tank and the two jackscrews fitted on the top and bottom side.

- **Stop Work** – A successful Stop Work Authority (SWA) program could enable the crew to use their authority to stop work in case of an apparent unsafe condition or behaviour and prevented this accident
- **Safe practices for the opening of the manhole** – The common practice identified in the investigation report to safely remove this type of manhole cover is to:
 - Remove all nuts except four crosswise;
 - Slightly loosen the four nuts by no more than ½ turn;
 - Tighten the jackscrews to detach the cover from the seat;

If a leakage is observed, the cover may be easily secured back by loosening the jackscrews and re- tightening the nuts

If no leakage is observed, loosen the nuts another ½ turn and tighten the jackscrews

If there is still no leakage, continue to loosen the four crosswise nuts and remove the cover
