LONE WATCHKEEPING GROUNDING AT NIGHT

WHILE ON PASSAGE AT NIGHT, A 2,281GT GENERAL CARGO SHIP RAN AGROUND ON THE PENTLAND SKERRIES IN THE EASTERN ENTRANCE OF THE PENTLAND FIRTH, SCOTLAND (FIGURE 1). THE SHIP SUSTAINED SIGNIFICANT HULL DAMAGE, BUT THERE WAS NO POLLUTION OR INJURIES.

INCIDENT CASE STUDY

No.3 | JANUARY 2021

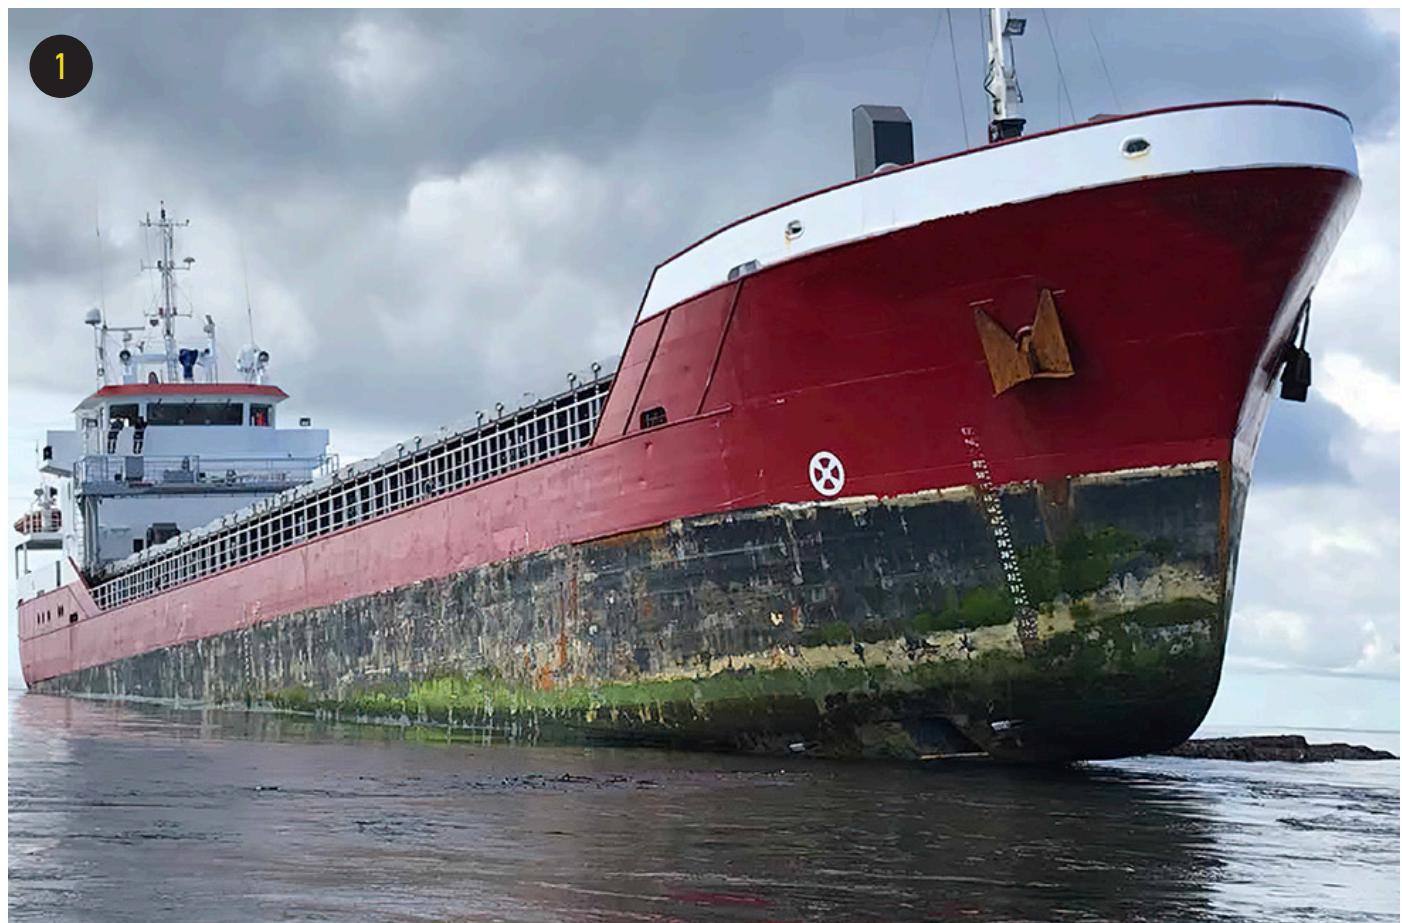
FIGURE 1 SHIP HARD AGROUND FOLLOWING THE INCIDENT. SOURCE: MAIB

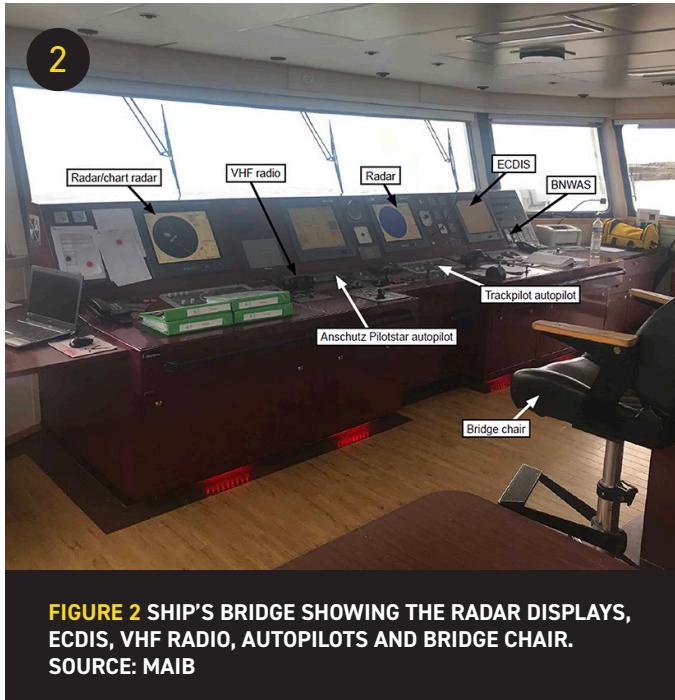
FIGURE 2 SHIP'S BRIDGE SHOWING THE RADAR DISPLAYS, ECDIS, VHF RADIO, AUTOPILOTS AND BRIDGE CHAIR.
SOURCE: MAIB

- The primary means of navigation, the ECDIS, was not fully utilised and a number of navigational alarms could have been used to warn the OOW of the danger. If the bridge navigational watch alarm system had been switched on, this would have assisted the OOW to keep alert and would have acted as a prompt to periodically monitor the vessel's position.

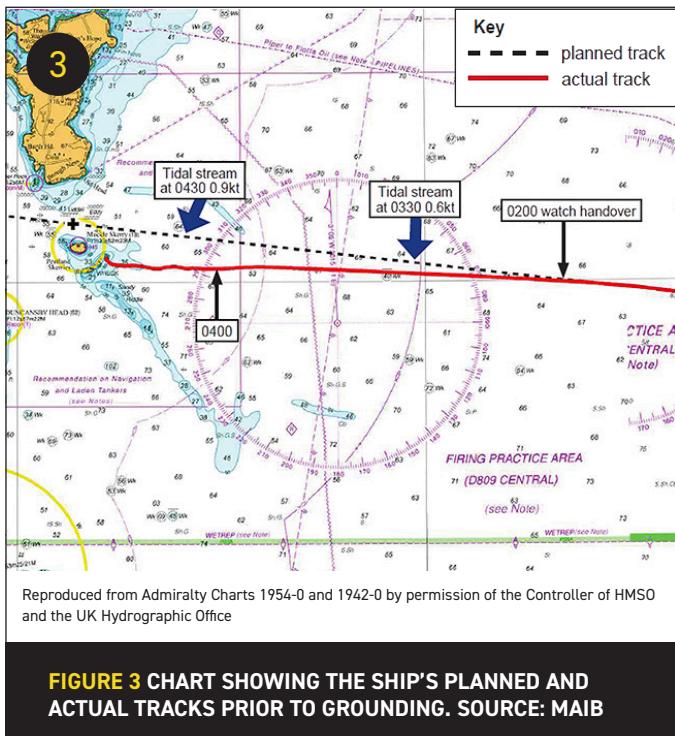
FIGURE 3 CHART SHOWING THE SHIP'S PLANNED AND ACTUAL TRACKS PRIOR TO GROUNDING.
SOURCE: MAIB

- The ship grounded because it had drifted to the south of the planned track due to the tidal stream while on autopilot. The OOW did not monitor the ship's progress for about two hours, while sitting in the bridge chair watching videos on his mobile phone. It is also possible that he fell asleep periodically during this period.

- Although there should have been sufficient time to regain the planned route when the OOW realised that the ship was off track, he instead chose a route between the islands that placed the ship in imminent danger. Reference to all navigational information, and not just the radar, would have led to a better decision.

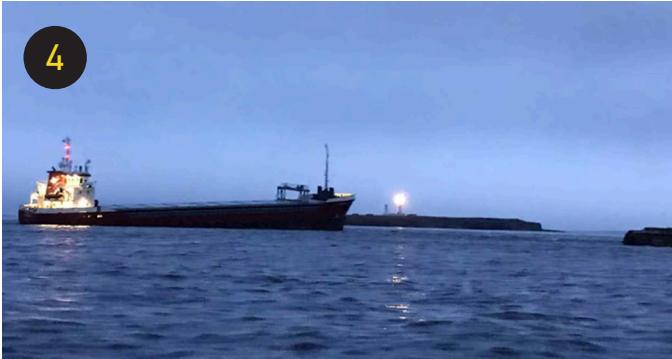
FIGURE 4 SHIP AGROUND WITH THE PENTLAND SKERRIES LIGHTHOUSE VISIBLE IN THE BACKGROUND.
SOURCE: MAIB

However, at 0443 the ECDIS depth alarm sounded as the ship crossed the 10 metre depth contour and then grounded seconds later on Pentland Skerries at a speed of 7kts (**FIGURE 4**). The sea was calm with light airs and good visibility in darkness. The tidal stream had been in a southerly to south-westerly direction in the period before the grounding.

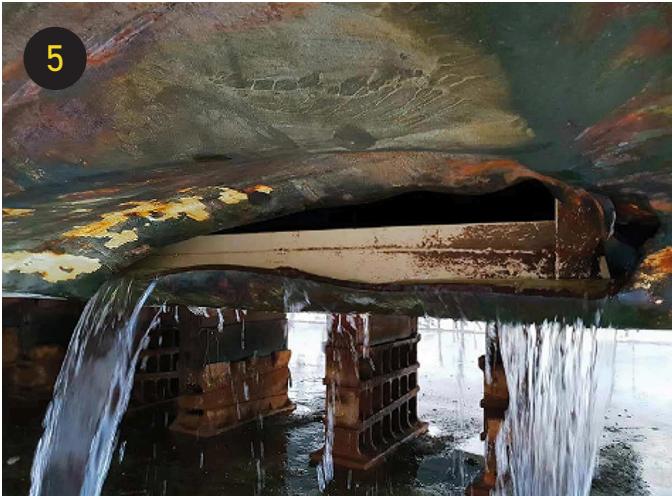
FIGURE 5 HULL DAMAGE. SOURCE: MAIB

No injuries or damage to the surrounding environment was reported, but the ship sustained extensive damage to its hull (**FIGURE 5**). The ship was refloated seven days after the incident, following the partial removal of cargo. After a diver inspection, the ship was able to proceed to Silloth under her own power to discharge the cargo before proceeding to dry dock.
