Death of electrician due to electrocution

Death of electrician due to electrocution**BACKGROUND**

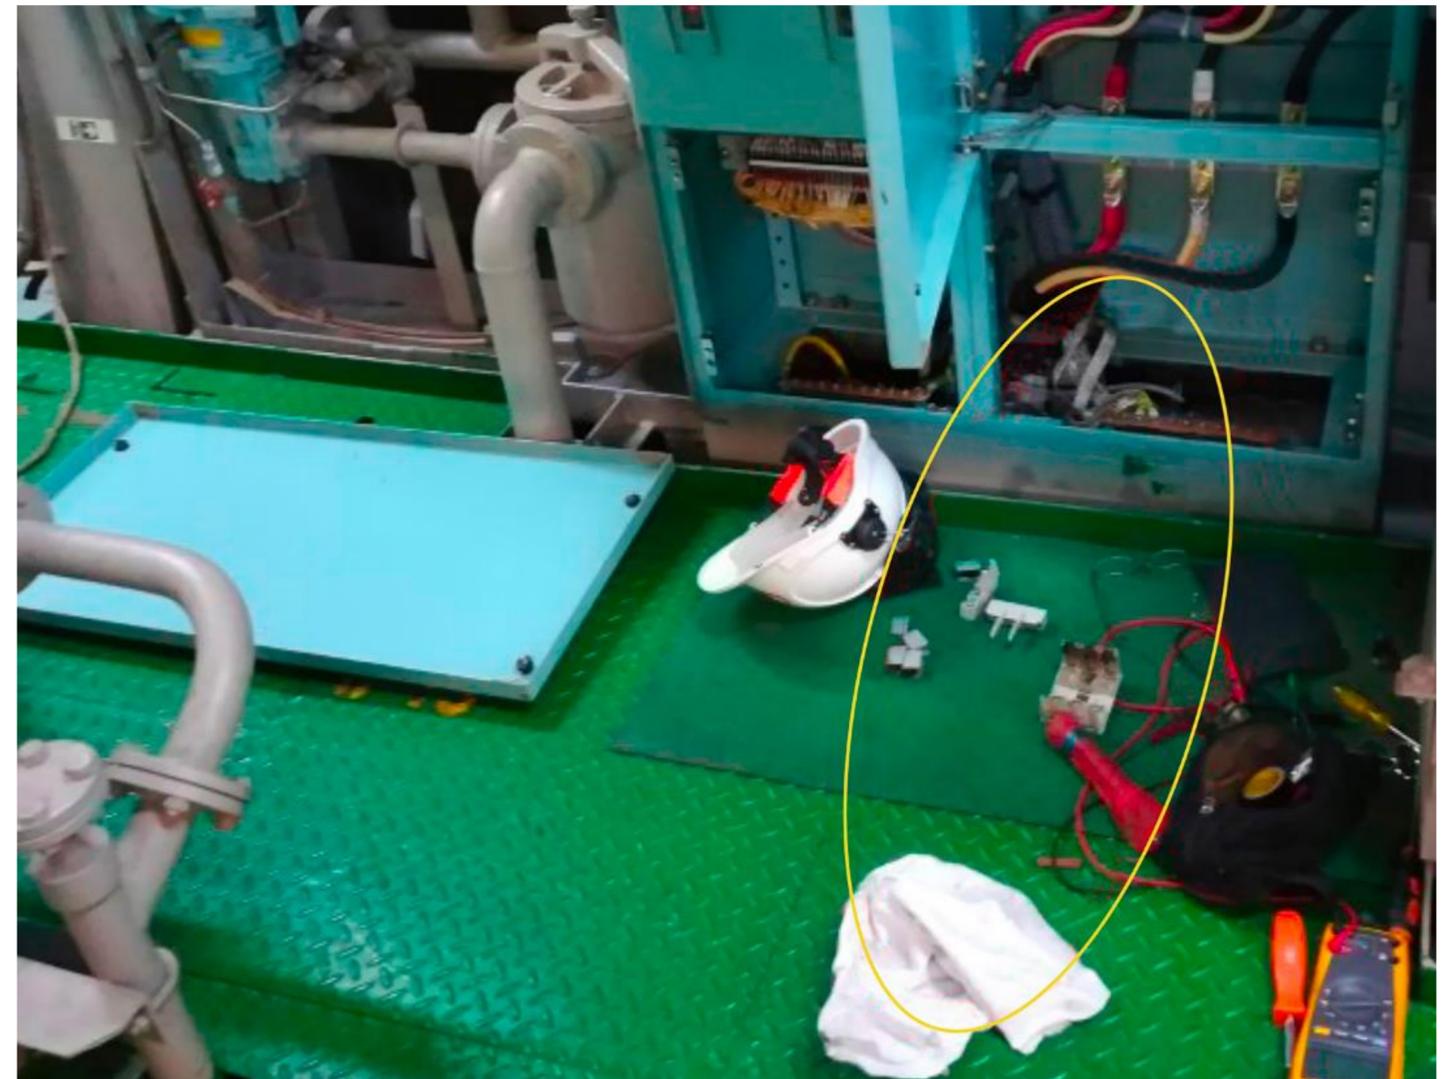
- At about 1130, the electrician told the engine cadet that he would be working on the IG scrubber pump starter panel.
- The cadet did not question the electrician about the work, nor did he tell any other engineering officer.
- At 1144, the engine control room (ECR) received a low 440V insulation alarm. The 2/E instructed the cadet to tell the electrician to investigate the cause.
- The cadet found the electrician unconscious, lying on the deck with his head and hands inside the lower section of the LGSP cabinet.

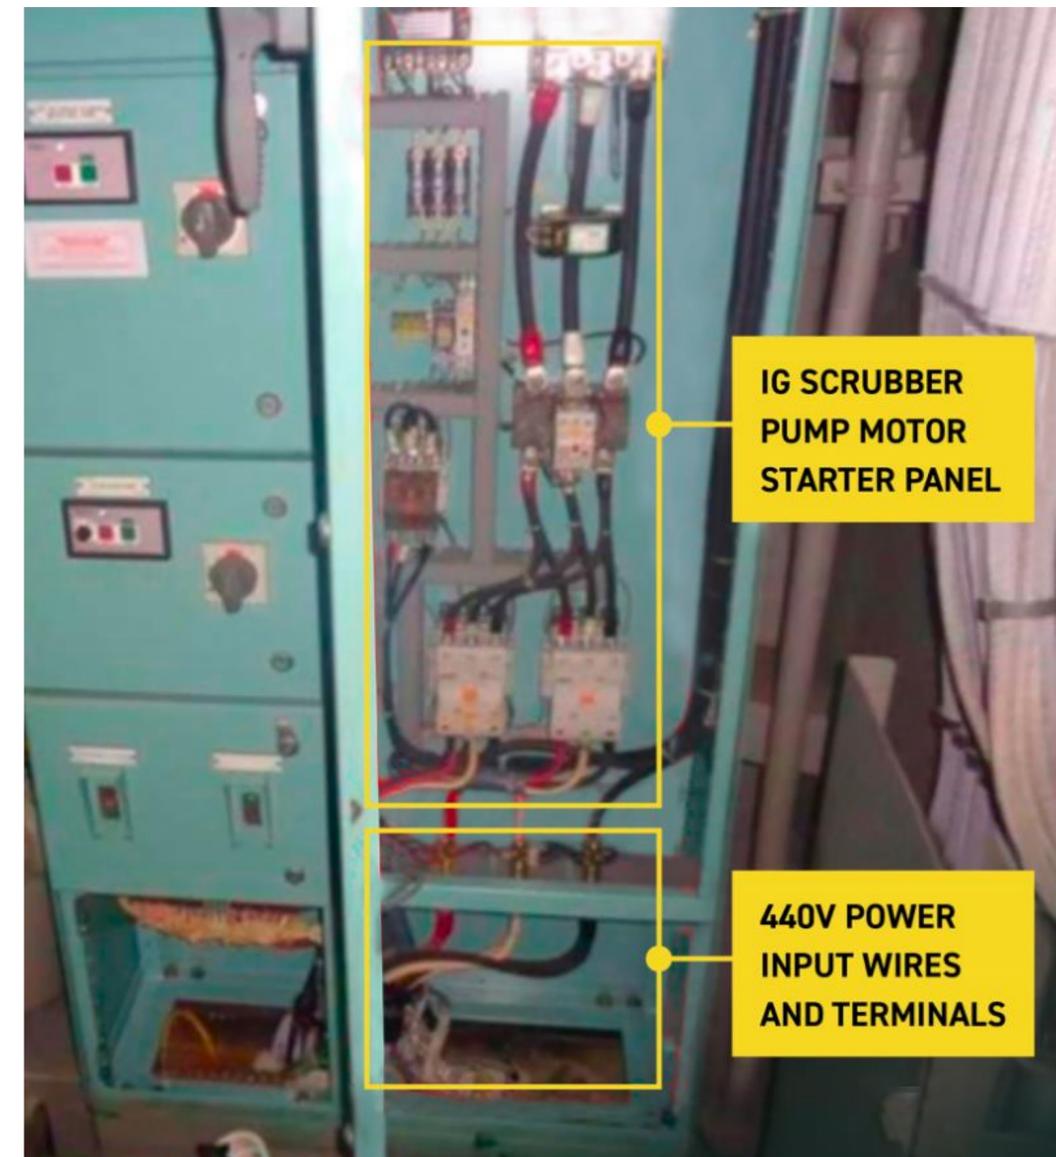
- The cadet then removed the electrician from the cabinet by pulling on his safety shoes.
- The cadet alerted the third engineer (3/E) and motorman working nearby. They moved the electrician further away, found he had no pulse and started cardiopulmonary resuscitation (CPR).
- A general alarm raised and emergency medical equipment brought to the scene. Despite continued CPR, the electrician could not be resuscitated.
- The ship diverted to a nearby port and the electrician was pronounced dead by shore medical personnel.

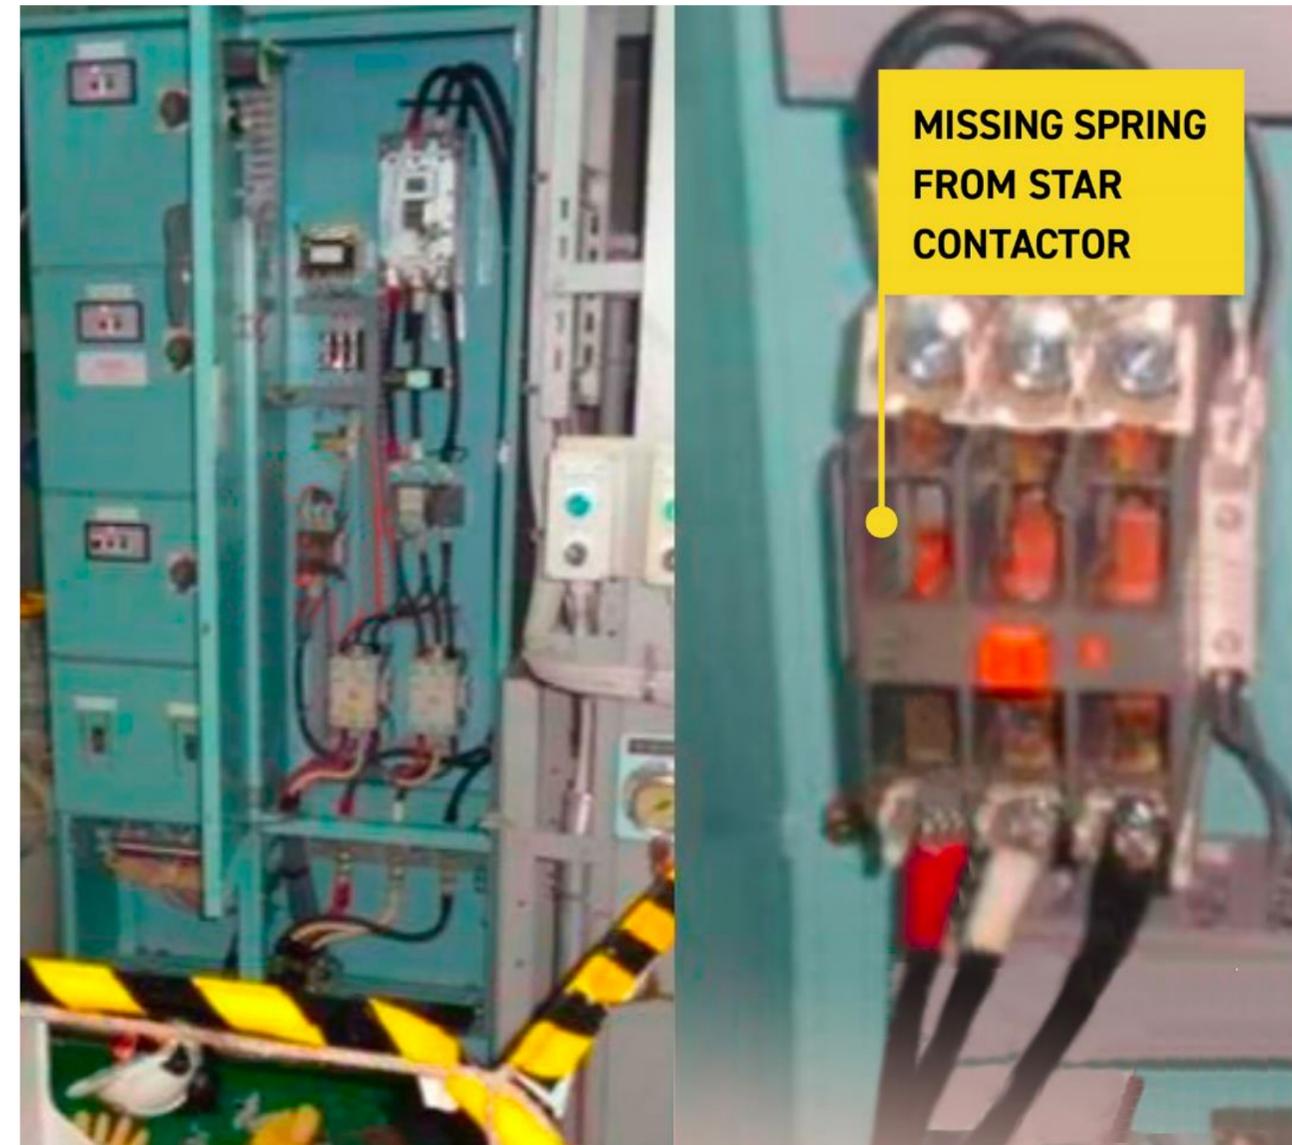
- Unlike other starter cabinets on the ship, the LGSP cabinet had no horizontal divider between the upper and lower section. Also the three power cable terminals in the lower section did not have covers over the power terminals to prevent accidental contact.

- The main circuit breaker inside the pump starter panel was found in the off (open) position.
- The star contactor for the pump starter was missing a spring and cover locking pin – they were found on the cabinet's lower framing and deck.
- The investigation presumed that the electrician inadvertently touched the energized 440V power terminals while retrieving the star contactor spring or the cover locking pin from the cabinet's lower section.

- **Physical barriers / electrical equipment protection** – If the cabinet had a similar section divider and terminal guarding as all other starter cabinets, it could have prevented this incident from occurring.
