Fatalities resulting from enclosed space entry

Fatalities resulting from enclosed space entry**BACKGROUND**

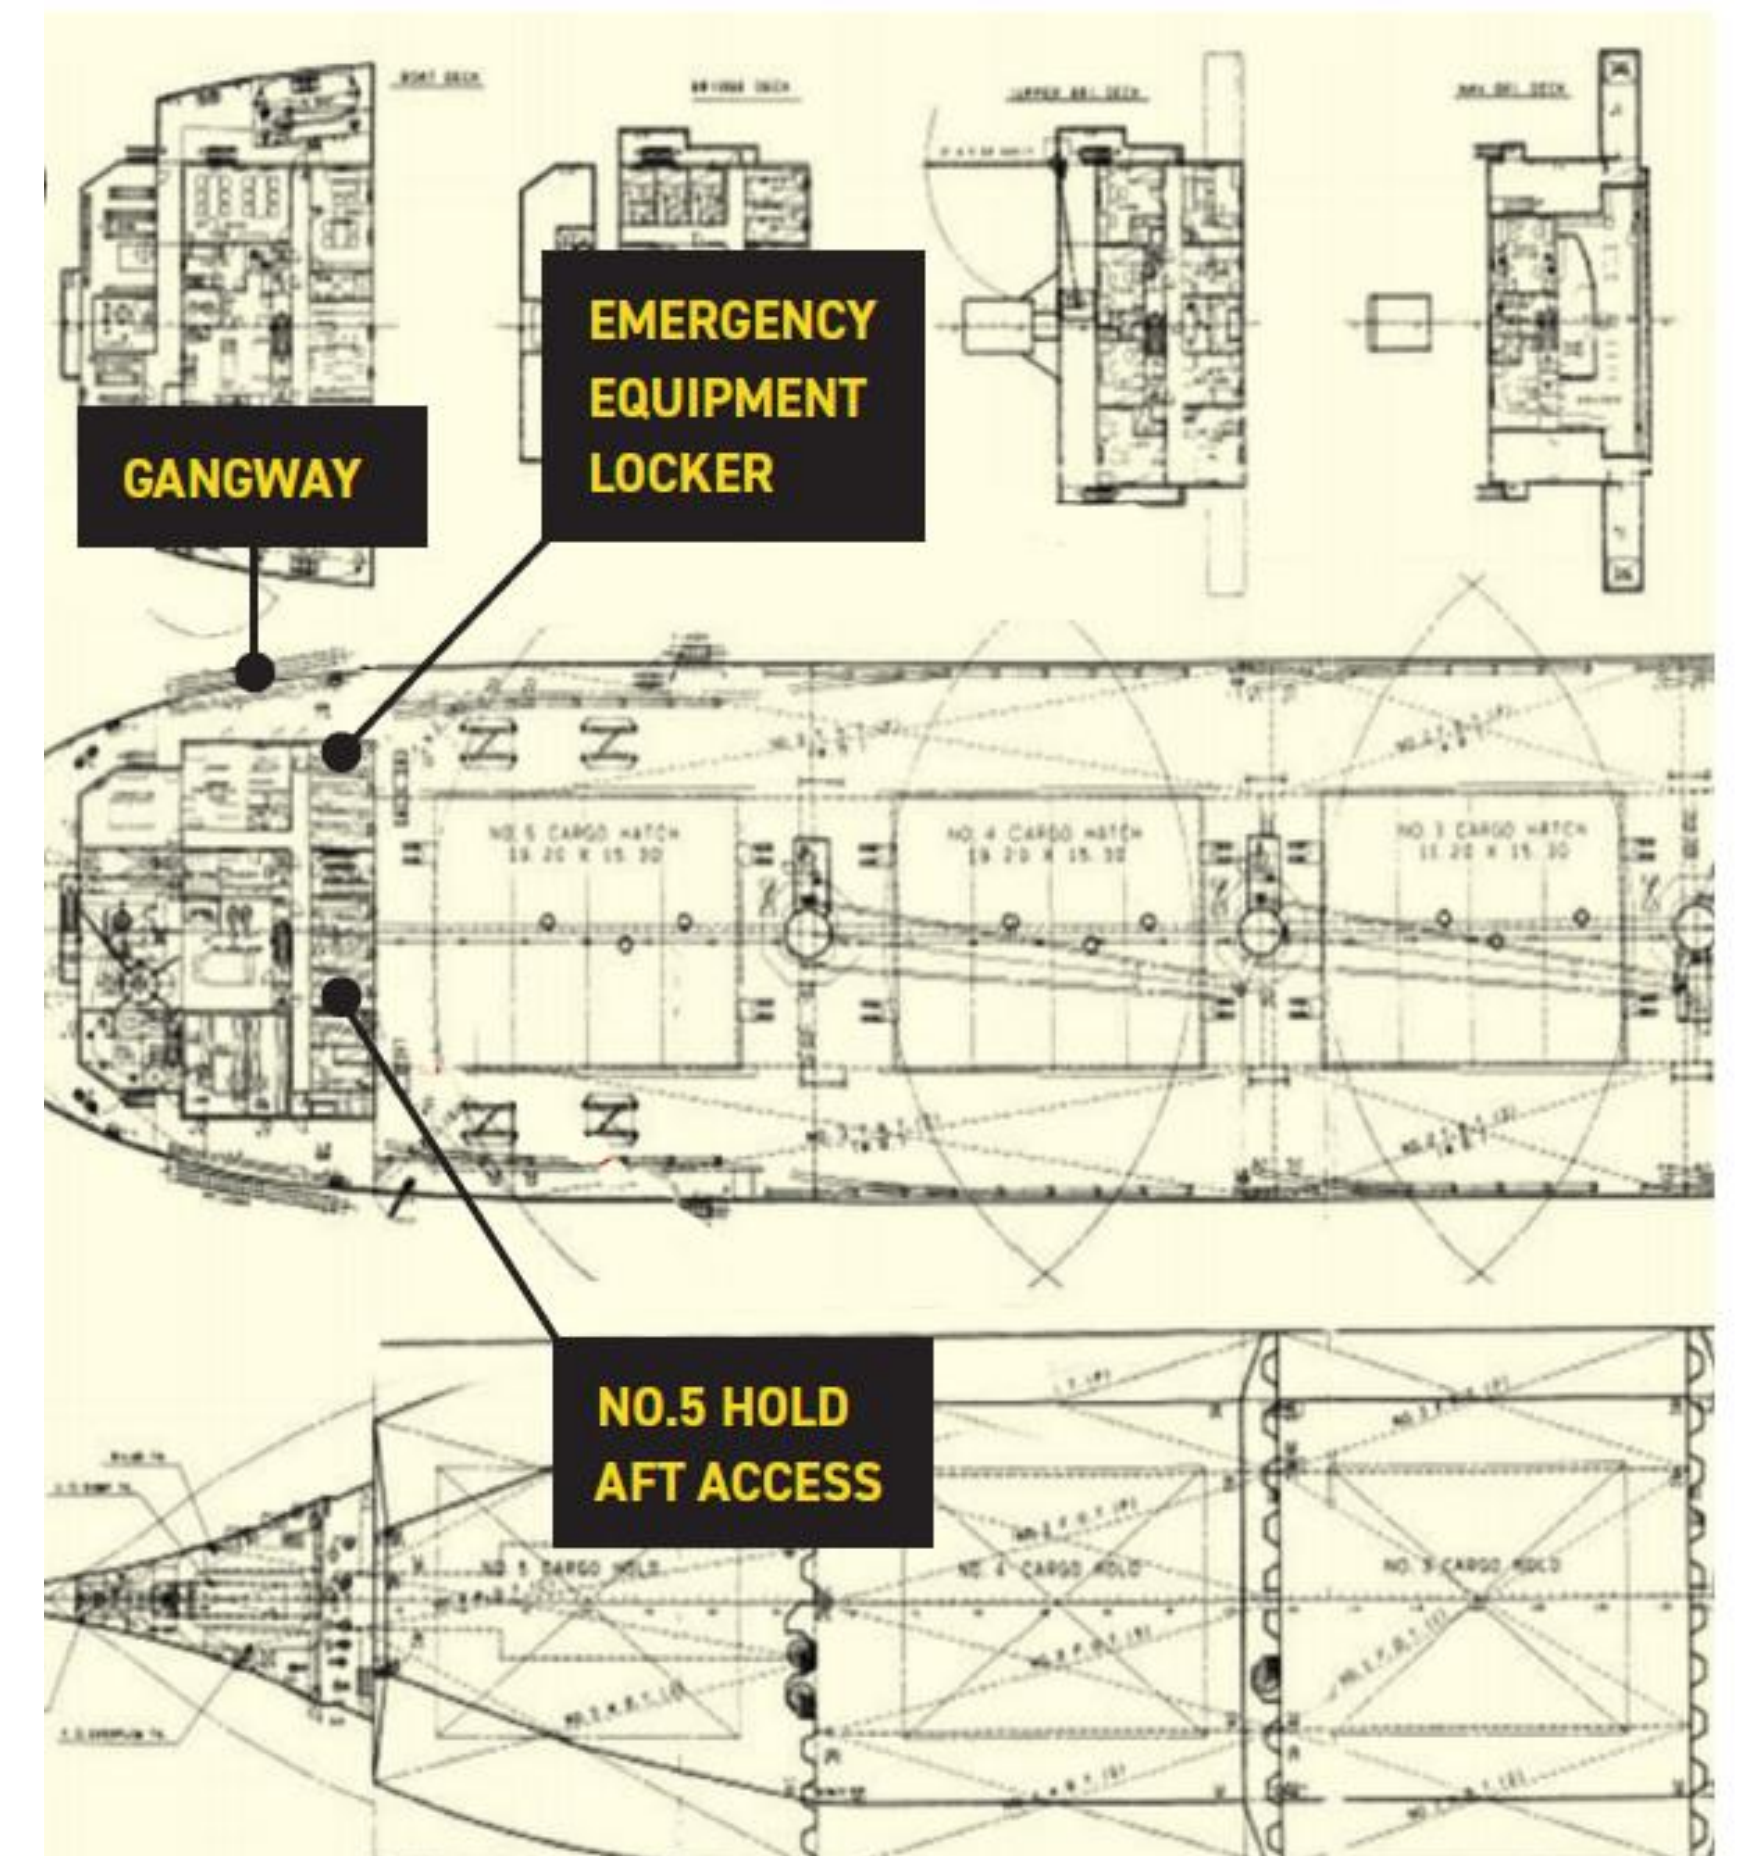
- On deck the C/O asked the bosun to follow him to hold No. 5
- On their way to the hold, the C/O told the bosun that he wanted to go down into the hold as there was water in it.
- The bosun asked him twice not to go down due to an unpleasant smell
- At the hold entrance they opened the access hatch and the C/O climbed onto the access ladder and descended
- The bosun tried to follow, but after the C/O had descended only 5 or 6 steps down the ladder, he suddenly fell onto the logs below.
- The bosun alerted the crew at the gangway, then made his way to the aft mooring station to get a rope to retrieve the C/O.

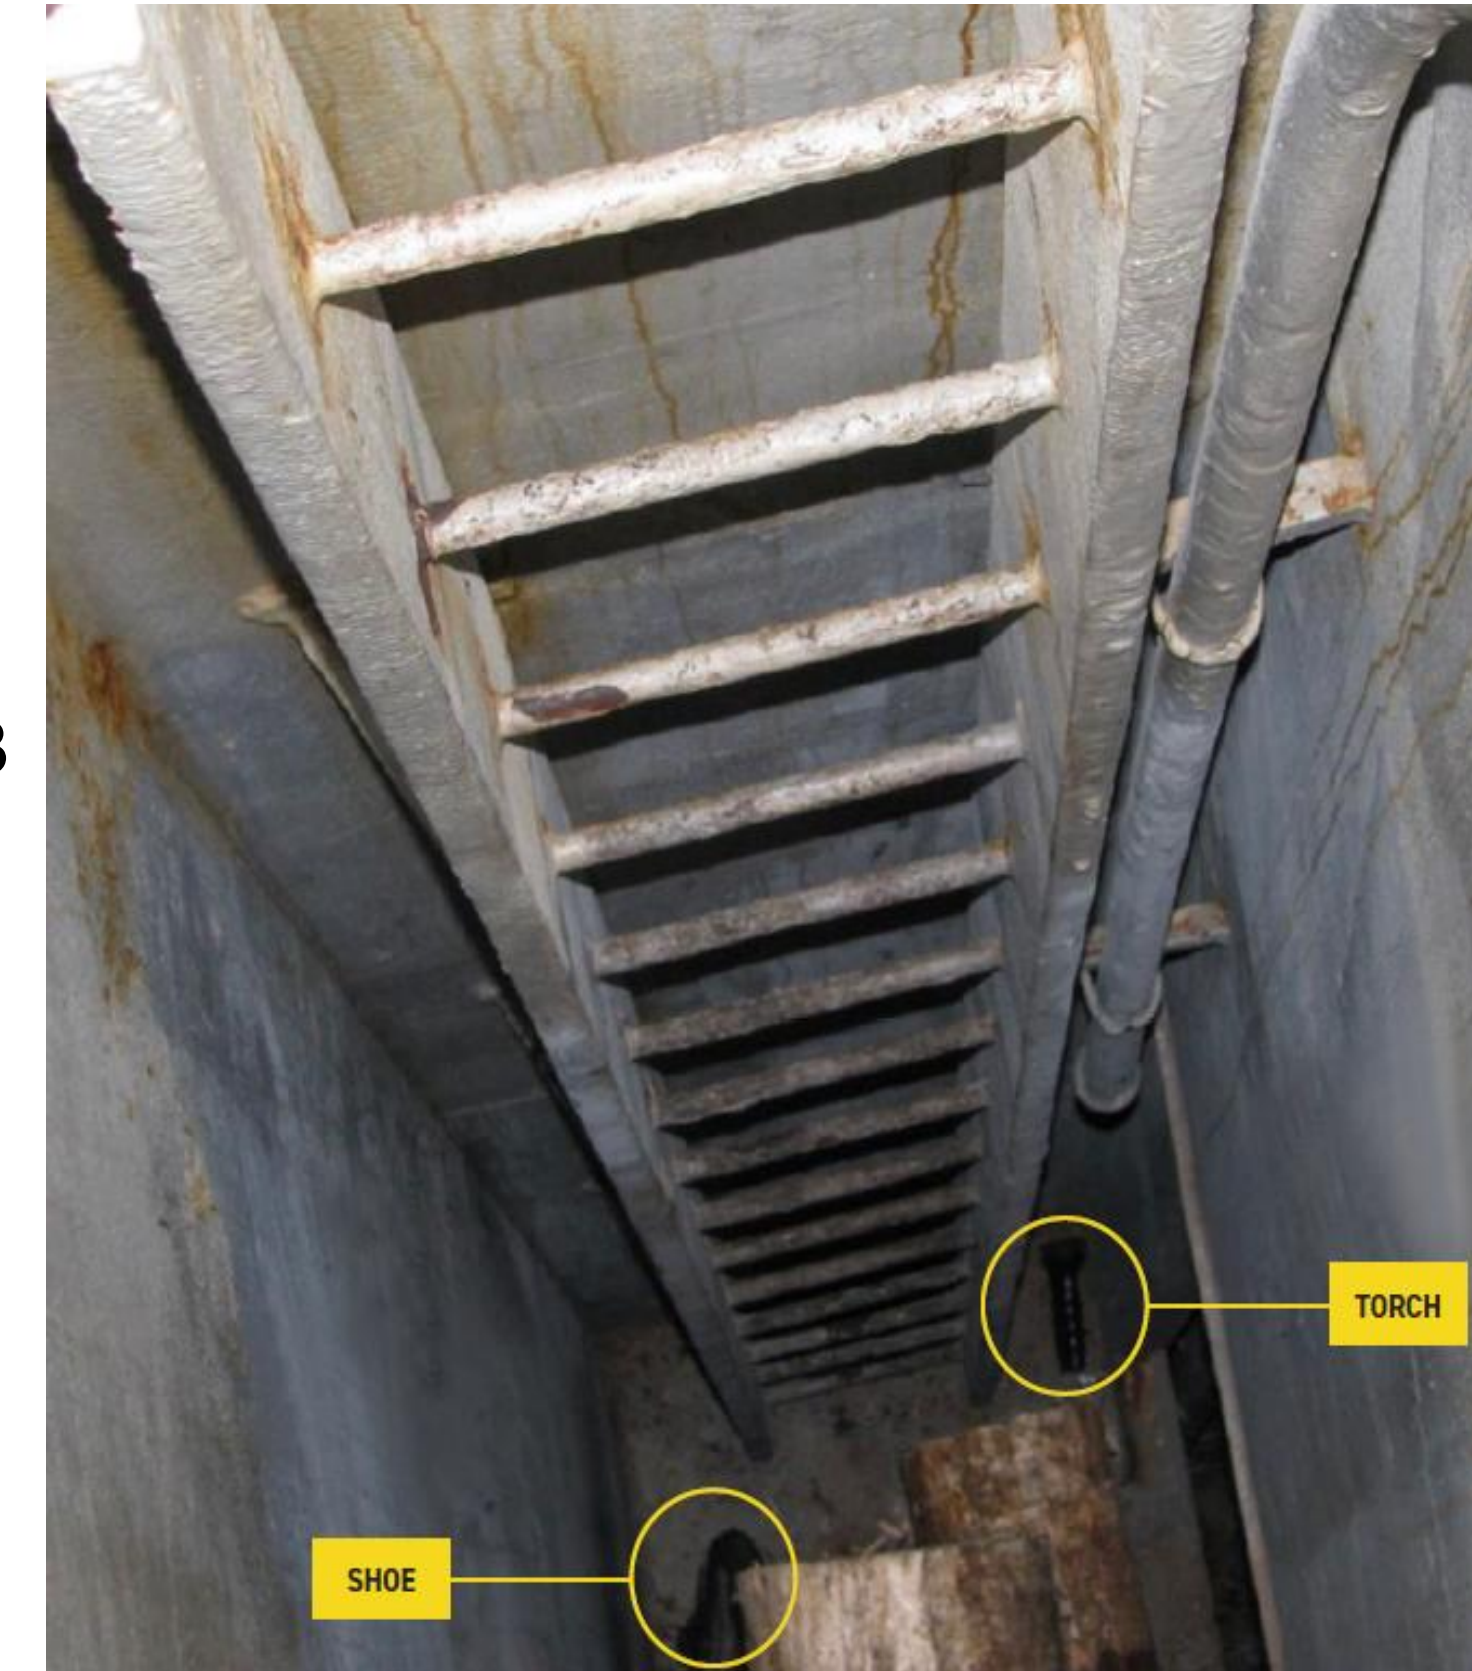
- As the bosun returned to the access, he found the AB who had alerted the 3/O, climbing down into the hold with another crew member about to follow.
- The bosun managed to prevent the last crew member from entering, but heard the AB fall. Looking down he noticed him lying, apparently unconscious, on top of the C/O.

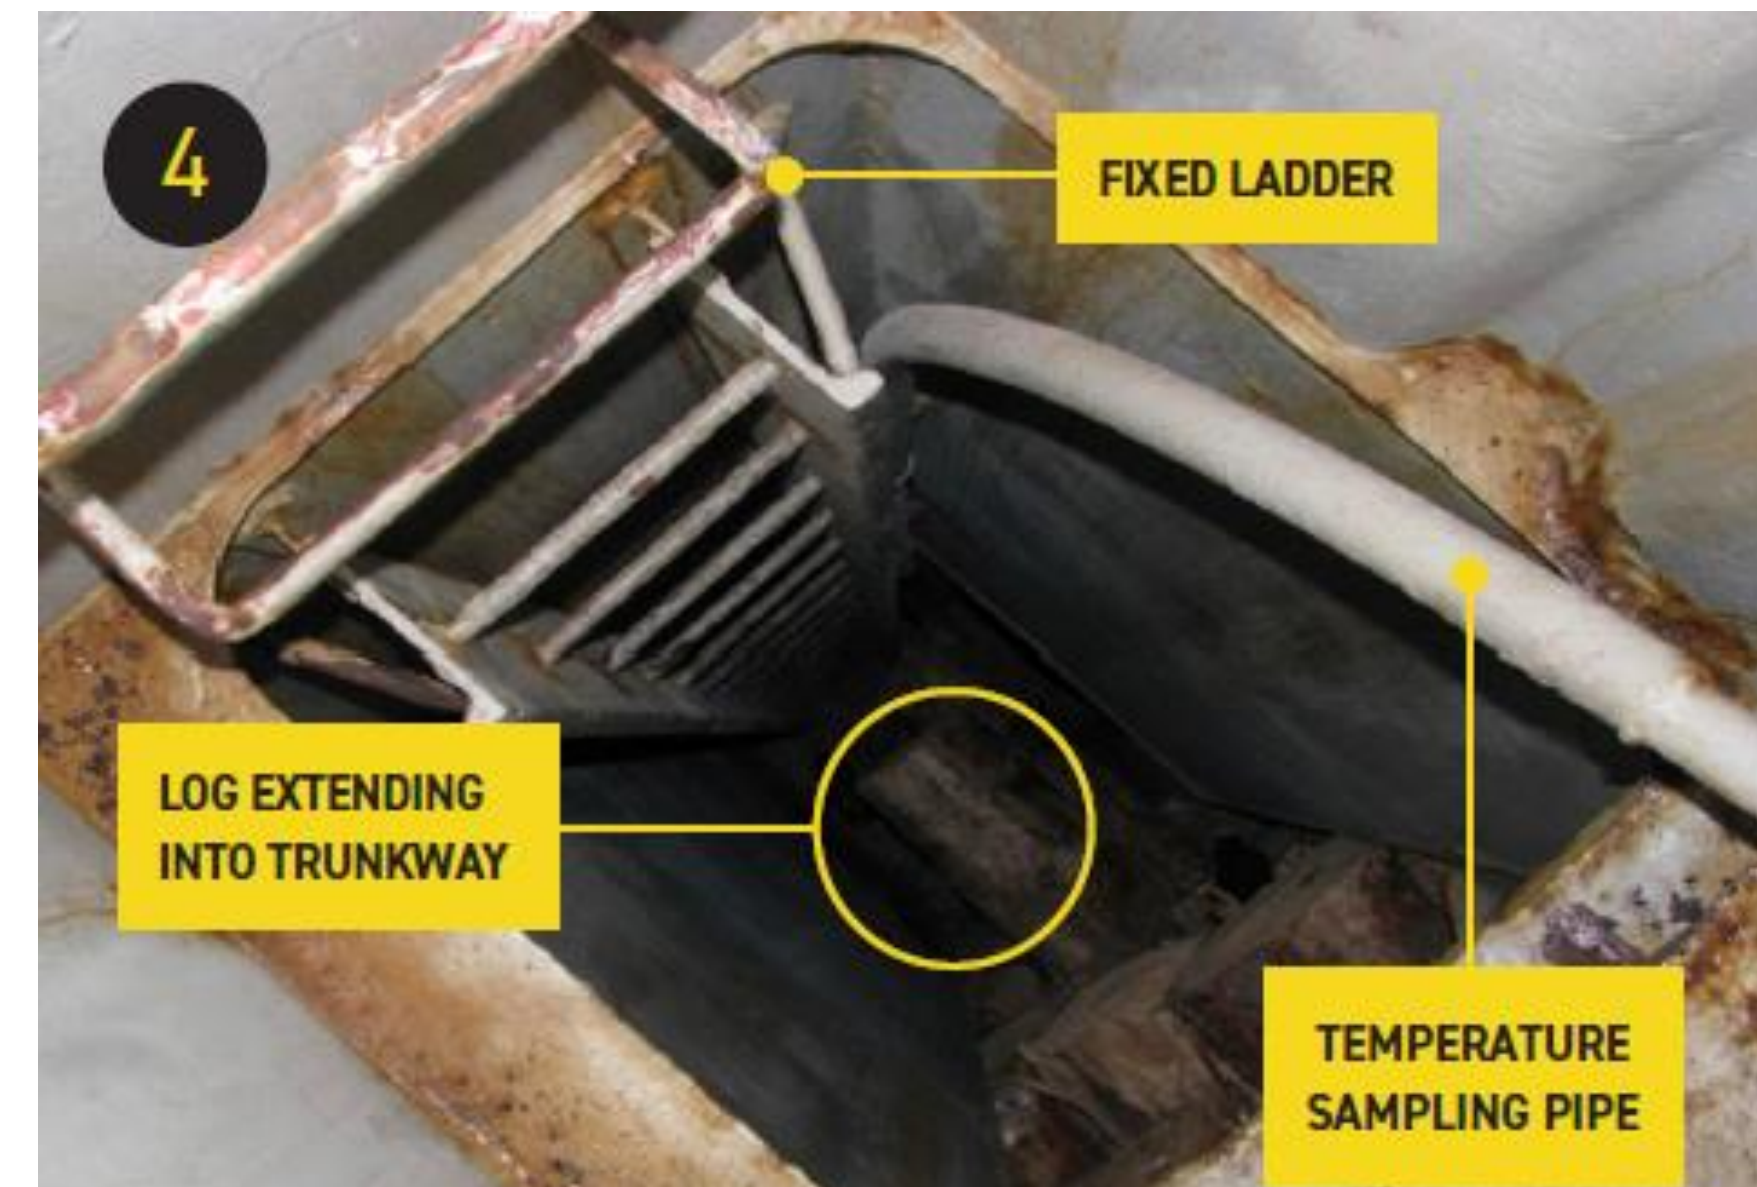
- The master arrived at the scene and instructed the 3/O to fetch a BA set and instructed the bosun and a crew member to raise the alarm.
- The master then went to the wheelhouse to activate the general alarm.
- On his way he informed the fumigation officials, who called the local emergency services to request an ambulance.
- The 3/O returned and put on the BA set, tied the rescue rope around his waist and entered the hold.
- He was able to tie the rope around the C/O, who was then hauled onto deck.
- The 3/O was too exhausted to attempt to rescue the AB, instead the first engineer (1/E) put on the other BA set and entered the access hatch.
- However, the BA set prevented him manoeuvring past a protruding log so he exited the hold and instead put on an emergency escape breathing device (EEBD) then re-entered.

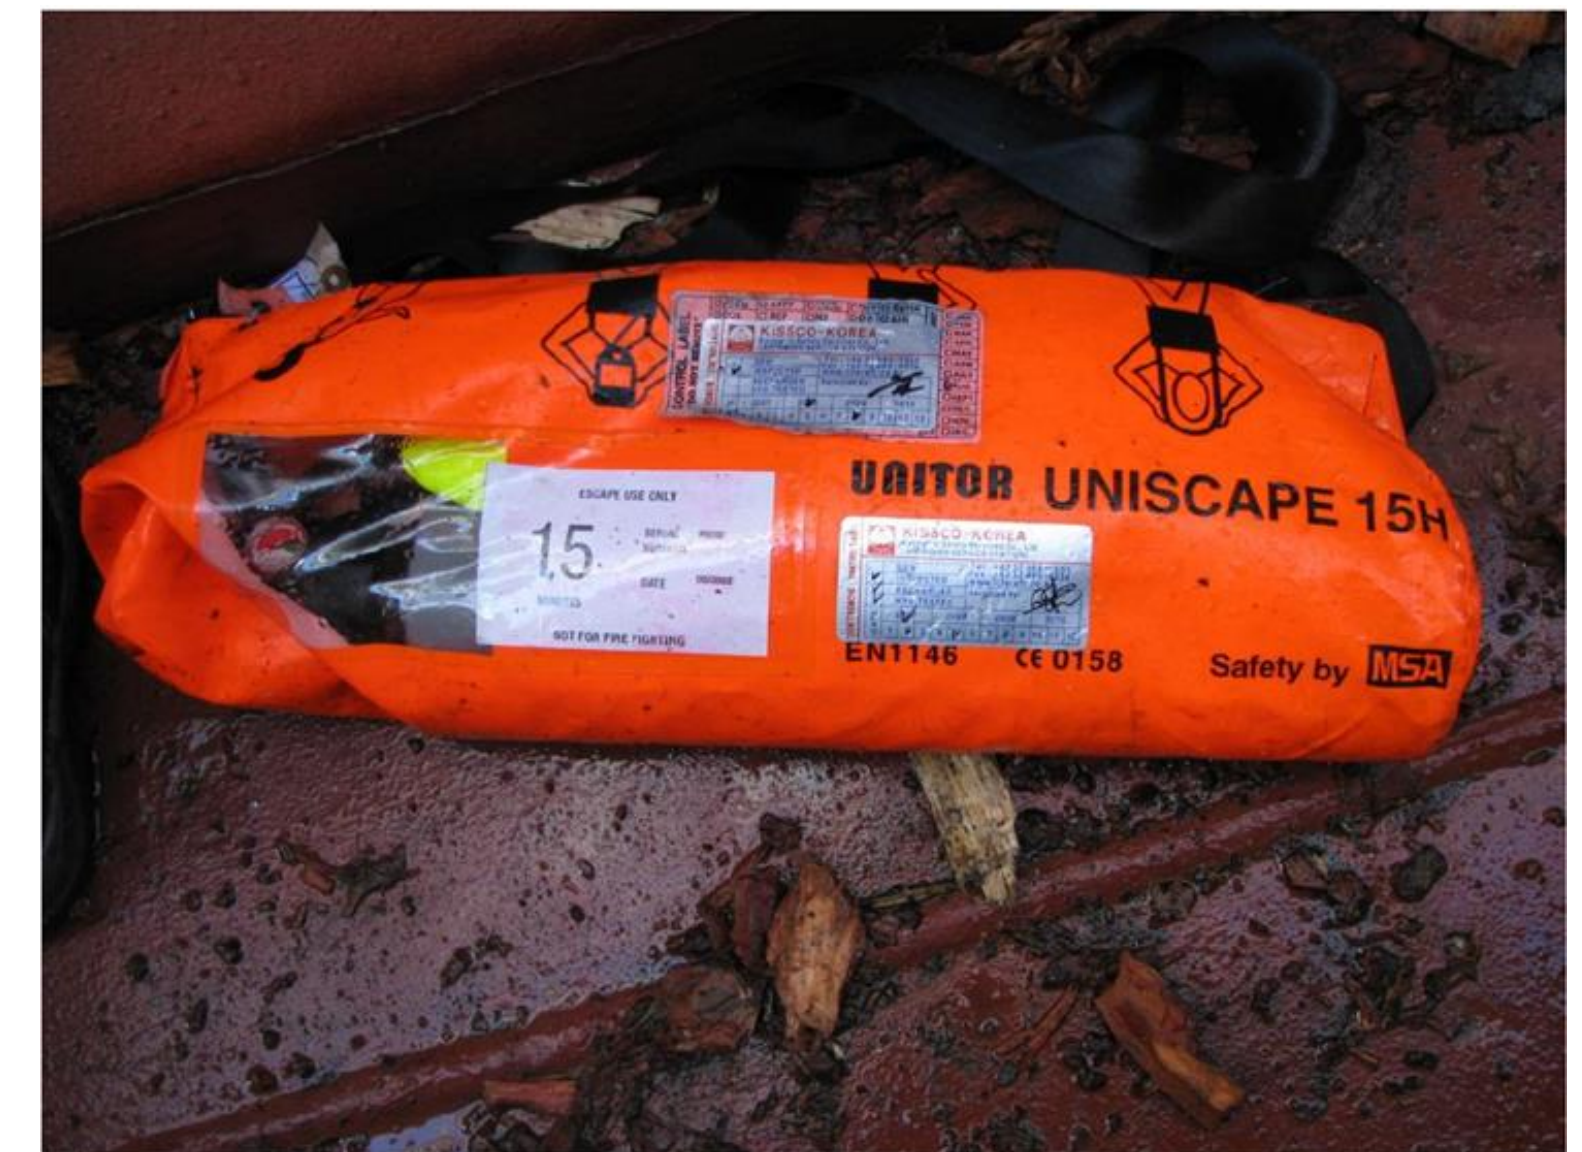
EEBD used during the rescue

- **Use of EEBD** – EEBD's are designed only to be used while escaping a hazardous atmosphere and should not be used to enter an oxygen deficient space
