DOUBLE FATALITY RESULTING FROM ENCLOSED SPACE ENTRY

A BULK CARRIER WAS LOADING LOGS IN PORT MARSDEN, NEW ZEALAND (NZ), WHEN THE CHIEF OFFICER (C/O) ENTERED CARGO HOLD NO.5 WHICH CONTAINED LOGS. UPON ENTRY HE RAPIDLY LOST CONSCIOUSNESS AND FELL FROM THE ENTRANCE LADDER ONTO THE CARGO BELOW (FIGURE 1). A FELLOW CREW MEMBER WHO ENTERED THE HOLD TO TRY TO RESCUE THE C/O SUFFERED THE SAME FATE. THEY WERE LATER BOTH PRONOUNCED DEAD AT THE SCENE.

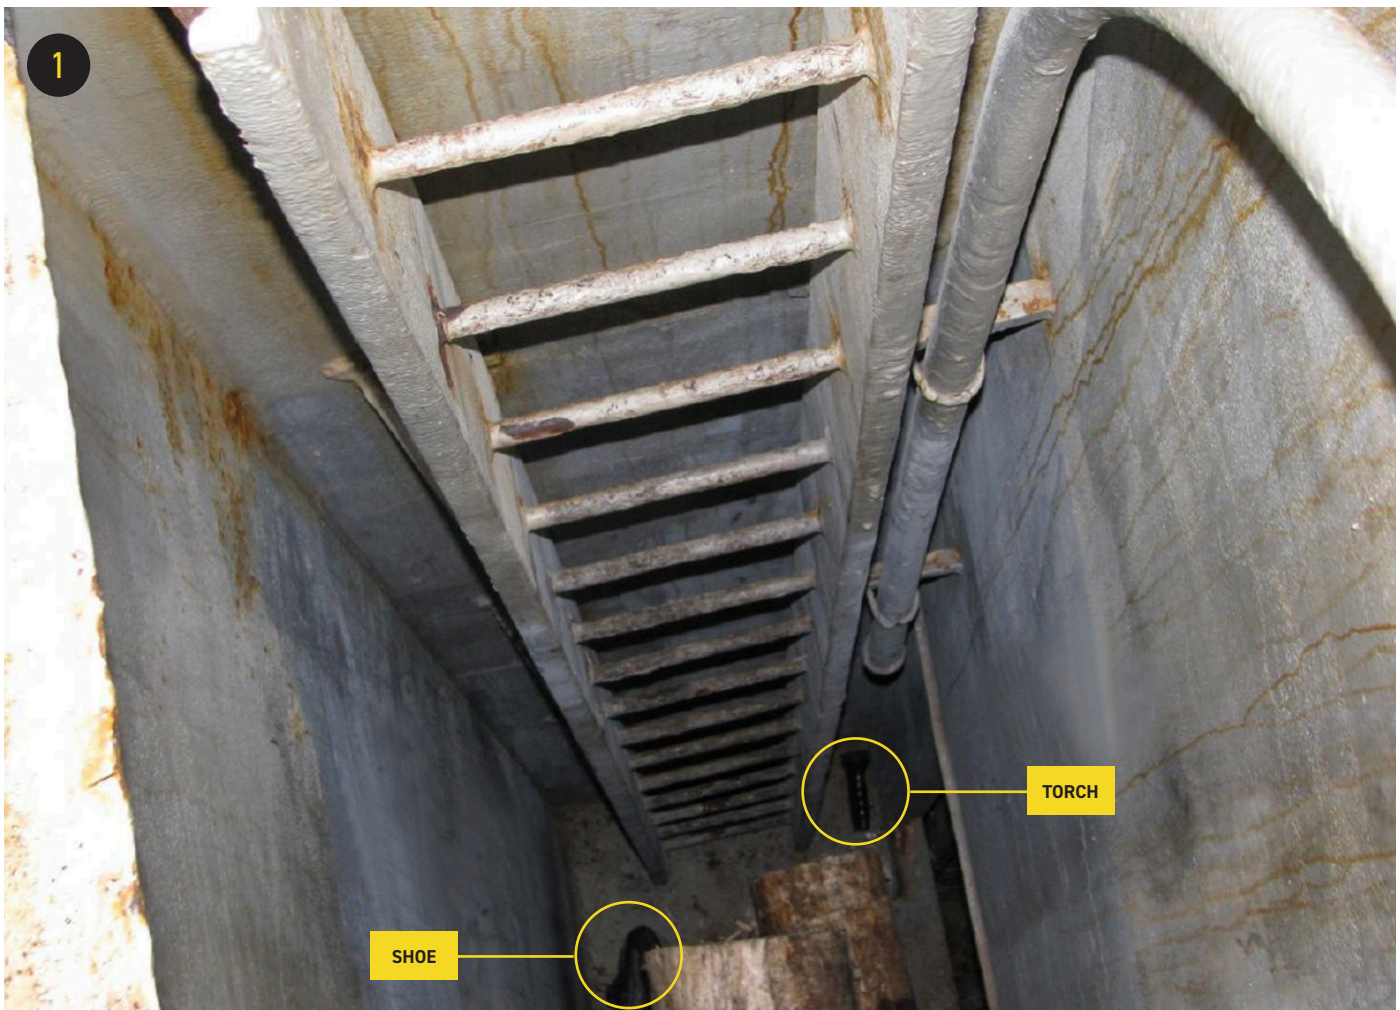
FIGURE 1 NO.5 HOLD AFT ACCESS SHOWING SHOE AND TORCH UNABLE TO BE RECOVERED
SOURCE INVESTIGATION REPORT BY THE TRANSPORT ACCIDENT INVESTIGATION COMMISSION, NEW ZEALAND

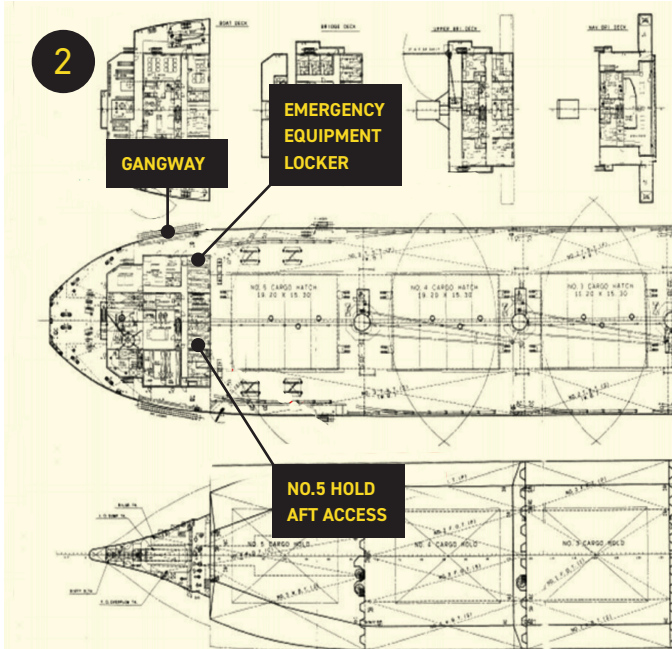
FIGURE 2 LOCATION OF CARGO HOLD NO.5 ENTRANCE.

On arrival in Port Marsden on 2 May, another 11,476m³ of logs were loaded. The logs were to be fumigated on passage to China, and on 3 May, two fumigation officials embarked to carry out a pre-inspection to ensure the ship was compliant for the fumigation. They reported to the master that hatches 1F to 4F had excessive amounts of water visible, which needed to be removed before fumigation could take place, and that the rubber seal on hold No. 5 aft access door (**FIGURE 2**) needed replacing.

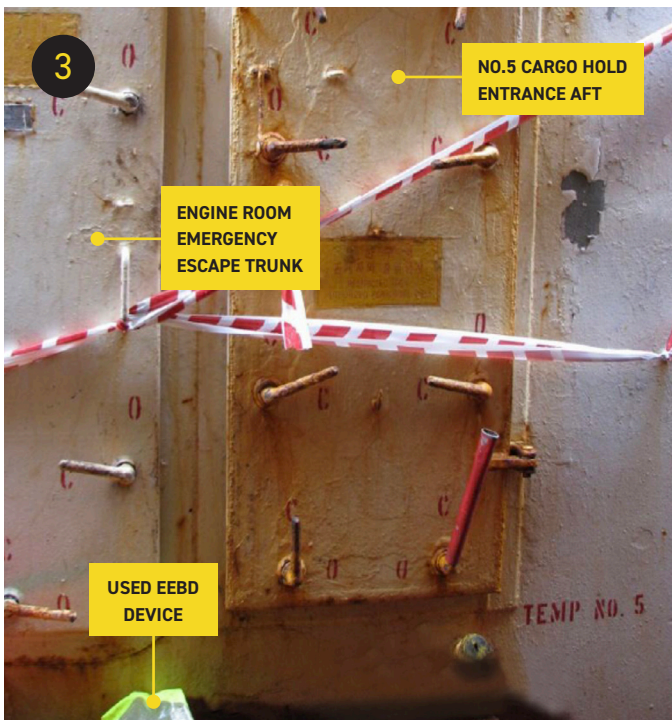
The C/O and bosun opened the access hatch (**FIGURE 3**) and the C/O climbed onto the ladder. He then said "OK, no problem" and started to descend. The bosun tried to follow, but after the C/O had descended only 5 or 6 steps down the ladder, he suddenly fell onto the logs below. The bosun immediately alerted the crew at the gangway, then made his way to the aft mooring station to get a rope to retrieve the C/O.

FIGURE 3 ENTRANCE DOOR TO NO.5 CARGO HOLD AFT

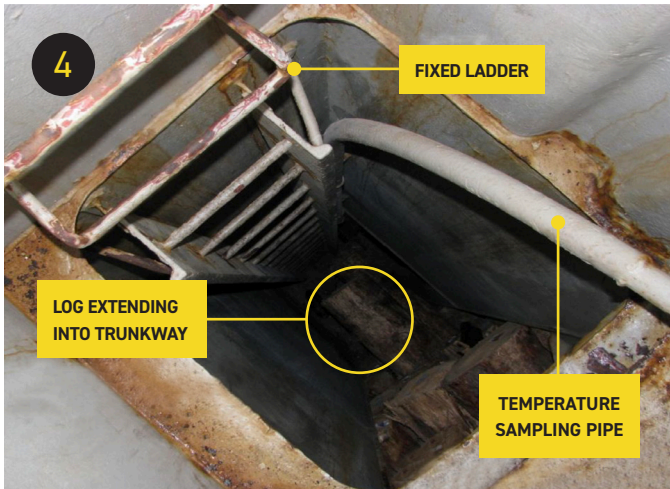
FIGURE 4 NO.5 AFT HOLD LADDER FROM INSIDE HOLD ENTRANCE DOOR

As the 3/O was too exhausted to attempt to rescue the AB, the first engineer (1/E), who had by now arrived, put on the other BA set and entered the access hatch and descended down to the hold. However, the BA set prevented him manoeuvring past a protruding log ((**FIGURE 4**)) so he exited the hold and instead put on an emergency escape breathing device (EEBD) (**FIGURE 5**), then re-entered. When he got to the AB, he noticed what he thought were signs of life. He took off his EEBD mask and placed it momentarily on the AB to try to revive him. He then replaced his mask and managed to attach the rescue rope to the AB, who was hauled onto deck. As the 1/E was nearing the top of the access ladder his EEBD ran low on compressed air, and he had to be hauled out. When he reached the upper deck, he was suffering from asphyxia.

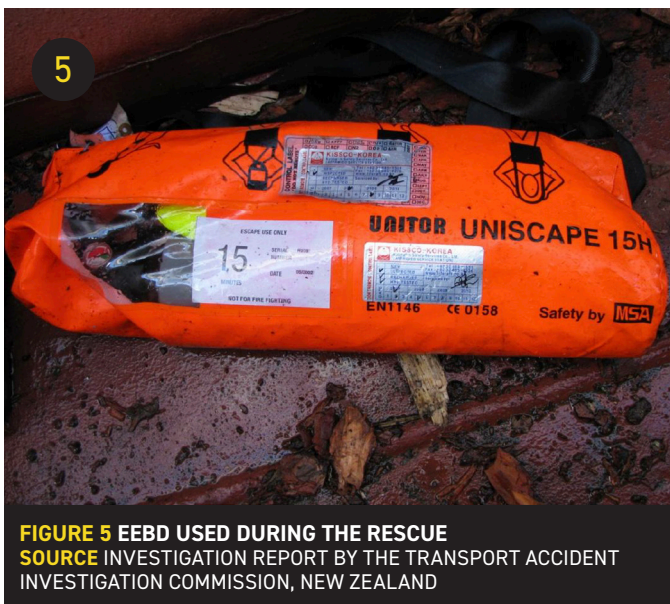
FIGURE 5 EEBD USED DURING THE RESCUE

- EEBDs are designed only to be used while escaping a hazardous atmosphere and should not be used to enter an oxygen deficient space.
