Scaffolding fall causes serious injuries

BACKGROUND

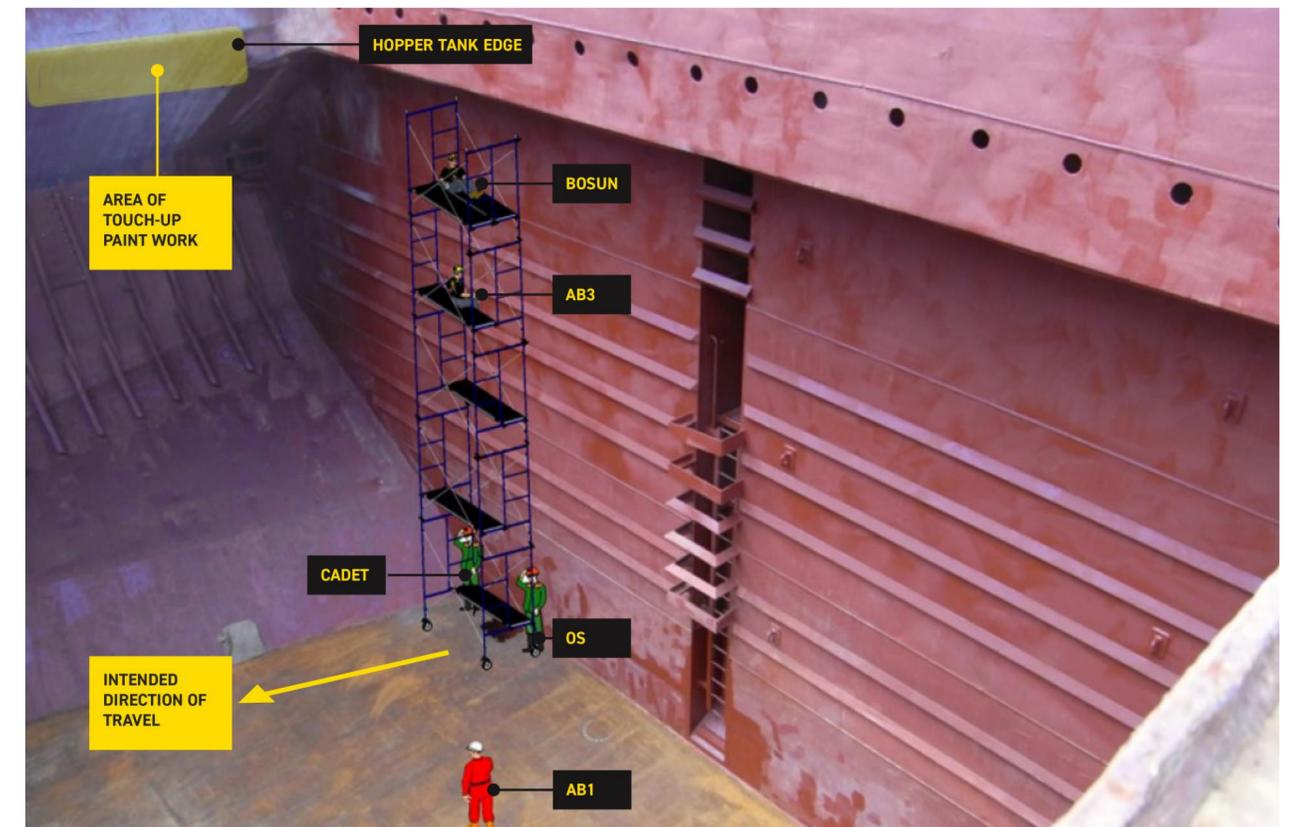
- Having finished the aft bulkhead, the bosun decided to touch up the hopper tank edge. He instructed the OS and cadet to move the tower forward; the AB3 was aware.
- The cadet and OS released the securing lines and went down into the hold.
- At about 1410 they released the wheel brakes and started to push the structure forward with the bosun and AB3 still in position near the top of tower.
- The tower moved about 0.5m when it suddenly toppled forward on to the deck, along with the bosun and AB3.
- The tower came apart on impact with the tank top and the bosun and AB3 were entangled in the scaffolding.
- AB1, the OS and cadet went to assist, while the master, who had been in his cabin, went on deck to investigate.

Hold No.4 showing the position of scaffolding tower, crew members and direction of movement

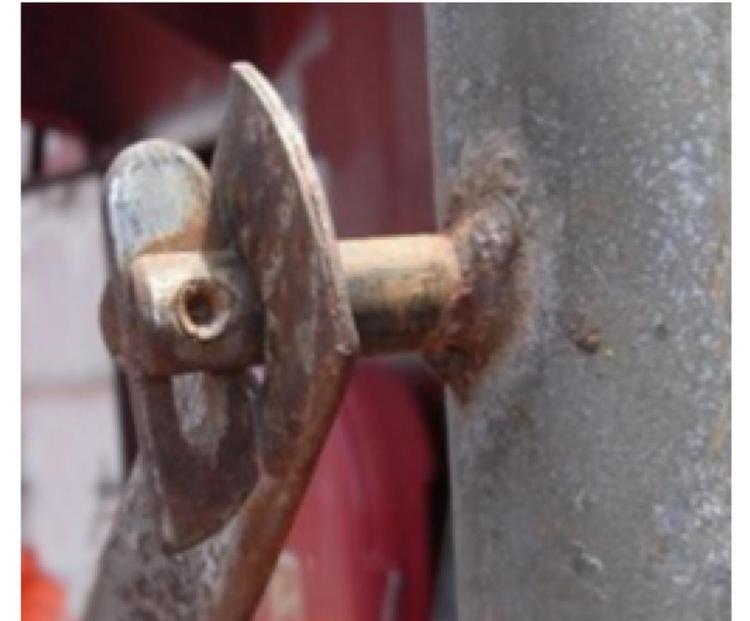
- The bosun and AB3 were given first aid on the tank top deck, before later being moved to the main deck.
- Between about 1700 and 1830, they were airlifted by helicopter to hospital.
- The bosun received multiple injuries to his pelvis, chest and arm and AB3 sustained a fractured sternum and back injury. They remained in hospital for 19 and 8 days respectively.
- Subsequent inspection of the scaffolding identified that it had no manufacturer's identification plate, and all components showed signs of regular use, wear and tear, damage and some repairs.
- This included missing securing pins on some connections, loose and bent cross bracing, loose cross brace locking pins and inoperative swivel wheel brakes on three of the four wheels.

Loose scaffolding cross brace locking pins

- **Scaffolding condition** – The incident could not be directly attributed to any of the identified defects on the scaffold tower. However, these would have exacerbated the instability of the structure. Scaffolding should always be in good condition and fit for purpose. It should also comply with relevant standards and be suitable for the work to be carried out.

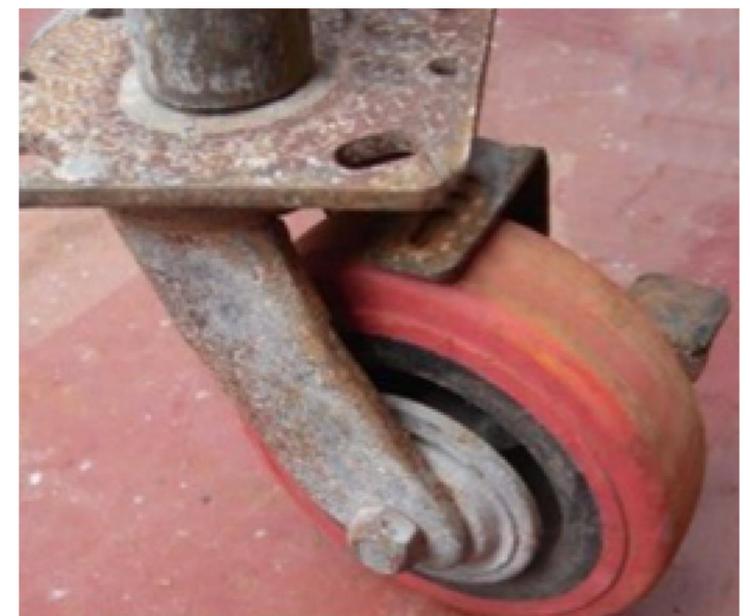
Inoperative scaffolding swivel wheel brake
