Engine Room Fire

- **FERNANDA** a 2,576GT Ro-Ro ship built in 1982 (Figure 1) was nearing the end of her voyage, when a fire broke out in the engine room.
- The vessel was not certified for unmanned machinery space operation.
- So at the time of the incident the Second Engineer (2/E) and one rating were on watch in the engine room.
- At the beginning of his watch, the 2/E recorded the machinery parameters in the log book indicating that everything was per normal operations.
- He then carried out maintenance work on a lub. oil separator, before the C/E instructed him to retrieve some fuel injectors at the engine room store located on upper deck.
- Meanwhile the rating on watch with the 2/E was working in the Electrician's Store also located on the upper deck.

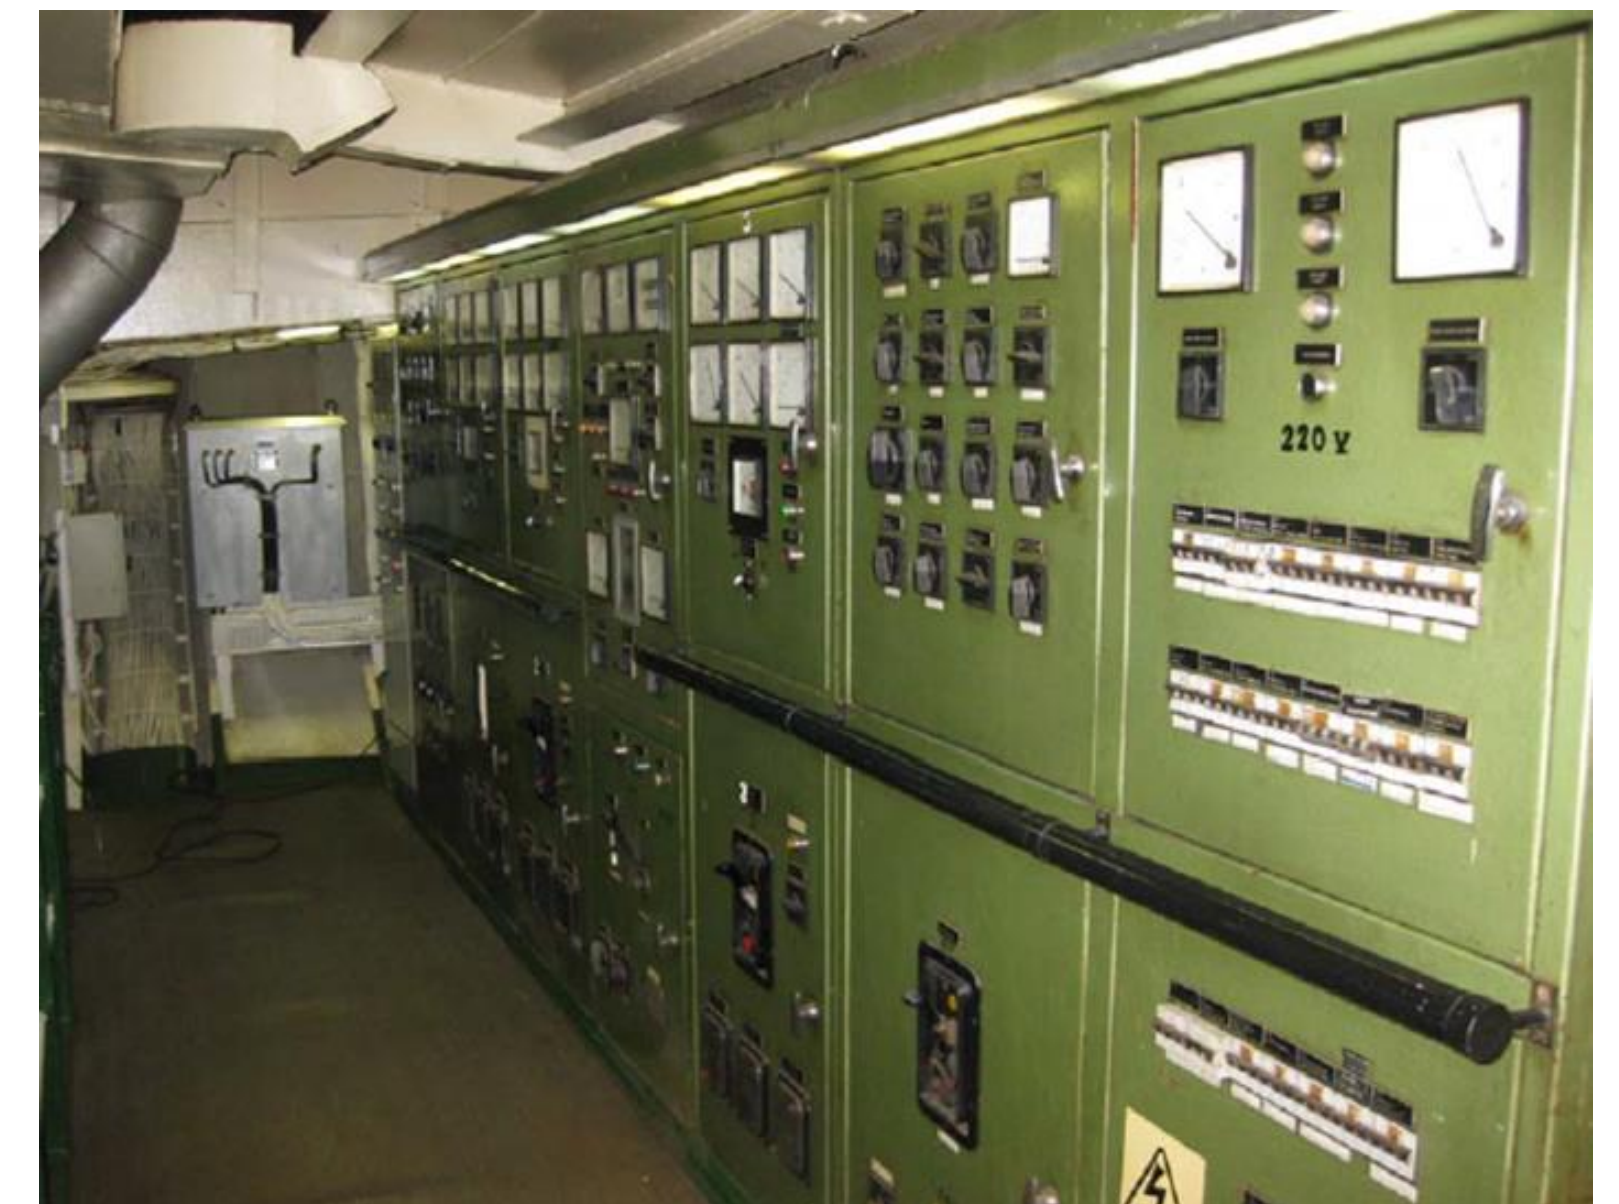
Main switchboard

- Following the incident an investigation were conducted and, as far as it could be determined, the fire started in the main switchboard.

- **Switchboard** – It is believed that fire started in the main switchboard. It then quickly spread upwards through open accesses to the funnels and later to the crew accommodation and the upper tween deck cargo compartment. However, as the switchboard was extensively damaged during the fire it was not possible to be certain that this was the cause of the fire.
