### ENGINE ROOM FIRE

THE *FERNANDA* A 2,576GT RO-RO SHIP BUILT IN 1982 (FIGURE 1) WAS NEARING THE END OF HER VOYAGE, WHEN A FIRE BROKE OUT IN THE ENGINE ROOM. DESPITE AN EARLY DECISION TO DEPLOY THE SHIP'S FIXED HALON FIREFIGHTING SYSTEM THE FIRE COULD NOT BE EXTINGUISHED, AND THE CREW HAD TO BE EVACUATED BY HELICOPTER. NO CREW MEMBERS WERE INJURED. HOWEVER, THE FIRE WAS NOT COMPLETELY EXTINGUISHED UNTIL 8 DAYS LATER AND THE SHIP WAS EVENTUALLY DECLARED A CONSTRUCTIVE TOTAL LOSS (FIGURE 2).

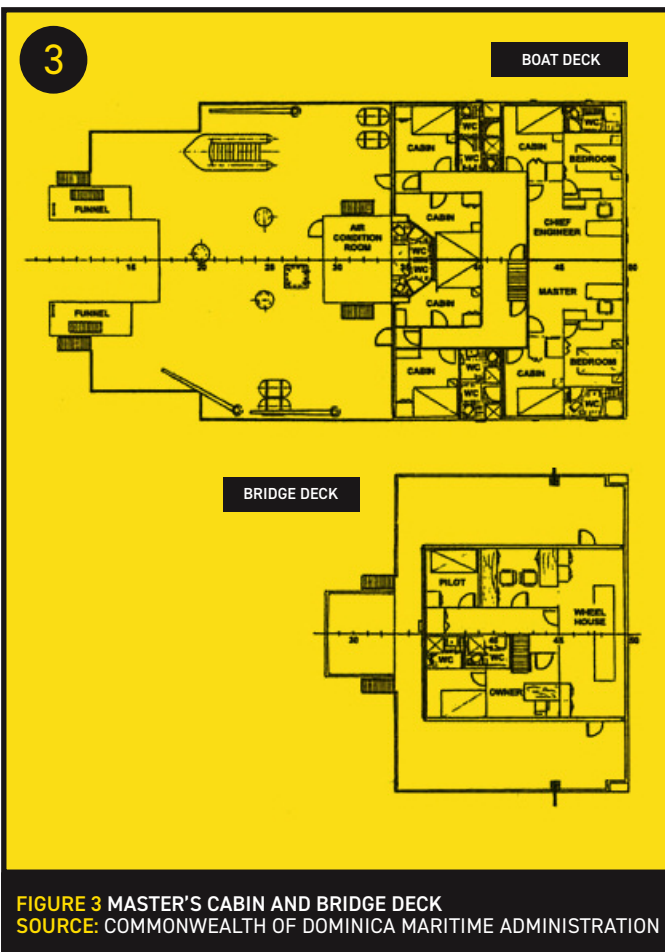
The Master was in his cabin when about 1250 UTC he heard the alarm from the fire detection panel and immediately went to the bridge (**Figure 3**). The machinery space and steering room fire detector was illuminated. He tried to reset the detector but could not do so. The Bosun was on the bridge so the Master instructed him to proceed to the engine room to assess the situation. The Bosun quickly returned and reported that heavy smoke was coming from the starboard side of the engine room. As the 2/E returned to the engine room he met the Bosun who said the steering room was on fire. The 2/E had not heard the fire alarm and opened the door to the engine room and noted heavy smoke. At that moment the main engine stopped which resulted in a power blackout and the emergency lighting came on. He then went to the door on the other side of the engine room and noted that the smoke was not as heavy but still could not be entered without wearing a breathing apparatus (BA). The Master made an announcement on the public address calling the crew to their fire stations.

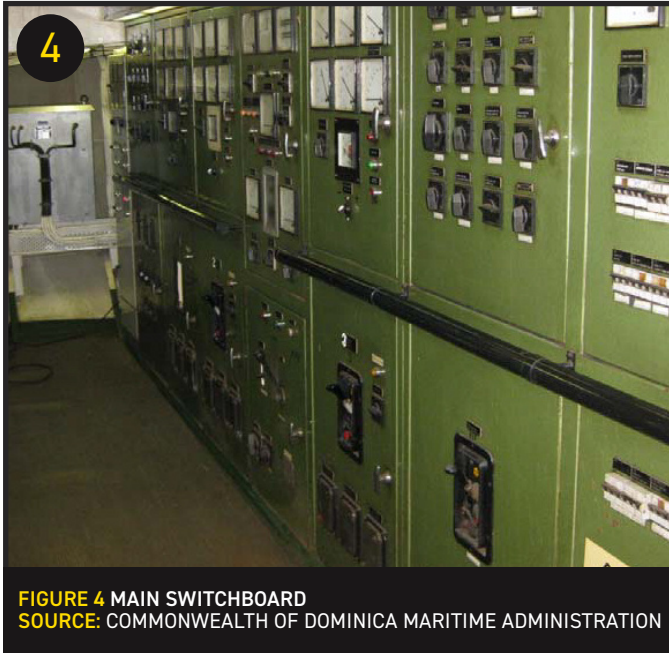
**FIGURE 4** MAIN SWITCHBOARD  
**SOURCE:** COMMONWEALTH OF DOMINICA MARITIME ADMINISTRATION

Following the incident the coast guard conducted an investigation of the machinery space and concluded that, as far as it could be determined, the fire started in the main switchboard (**Figure 4**) located at the aft part of the main engine room.

- Following the fire an investigation of the machinery space was conducted and it was established that the fire started in the main switchboard located in the aft part of the main engine room. From here the fire quickly spread upwards through open accesses to the funnels and later to the crew accommodation and navigating bridge as well as to the upper tween deck cargo compartment. As the switchboard was extensively damaged during the fire it was not possible to identify the cause of the fire.
