Fatality inside the elevator shaft

BACKGROUND

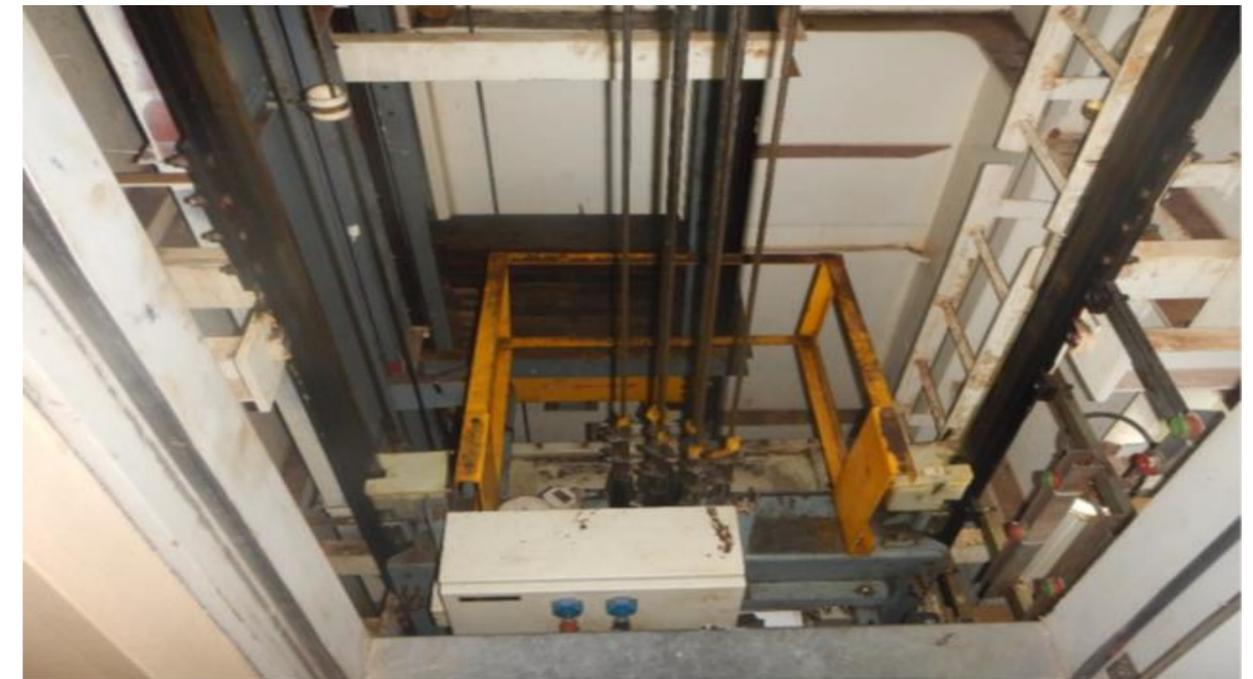
Top of elevator car showing maintenance box and safety cage
Source: Investigation report 06/2018 by Transport Malta – Marine Safety Investigation Unit

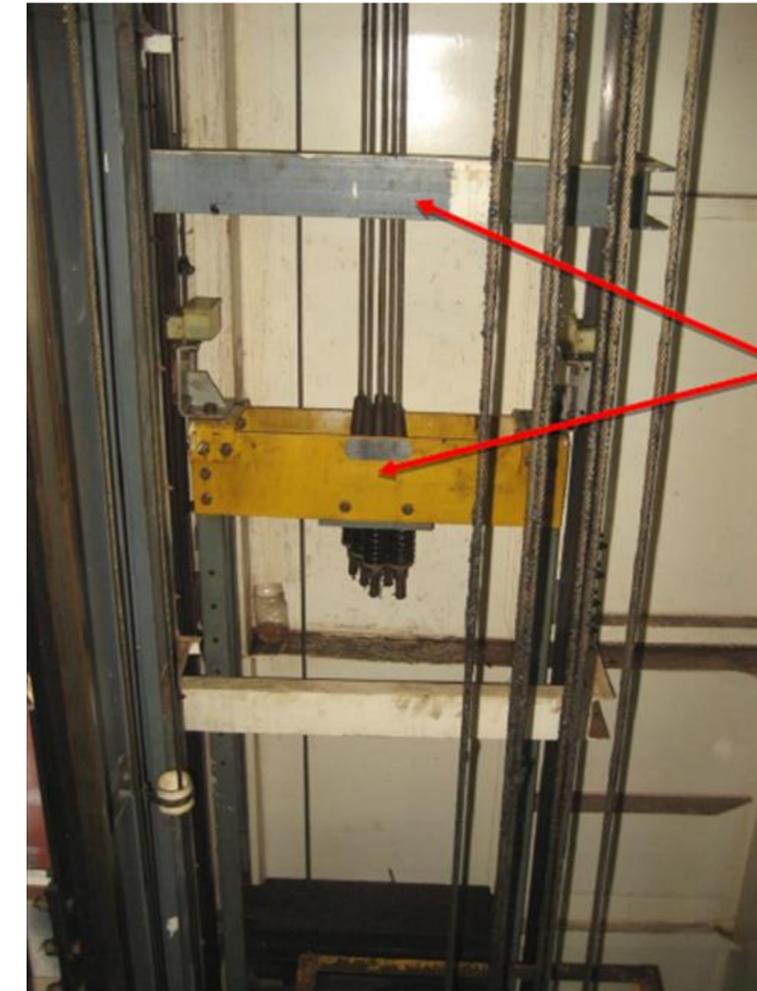
- The electrician had his right leg draped over the counterweight and his upper torso trapped between the counterweight and one of the counterweight guard beams.
- The electrician was wearing a safety harness and he was outside the safety cage on top of the elevator car.
- The C/E notified the master immediately, who raised the general alarm and then went to the bridge to inform the company.
- A member of the onboard medical emergency team entered the elevator shaft and confirmed that the electrician was not breathing and he could not detect a pulse.
- A hoisting arrangements, using wires and chain blocks, were rigged, which allowed the elevator car to be hoisted and the counterweight to move down and free the electrician. When pulled out from the elevator it was confirmed that the electrician had no pulse.

The electrician's torso trapped between the counterweight (yellow) and the beam (grey), with his right leg straddling the counterweight.

The area where the electrician was found inside the elevator shaft
