FATALITY INSIDE THE ELEVATOR SHAFT

WHILE AT ANCHORAGE AN ELECTRICIAN DID NOT APPEAR FOR DINNER AND CONSEQUENTLY A SEARCH WAS INITIATED. HE WAS LATER FOUND TRAPPED INSIDE THE VESSEL'S ELEVATOR SHAFT BETWEEN THE ELEVATOR'S COUNTERWEIGHT AND A PROTECTIVE BEAM, WHERE HE HAD BEEN WORKING EARLIER THAT SAME DAY. HIS FELLOW CREW MEMBERS MANAGED TO GET HIM OUT OF THE ELEVATOR SHAFT, BUT, DESPITE ADMINISTERING FIRST AID, THE ELECTRICIAN WAS PRONOUNCED DEAD AT THE SCENE.

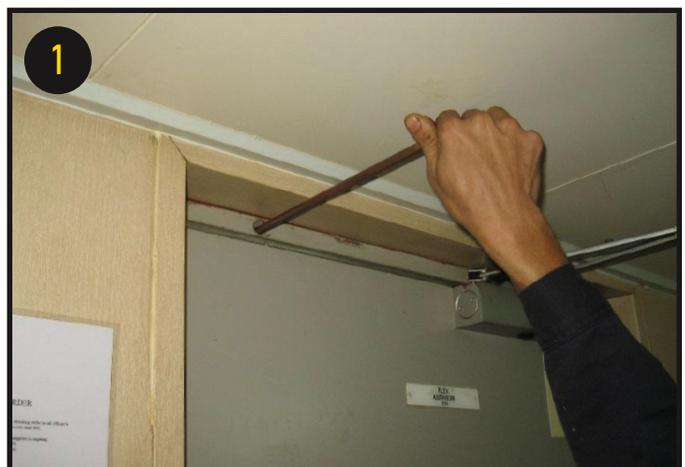
FIGURE 1 EMERGENCY DOOR TOOL
SOURCE: INVESTIGATION REPORT 06/2108 BY TRANSPORT MALTA - MARINE SAFETY INVESTIGATION UNIT

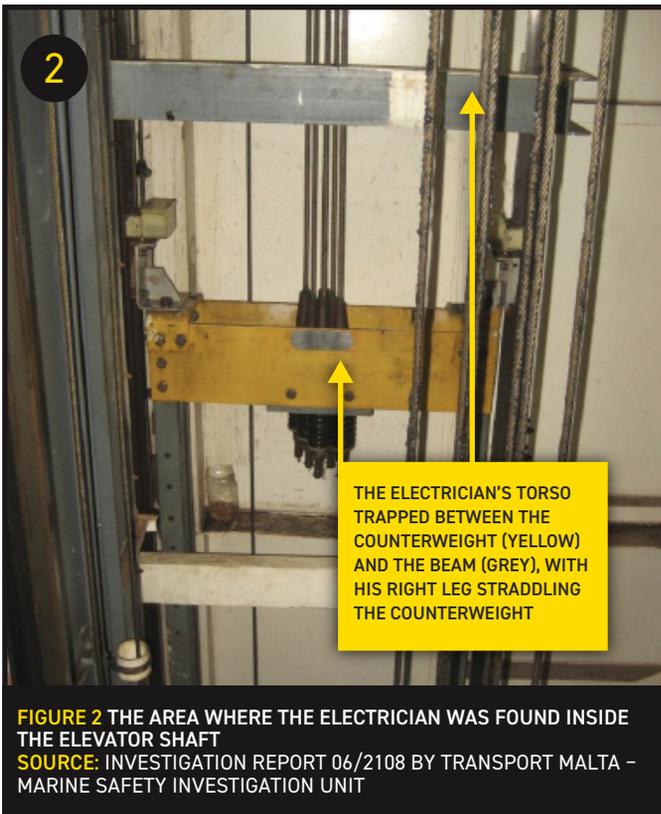
the electrician inside the elevator shaft with his right leg draped over the counterweight and his upper torso trapped between the counterweight and one of the counterweight guard beams (**Figure 2**). It was noticed that the electrician was wearing a safety harness and he was outside the safety cage on top of the elevator car (**Figure 3**).

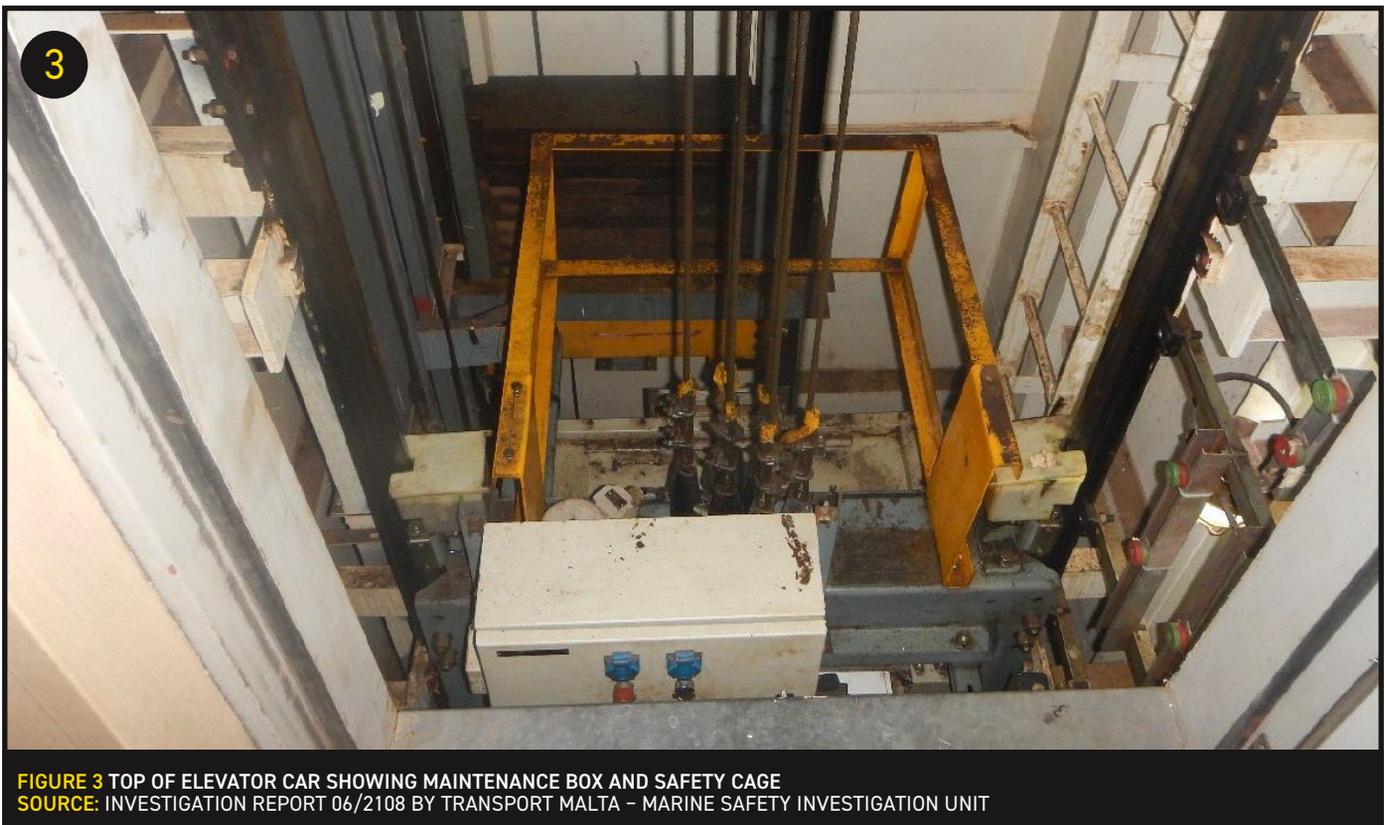
- A safety cage is provided on top of the elevator car to safeguard the person(s). The electrician was found outside the safety cage, which may have exposed himself to additional danger.

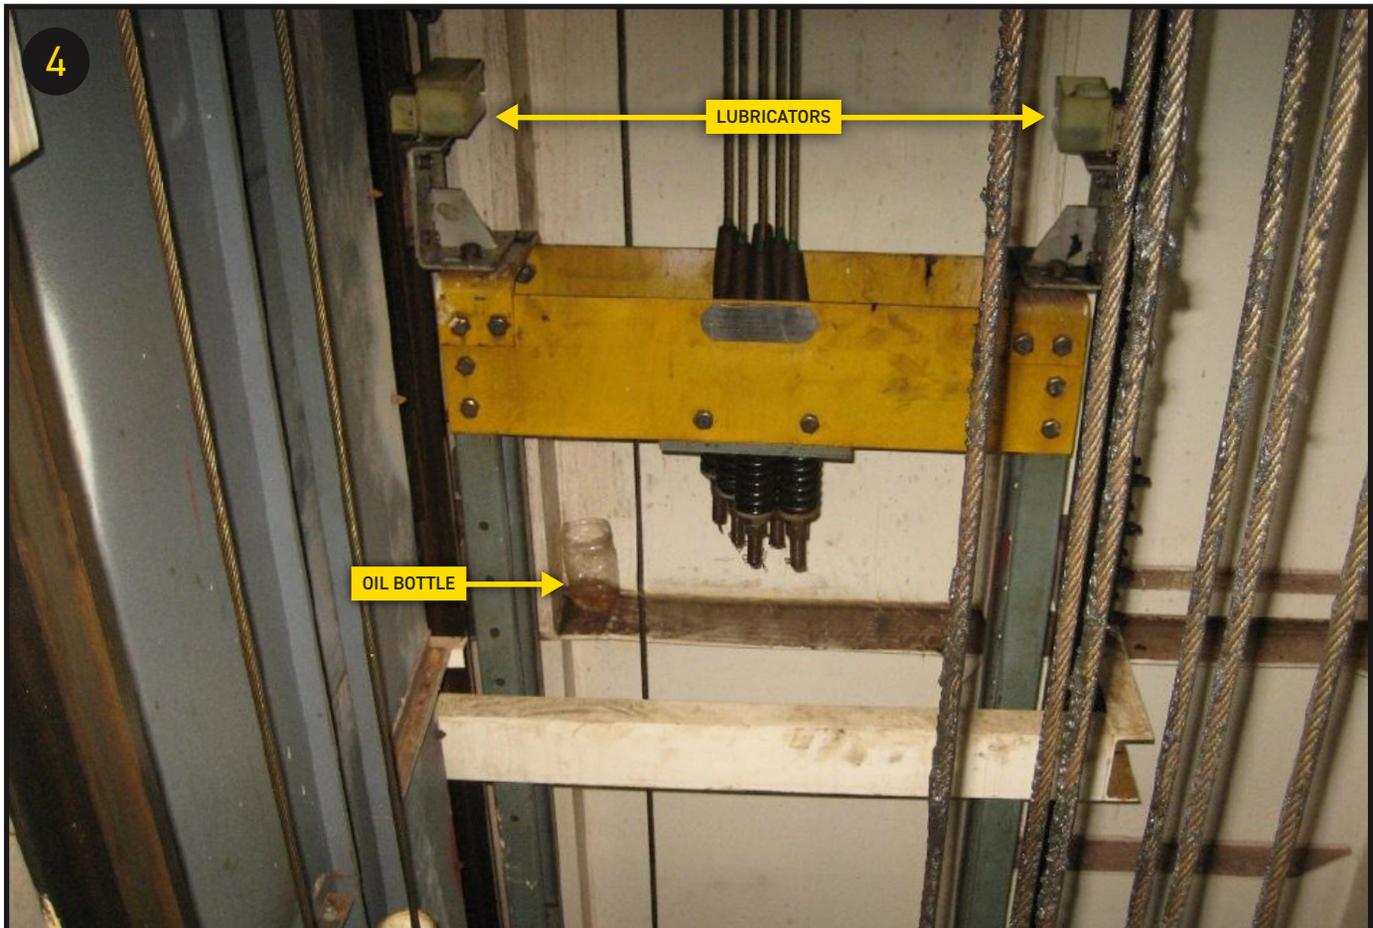
FIGURE 4 POSITION OF LUBRICATORS AND PLASTIC OIL BOTTLE LEFT IN THE ELEVATOR SHAFT
SOURCE: INVESTIGATION REPORT 06/2108 BY TRANSPORT MALTA – MARINE SAFETY INVESTIGATION UNIT

- The investigation could not establish why the electrician re-entered the elevator shaft. From the position in which the electrician was found, the investigation hypothesised that he likely re-entered the elevator shaft to retrieve a plastic bottle containing oil used to top up the guide rail lubrication boxes (Figure 4). While trying to retrieve the bottle, it appears that he got trapped between the counterweight and the counterweight guard beam.
