RISK WATCH

Collision case studies

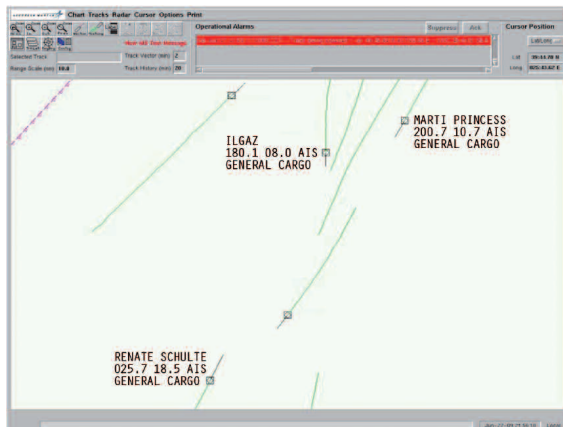
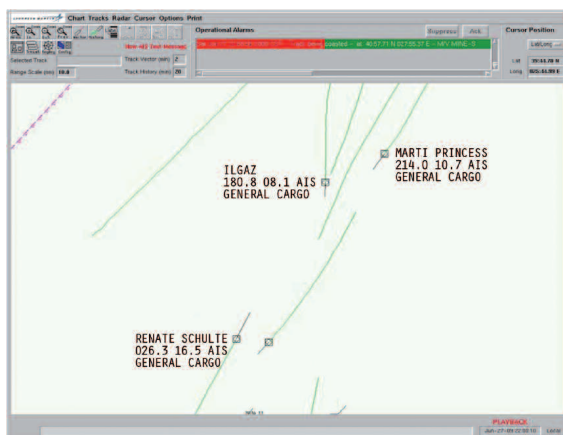
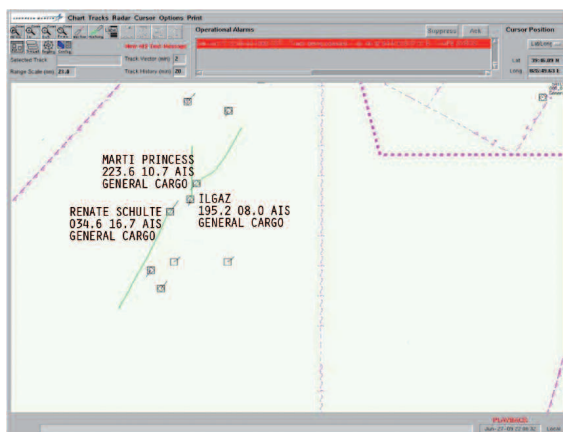
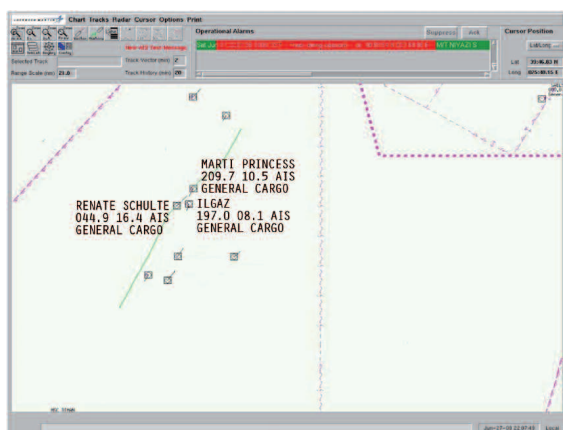
At 2210, *MP* and *RS* collided. *RS* contacted *MP* on her port side, almost perpendicular to cargo hold no. 2. *MP* sustained a huge tear on her port side. No. 2 hold was open to sea.
