# RISK WATCH

## Hatch cover maintenance

### Hatch cover maintenance (continued)

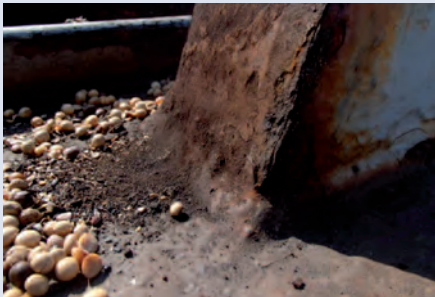
Hatch coaming not swept, cargo debris and rust still evident. Centre line joint closing wedge showing severe wear.

**1** Before closing the hatch covers, ensure that the hatch coamings and double drainage channels are swept clean of any cargo debris. This will ensure that the coaming drain non-return valve remains clear and free as well as ensuring that no damage occurs to either the hatch cover rubber packing or the compression bar. It will also ensure that there is no obstruction to the correct and proper sealing of the hatch cover.

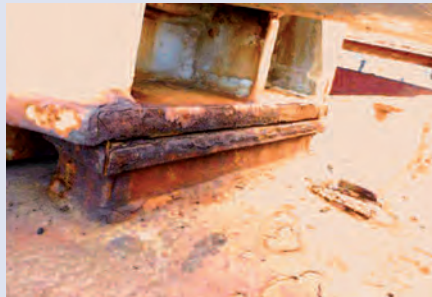
Corroded and wasted hatch cover landing pads.

**5** Grooved, corroded or worn down landing pads are to be either built up with welding and ground back to original dimensions or cropped off and completely replaced.

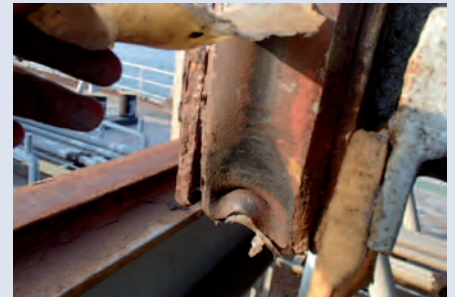
Hatch cover sealing rubbers damaged and showing permanent deformation beyond the recommended limits. Rubber seal channels severely corroded.

**8** When cleaning the seals, check for signs of permanent deformation (a useful general rule is 30% of the seal thickness). If sections of sealing rubber are required to be replaced, the minimum length is 1m. However, it is often better to replace a full length of sealing rubber to ensure effective and even compression.

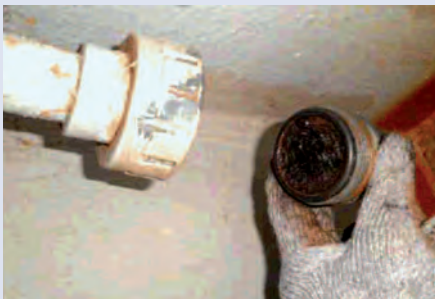
Hatch coaming drain completely blocked with debris and rust.

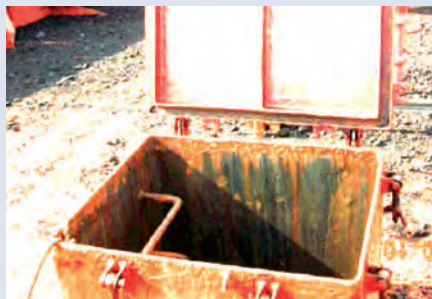
Evidence of water ingress at the cargo hold entrance hatch and the hatch coaming.

**6** Check for any rust streaks on the inside of the coaming which would indicate water ingress from leaking hatch cover seals. Take remedial action and repair the seal and clean off the rust streaks.

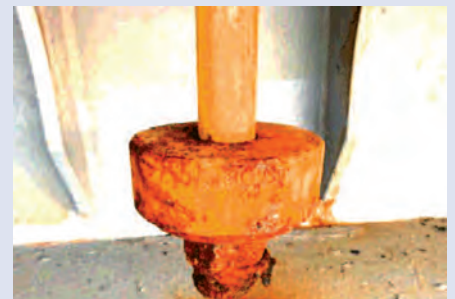
Hatch securing cleat, seized and painted over.

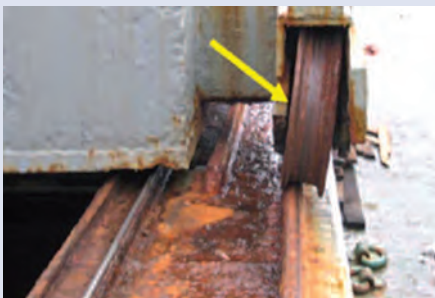
Hatch cover guide wheel bearing failed – hatch cover will not close evenly.

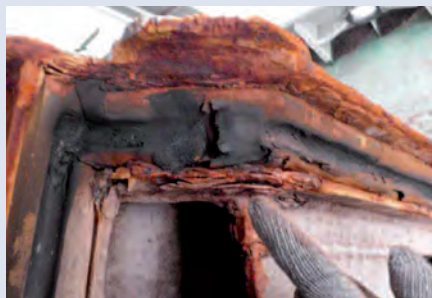
Hatch cover sealing rubbers damaged and showing permanent deformation beyond the recommended limits. Rubber seal channels severely corroded.

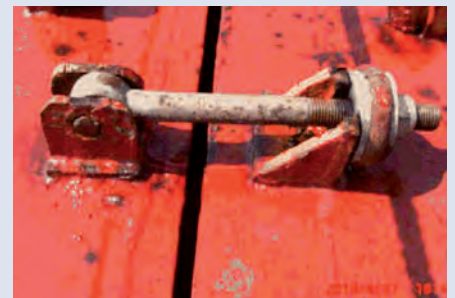
Cross joint cleat renewed but old perished rubber still in use

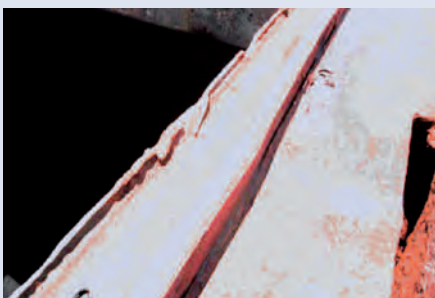
Mechanical damage to the compression bar and inner drain channel.

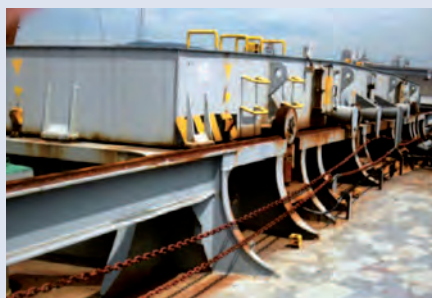
Same class of ship, same age, two different owners, can you spot the difference?

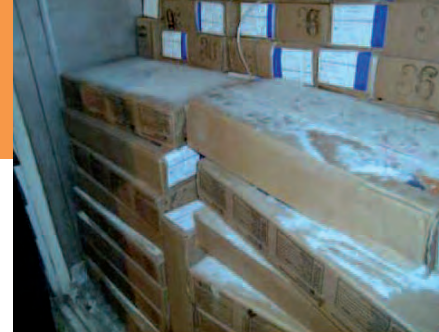
A cargo of frozen minced fish meat, shipped from Argentina to Japan, was found on arrival to be covered in a mysterious white powder.

In this recent case reported to the Club, no issues were found in relation to the cargo temperature. The white powder was analysed and found to consist mainly of aluminium oxide and a little aluminium sulphate.

The question is: where did the aluminium oxide come from? Aluminium oxide is a coarse crystalline deposit most likely the result of surface corrosion of the aluminium parts within the reefer container. Surface corrosion can occur due to exposure to some fumigants which are commonly used for perishable cargoes such as grapes. Surface corrosion can also be caused by the use of low quality alloys used on the container components.

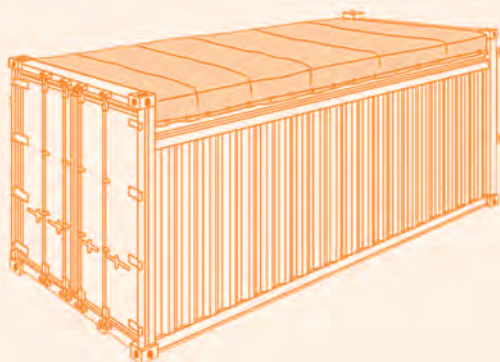
A common scenario reported to the Club is that the container is stuffed at the shipper's premises and then a tarpaulin is stretched across to form the 'roof' of the container. However, sometimes the cargo itself also forms part of the roof bows or extends higher than the bows. Because the cargo is not declared as OOG or OH, no special instructions or arrangements are provided to the stow planners and consequently other cargo is loaded on top causing the cargo inside the open top container to be crushed

and damaged. In some cases, the floor of the container itself is also damaged by the cargo being compressed and this makes discharge at the destination a problem and can cause delay.

Where open top containers are planned to be loaded it is recommended that crew take a few moments to look at the container to see if there are any obvious signs that the cargo may be over height, such as unusual bulging of the tarpaulin or obvious creases in the tarpaulin as it is stretched over the packing material or even over the cargo itself. In cases where the ship has a concern about the height of the cargo inside the container it may be possible to reject the container or arrange for it to be loaded without additional cargo on top.
