# RISK WATCH

# Collision case study

*PAULA C* and *DARYA GAYATRI*: the importance of proper bridge team management in busy traffic lanes

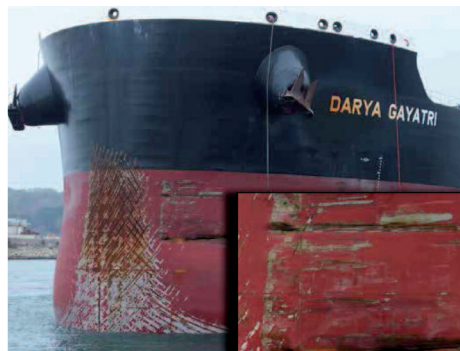
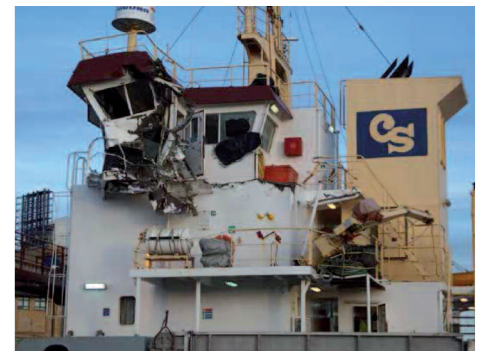
Damage to *DARYA GAYATRI* and *PAULA C*

At 0027 PAULA C's port bridge wing collided with DARYA GAYATRI's port anchor. The master of the DARYA GAYATRI arrived on the bridge just as contact was made. At the time of the collision DARYA GAYATRI was heading 198° at 12.9kts; PAULA C was heading 070° at 6.2kts.

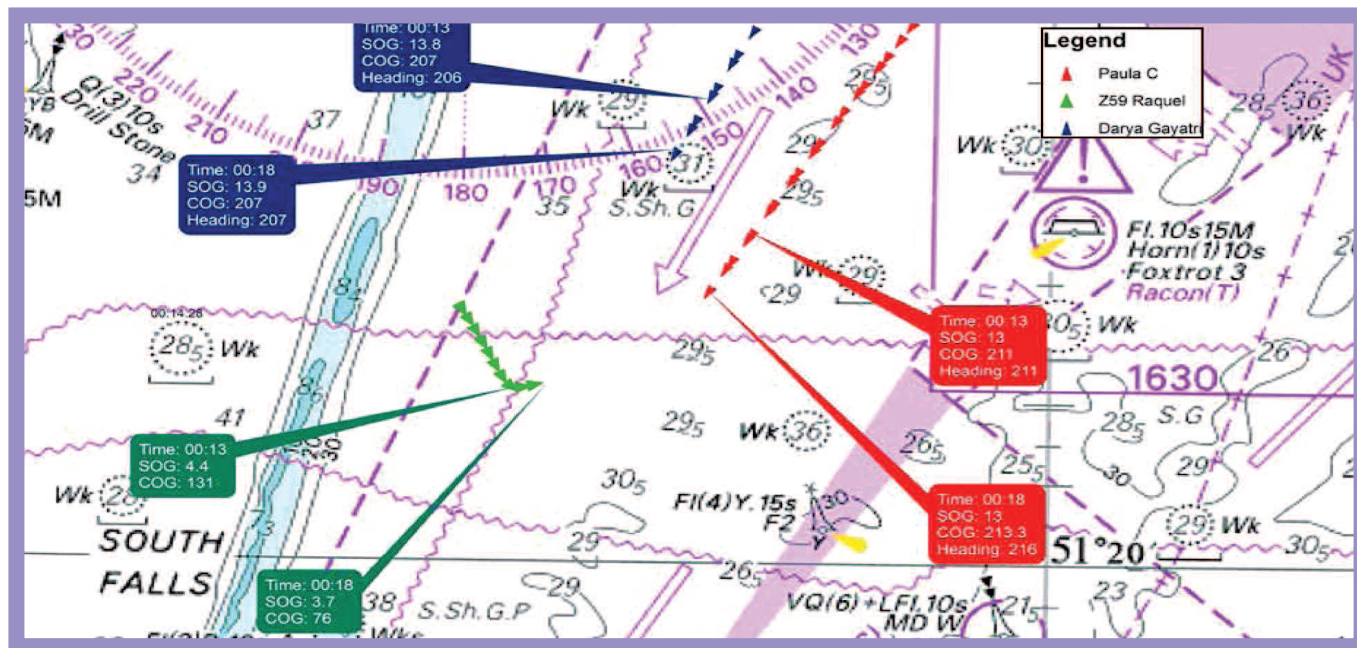
Positions of ships at 0013 and 0018

At 0018 *PAULA C*'s second officer adjusted the autopilot heading to 230°, an alteration of almost 20° to starboard, in line with his understanding that he was the give way ship. *RAQUEL* and *PAULA C* were 1.82nm apart, no sound signal was made and the second officer did not look over the starboard quarter to make sure that there were no other ships in close proximity.

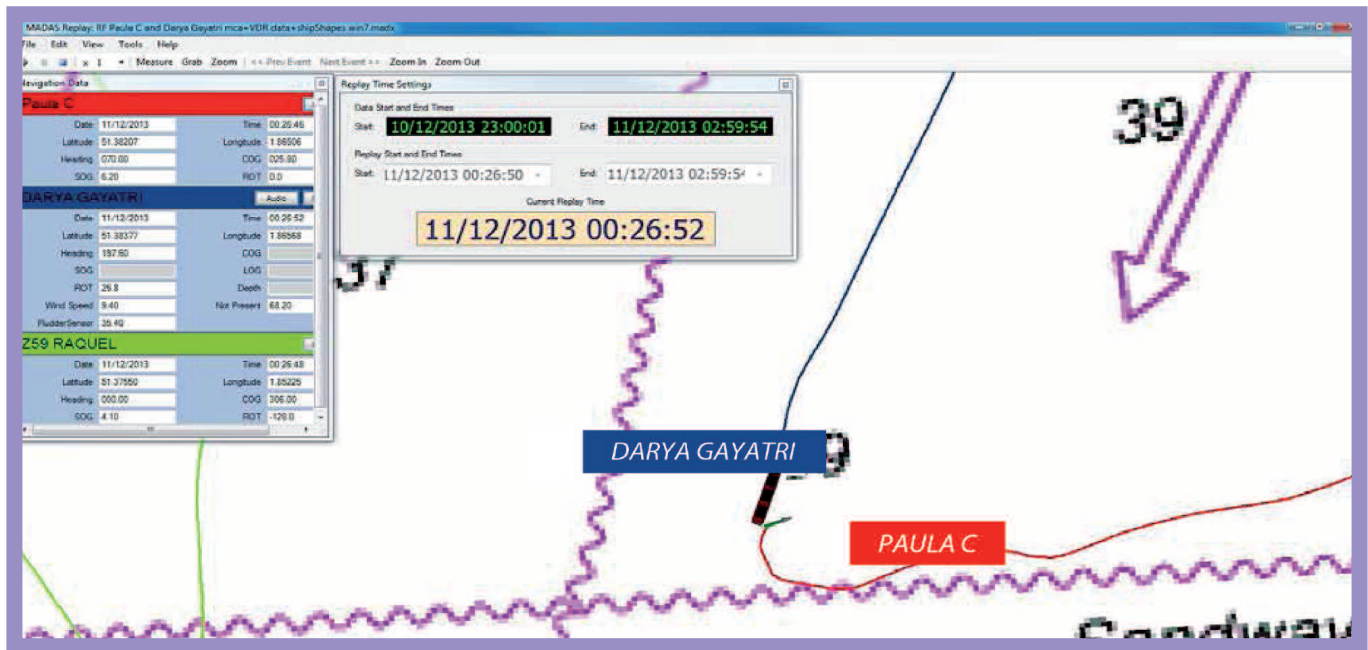
The collision

- 1) The master of the PAULA C's decision to allow an inexperienced officer to keep the bridge watch alone in one of the busiest shipping lanes in the world was ill judged. Since qualifying, the second officer had been in charge of only 10 bridge watches and had arguably not yet developed sufficient competency to keep a bridge watch in the Dover Strait at night and without a lookout for support. It was not surprising therefore that he lost situational awareness when tested in such a busy shipping channel for the first time.

- 2) The PAULA C's second officer had not effectively used the electronic aids available to maintain a proper lookout, nor to identify RAQUEL's identity as a fishing ship. He did not use the ARPA's 'trial manoeuvre' function prior to the initial alteration of course to 230°, or complete basic checks such as ensuring that the ship's starboard side was clear before altering course.

3) The second officer's inexperience also turned the intervention of the Dover Coastguard, which was timely and well-intentioned by itself, into a contributory factor to the collision. While a more experienced officer might not have been so easily influenced by the Coastguard's question regarding a 'three-sixty', to the young second officer (given that he did not know what action to take next) it was extremely influential.

4) It is evident that an additional lookout was rarely, if ever, employed on board PAULA C, regardless of the circumstances. If an AB had accompanied the second officer on the bridge he could have assisted him in his duties (for example by checking the starboard side was clear, monitoring the DARYA GAYATRI, or taking the helm when required) and helped the second officer to maintain his situational awareness.

5) Neither PAULA C's nor DARYA GAYATRI's OOW called their masters to the bridge as they had been instructed, despite clearly being 'in doubt'. It is possible that PAULA C's OOW did not want to disturb the master, who was also a watch-keeper and had recently gone to bed. To be effective, a master's order to call 'if in any doubt' needs to be meaningful and followed, not just written.

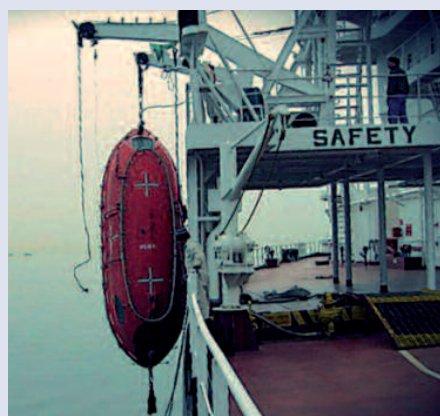
FPDs where they should be fitted. In addition, we have been notified of a recent incident where a lifeboat fell into the water from the falls due to equipment failure of the release hooks and because no FPDs were fitted. A number of crew required hospital treatment but luckily there were no fatalities.

The causes of accidental release are varied and not confined to failure of the mechanisms in place. Crew are often not familiar with the equipment fitted on board and a lack of maintenance can also be a reason for accidental release.

Mechanical failure

The use of FPDs effectively prevents any accidental release caused by the failure of the release hook system or by human error. It is recommended that all owners, operators, masters and crew members check whether the use of FPDs is common practice on board their ships.

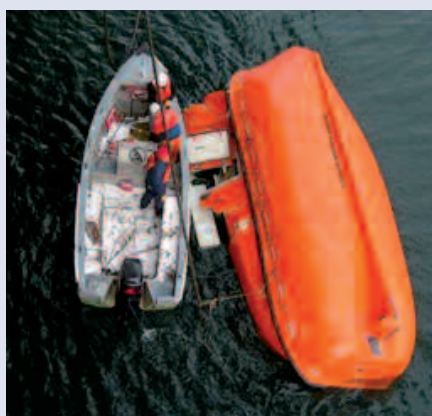
Fatal consequences

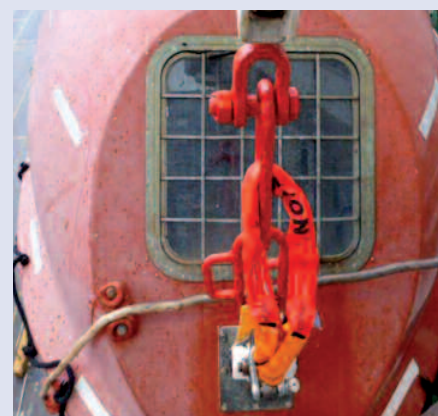
FPD correctly rigged
