RISK WATCH

A costly trap – the VHF assisted collision

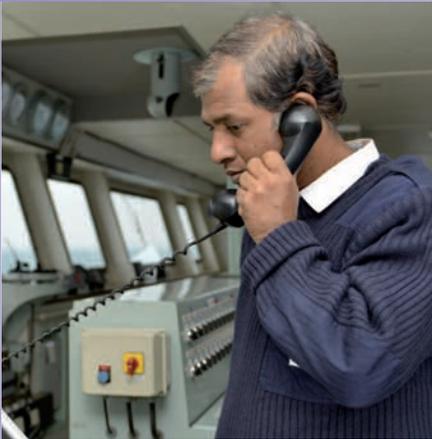
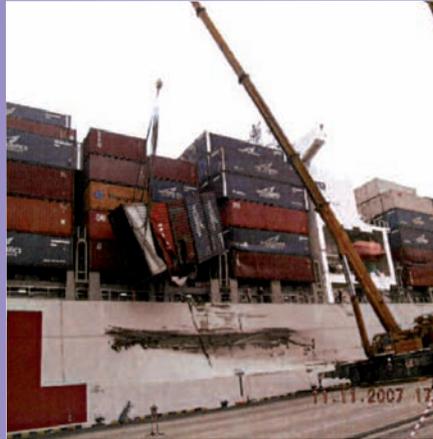
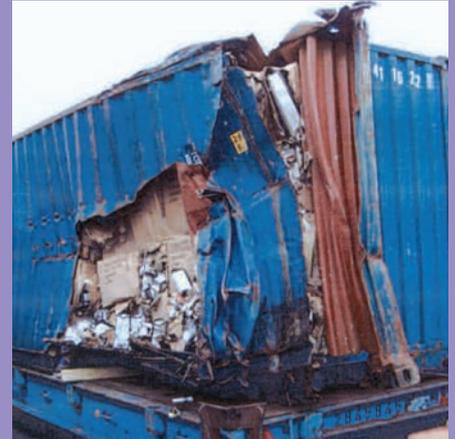
It should also be noted at this point that *OPPORTUNE* had an enclosed bridge. As is common in enclosed wheelhouses, a combination of heavy weather and rain had caused the windows to salt up, preventing a clear view of ships' lights from within the bridge. With this arrangement, the only

way that a watch officer can check on another ship (without using the forward windows) is either to open one of the side windows or to go on top of the monkey island. It was difficult for the lookouts and the third officer to see the lights of *NOTORIOUS* clearly enough to determine how the ship was crossing, yet no-one went outside to look.

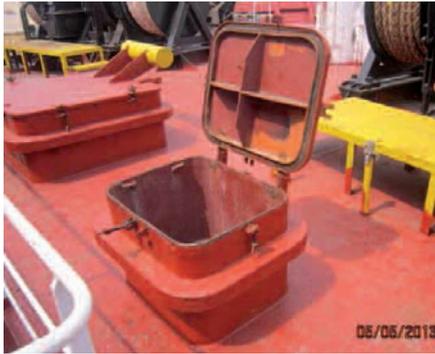
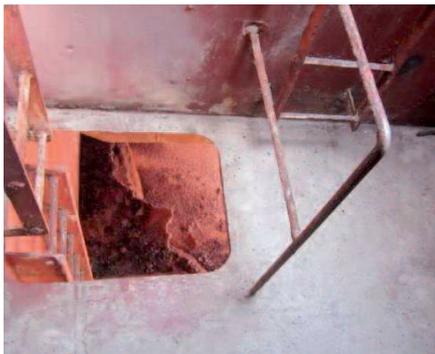
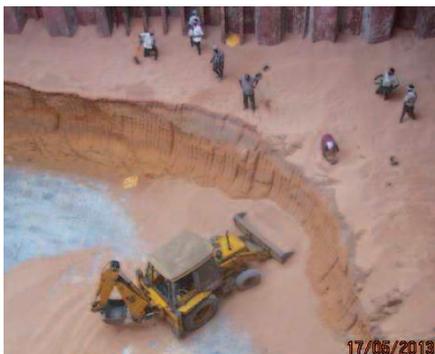
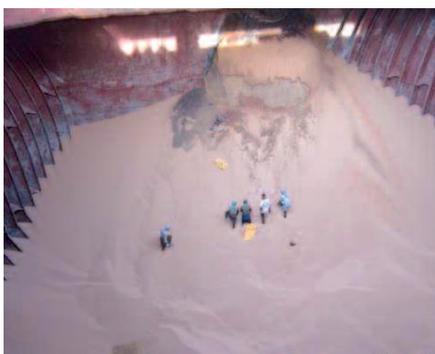
The Member's ship had loaded 44,000mt of grain in Australia and 8,515mt of dun peas in hold no. 1. When the cargo was discharged in India, a column of wet/mouldy cargo beneath the hold access compartment was observed. As the discharge of no. 1 hold progressed, the extent of cargo affected became apparent: not only did the column of seawater damaged cargo extend from the top of the hold to the tank top but a 3m deep layer of wet damaged cargo existed across the whole tank top. The initial cause of the seawater entry was a holed eductor pipeline.

The forepeak eductor pipeline which passed through the no. 1 hold forward access compartment was corroded. The pipeline was also used for the anchor wash and mooring winch cooling system. Sea water flowing under pressure had leaked from the corroded pipe into hold no. 1. While waiting for a berth at the first discharge port, the ship had frequently dragged anchor and hence the anchor winches had been used frequently. The winch cooling water and anchor washing system had also been used and part of this water had leaked into hold no. 1 through the corroded eductor pipeline. This leakage was not discovered immediately and was found only during the discharge from hold no. 1 at the second discharge port, when discoloured/damaged cargo lumps slid towards the centre of the cargo hold.

Following investigation, the quantity of water ingress into the cargo hold was found to be around 600 mt, a very significant amount, which could be explained by the continued use of the anchor winch and the washing of the anchors, combined with the size of the corroded hole.

The surveyors found that the sounding log for the voyage from the load port to the discharge port did not record any change in the no. 1 hold bilge soundings, despite an extensive ingress of water. Upon sounding the no. 1 hold bilges after the ship's arrival at the second discharge port, it was observed that the soundings were nil.

The water ingress alarm sensor located at the aft bulkhead of hold no. 1 also had not provided any alarm during the ingress.

The ship's previous cargo was cement clinker in bulk and it is probable that the bottom portions of the hold bilge sounding pipes and the water ingress alarm pipe may have been covered by the hardened cement clinker cargo, which is why the ingress had not been revealed.

Approximately 2,900mt of cargo was damaged. A large proportion of that damage could have been avoided if the bilges and associated sounding pipes had been properly maintained and regularly sounded and also if the high water alarms had been regularly tested.

- It is essential that documented procedures for the regular inspection, sounding and pumping of bilges and testing of bilge alarms are followed and the information observed is accurately recorded in an appropriate document. Any omissions from a regular inspection schedule should be shown in the record together with reasons why.

- When sounding cargo hold bilges it is important that exact soundings are properly taken and recorded. An accurate calculation should be made of the actual quantity of any water being pumped out.

- Cargo hold bilges should ideally be checked and sounded twice a day, weather permitting. Any deviations from this should be recorded with reasons why.

- Bilge systems and alarms should be tested regularly. In the event of any faults with the bilge alarms being noted, regular manual soundings or similar means of checking should be initiated.

- Cargo residue and other debris can impede the proper functioning of the bilges and all bilges should be inspected and cleaned if necessary, prior to loading any cargo.

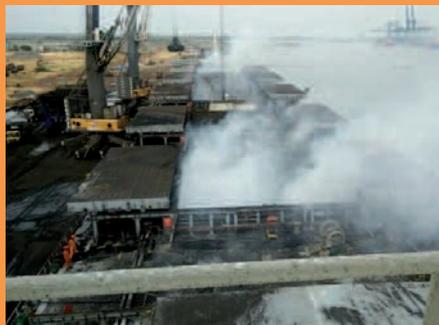
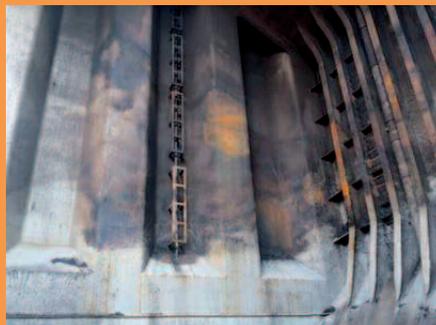
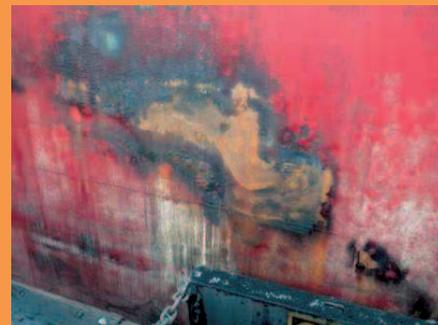
The Club has recently seen several cases of inadequate monitoring of Indonesian coal before loading and during voyages which has given rise to safety concerns.

Indonesia is one of the world's biggest exporters of coal. Due to limitations in some ports, loading often occurs via barges and it is known that there are a number of operators who are shipping coal (via barges) without following accepted industry good practice. Examples include misdeclaring the cargo as not being prone to self-heating or providing no details of the self-heating or methane-emitting characteristics of the cargo.

The IMSBC Code states that before and during loading the temperature of the cargo on the barge must be measured when the shipper informs that the cargo is likely to self-heat. However, in view of possible misdeclaration, we recommend that in all instances the temperature of the coal be measured before loading. Minton Treharne & Davies (MTD) have advised the Club's Members on several occasions and recommend that a 'thermocouple probe' is used for this purpose. They suggest that a pit of 0.3-0.5 metres is dug into the cargo while it is on the barge and a number of measurements are taken after inserting the probe. They recommend that the temperature range is recorded in at least 21 places. During loading, they suggest re-measuring the cargo again when 33% has been discharged from the barge and then again when 66% of the cargo has been

discharged. Any cargo above 55 degrees centigrade is evidence of self-heating and should be rejected.

If cargo is found to be on fire, or above 55 degrees centigrade in the barges during loading, MTD recommend that the following steps should be taken:

- Loading from the relevant barge is to cease immediately.
- All cargo that has been loaded from this barge will need to be discharged from the holds back into the barge as soon as possible, making sure that all the relevant coal is discharged. This can be done using the grab.
- Consider spraying localised areas of the hot coal in the holds with fresh water. This is to be jetted onto the hot areas in intermittent bursts, allowing the steam to dissipate between each burst.
- Fresh water is preferred however if safety is at risk then the crew should use whatever water is available. If time or circumstances permit,

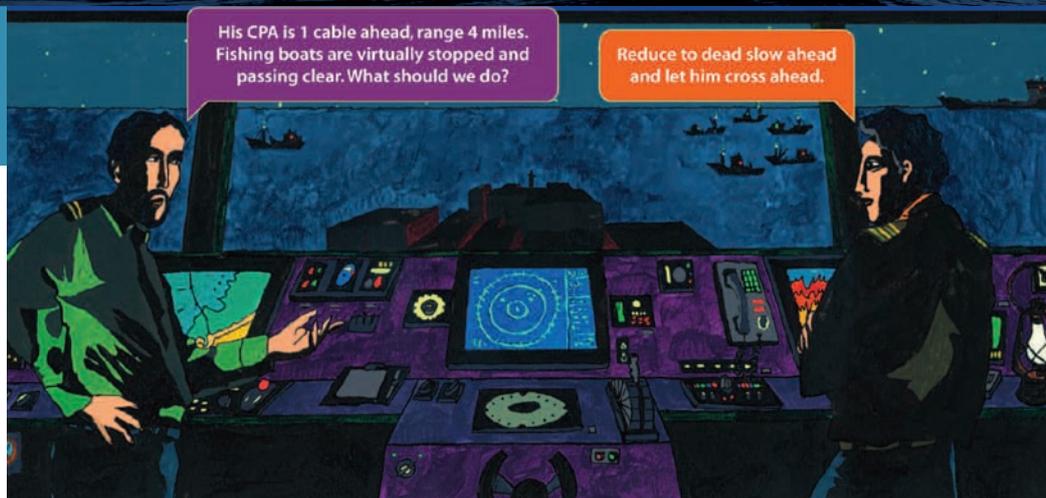
Loss prevention poster campaign: fishing boats COLREGs 6, 15, 16 and 18

In the situation illustrated in the poster, the fishing boats are clustered together in a large group. They are virtually stopped and are passing safely down each side. The ship on the starboard side is on a steady bearing with a small closest point of approach (CPA) of around 1 cable ahead.

The situation highlights that, as a give way vessel for both the ship and the fishing boats under Rule 18, an alteration to starboard would result in a close quarters situation with the fishing boats. Waiting until the fishing boats have passed and are clear prior to altering course boldly to starboard will place the two ships in a close quarters situation. Further, an alteration of course to port is difficult in view of close proximity of fishing boats and would require crossing ahead of the other ship which should be avoided, as required by Rule 15. Slowing down is the most obvious and effective means of resolving the situation.

A reduction in speed whilst being effective may take a little more time to be observed by the other ship. However, given the range of the ship at this point, a reduction in speed would clearly provide a positive outcome as the action taken would be early and substantial.
