# RISK WATCH

# Complacency causes grounding?

The UK Marine Accident Investigation Branch (UK MAIB) has recently published its report on the *HOEGH OSAKA*, a pure car and truck carrier (PCTC) which grounded on Bramble Bank in the Solent shortly after departing Southampton in January 2015.

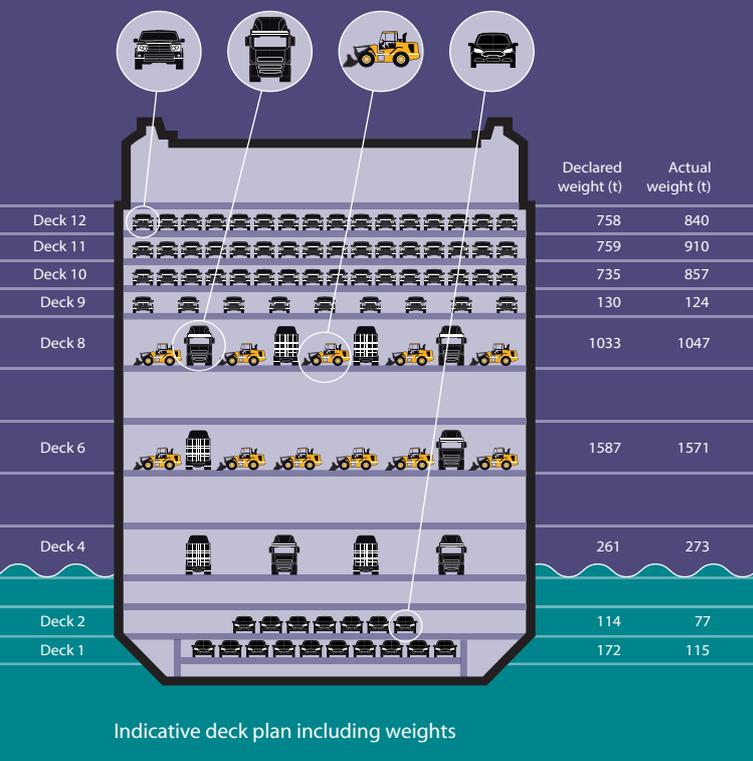
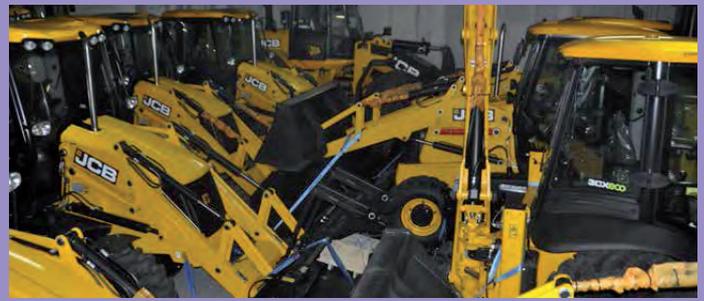
JCB cargo indicating various securing points

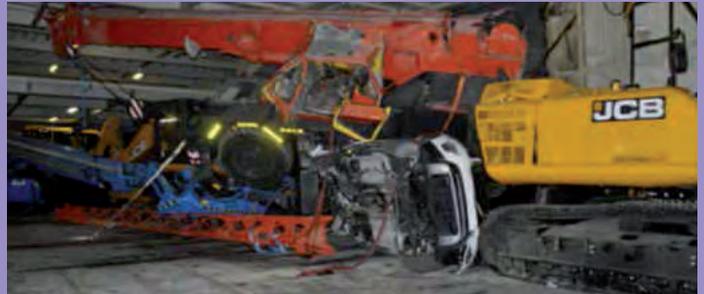
Some of the large cargo units broke free from their lashings and shifted which resulted in the ship's hull being breached. Sea water flooded into deck 6 and then into lower decks.

Deck 6 – starboard side cargo damage

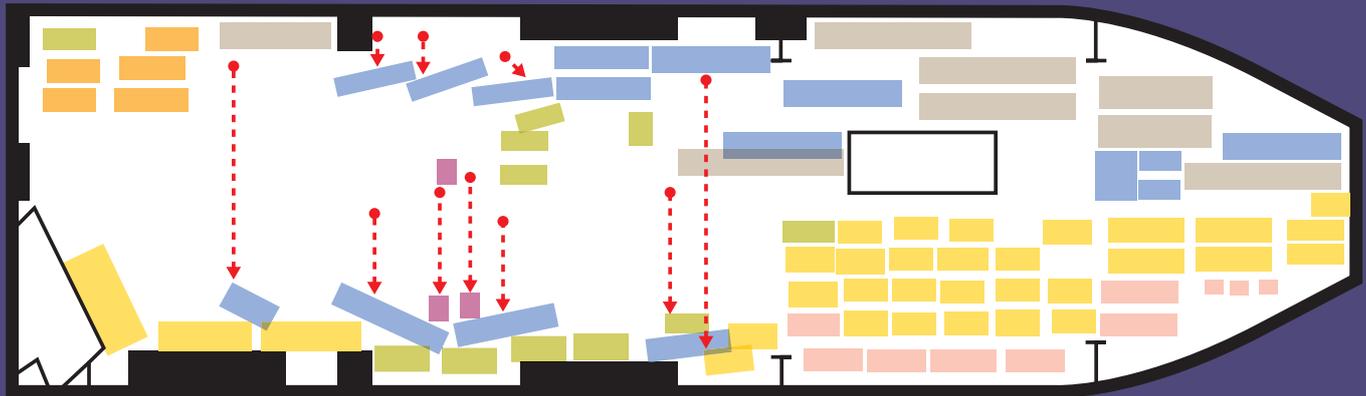
Deck 6 – original stowage and direction of shift of displaced cargo

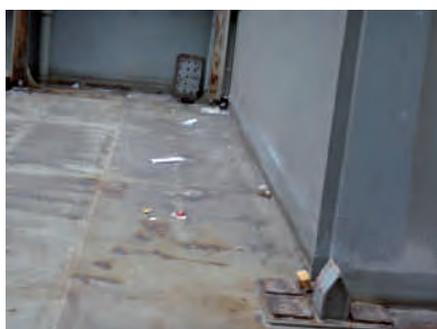
In the case in question, hold no. 4 of a small container ship flooded to a depth which affected cargo in several containers loaded on the tank top. Sounding of the bilges indicated that no water was present. Investigating surveyors could find no fault in the structure or piping of the ship nor any problem with the bilges. The conclusion was that a small amount of rubbish left by stevedores had blocked the bilge grating covers which meant that accumulated water from rain and snow could not flow into the bilge well and therefore built up in the bottom of the hold.

Rubbish on tank top plating

The lesson to be learned from this case is that every opportunity should be taken by the crew to clean up small amounts of rubbish and refuse from the holds, even if the hold is partially loaded. In addition, stevedores need to be discouraged from throwing their rubbish into the hold and should dispose of it properly.

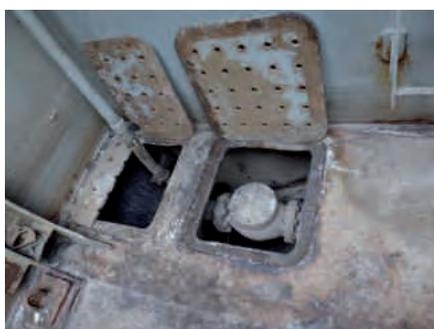
Starboard bilge well
