RISK WATCH

Fender damage when berthing

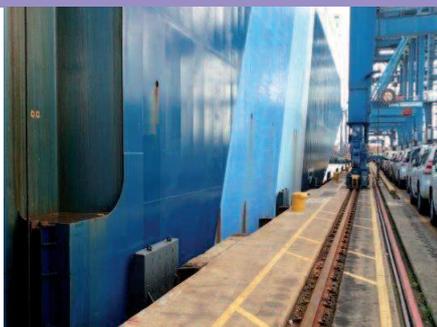
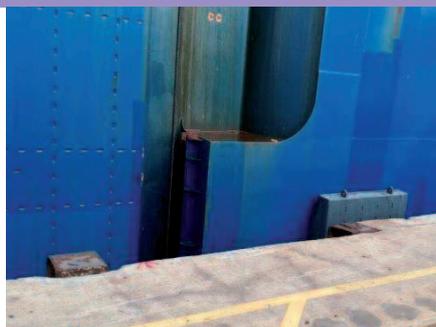
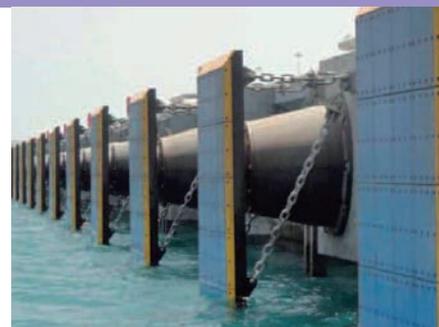
In a recent case handled by the Club, a car carrier completed berthing about 15 minutes before low tide. The ship was positioned in accordance with the instructions of the port personnel but it seems that they focussed on making sure that the ship was positioned in their own preferred location for setting down the ship's stern side ramp on the berth rather than taking into account the position of a fender. Nobody on the ship noticed that the

tide was so low that the base of the stern side ramp was directly below a fender and that there was a risk of the ship's hull becoming caught on the fender when the tide began to rise. Several hours later, the inevitable happened. The ship's crew managed to adjust the mooring lines and shift the ship slightly along the berth but it was too late and the fender had by then been partially ripped away from the berth wall.

A risk assessment should be considered to make sure that the master and crew are aware of any undesirable locations in relation to port property, such as where fenders might

become damaged by the ship, either during the actual berthing or with the changing tide. The master should receive continual observations and assistance from ship's officers at the fore and aft stations during the berthing manoeuvre. A responsible officer should also be tasked to verify that the final position is safe in respect of potential protrusions on the ship or the berth before 'shutting down'.

A further precaution would be to incorporate visual reminders on the ship's hull, such as using paint to highlight any areas at risk of being caught on fenders and also using signs saying 'no fenders' near the stern area of the ship.

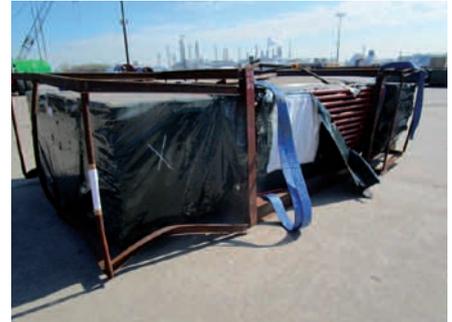
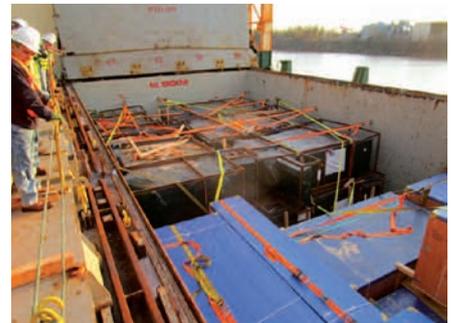
In a recent case reported to the Club, a consignment of pressure boiler parts was physically damaged during moderately heavy weather whilst en route from Hong Kong to Houston. The ship encountered high seas and winds of Beaufort scale 9. The master had adjusted speed and course so as to minimise rolling and pitching but despite his actions, inspections carried out by the master in the cargo holds revealed the cargo stowed in hold no. 2 had been damaged.

Investigating surveyors attended discharging operations at Houston to ascertain the nature and extent of the damage. The stowage and securing of the cargo was found to be in good order and the Cargo Securing Manual (CSM) instructions had been followed. The conclusion was that the cargo packaging and protection (carried out by the shippers) which consisted of a framework of small dimension steel angles, was found to be insufficient for an ocean voyage.

The cargo loading and stowage had been monitored by the chief officer throughout the process, but he had not paid attention to the packaging and protection of the cargo. The design of the steel structure and the dimension of the steel structurals (angles) used to protect boiler pipes were clearly inadequate for the forces to be expected at sea and was clearly designed only to accommodate inland transportation and shore storage purposes.

The shipper is under a duty to package cargo in a manner sufficient to withstand the rigours of an ocean voyage. Although the master (owners) may not be responsible under the terms of a charter for stowage and securing and the cargo damage resulting therefrom and will rarely be responsible for the consequences of inadequate packaging, nevertheless, the master and/or party responsible for loading and stowage of such cargo should endeavour to note the adequacy of packaging/protection for the intended voyage and should put charterers and/or shippers on notice of any obvious concerns. In any event, the master has a duty to ensure that cargo is packed and protected so as to ensure no damage or hazard to the ship and other cargo loaded on board can result from the failure of that packaging.

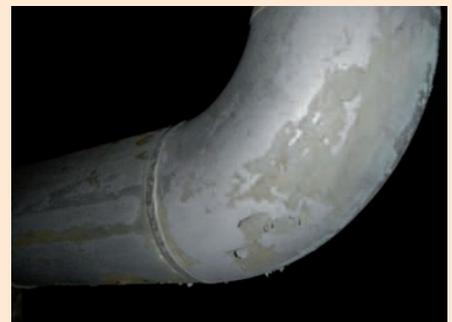
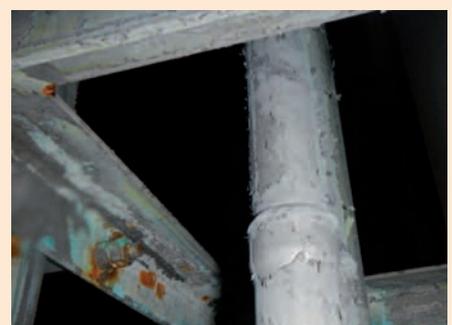
There have been recent incidents where stainless steel cargo tanks of chemical tankers have been damaged following the carriage of phosphoric acid cargoes from the east coast of India.

The extent of the damage to the stainless steel cargo tanks ranges from mild pitting on the tank surface to more extensive corrosion, causing the tank surface to peel off as shown in the photographs on the right. Repairs can be labour intensive and time consuming and there is the additional risk of contamination of the cargo being carried. To minimise these risks, the following issues should be considered:

It is important that the crew are familiar with the type of cargo being carried and the type of stainless steel within the ship's tanks. Food grade phosphoric acid is not corrosive to stainless steel but fertilizer grade acid is far more aggressive. The crew must familiarise themselves with the Safety Management System (SMS) which should contain information on the dangers of

The levels of fluoride and chloride, together with the cargo temperature, will influence the extent to which the cargo may react with the stainless steel cargo tanks. Cargo tank resistance tables, usually provided by the manufacturer, provide information on the safe temperature levels for carriage.

Cargo can sometimes be loaded at an excessive temperature. The crew should be aware of the location of temperature gauges and monitor the cargo temperature at the beginning and during loading. If the temperature is excessive, loading should be stopped.
