RISK WATCH

Collision

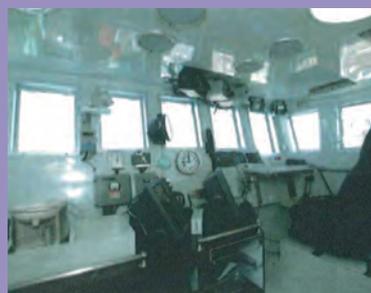
Steering room of *YUJIN MARU No. 7*

The deckhand of *YUJIN MARU No. 7* did not notice *NOCC OCEANIC* because he kept watch by sight in a position where there was a blind area caused by a wall in the watch room. He did not see *NOCC OCEANIC* approaching on a bearing of 83 degrees on the starboard bow. He was not permitted by the master to adjust the settings of the radar himself.

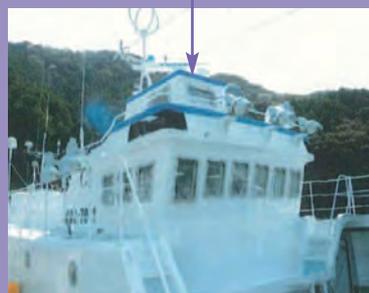
External view of steering and watch room

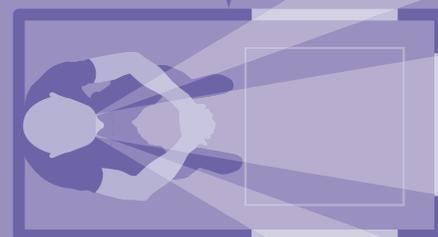
Diagram of watch room

Plan view of watch room showing deckhand's limited visibility when sitting with his back against the wall

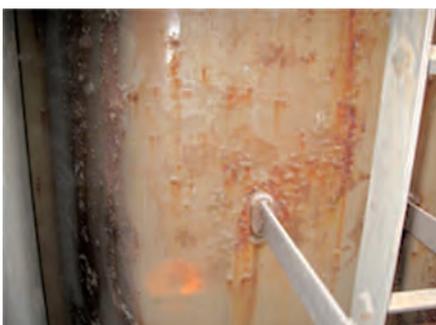
- Tank coating damaged due to poor preparation during application and by not curing properly. Failure to repair this in time could lead to previous cargo becoming ingrained into the coating and contaminating the next cargo.

Deterioration of tank coating.

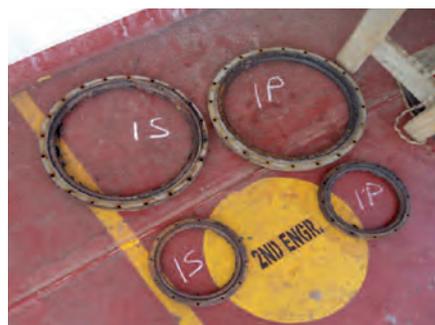
Damaged 'O' rings due to corrosive nature of the cargo.

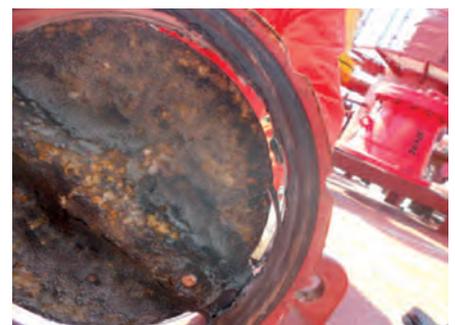
- Valve leakage, which could lead to cross contamination between grades of cargo.

Damaged drop valve.

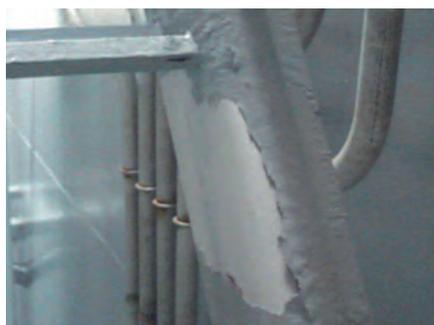
In one incident the coating specification included a limit to the number of days that a cargo could be stored at a higher temperature. The time limit was ignored and the tank coating peeled off and contaminated the cargo.

Tank coating damaged due to excessive heat.
