# RISK WATCH

# Heavy weather

## A tragic death and the complex causes

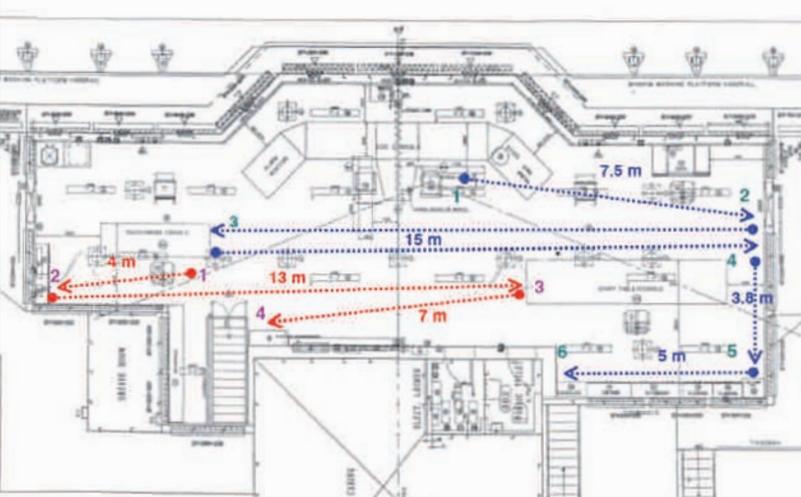
Due to large deformations and scuff marks in parts of the interior panelling at floor level on the bridge, it became apparent that the Master and AB must have been more or less catapulted across the entire width of the bridge.

Presumed movements of the master and lookout after they had fallen.

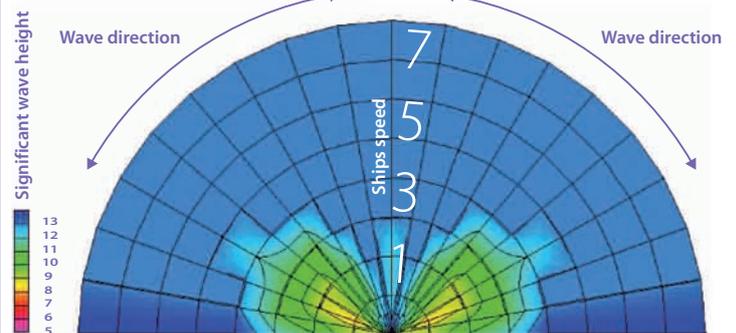
Significant wave height required to produce a roll of 45 degrees.

simultaneous low roll damping produced by a low speed. Despite the crew's best efforts to steer the vessel into the prevailing seas it was likely that one or more large waves approached from one side when the vessel's speed was below a critical level. This coincidence of circumstances induced a heavy rolling motion.

To support the findings in respect of 35° roll angles, the computer modelling was run through alternative circumstances and it was found that the roll angle of the vessel of about 25° occurred in virtually every single situation where the vessel was steaming below 5 knots. This corresponded with the witness evidence of the vessel rolling around 20° when at speeds of 3 – 5 knots. The model showed that roll angles of 45° would be generated where the speed was less than 3 knots and the course steered resulted in waves being encountered at an angle of 60° to the bow.

The obvious solution was perhaps to reduce the vessel's GM. The report affirmed that a certain level of reduced stability would have resulted in the accident being unlikely to have occurred. However the more relevant question is to what extent could the stability have had to be reduced to achieve an appreciable effect on the rolling and whether that level of reduction of GM could have been achieved by the vessel given the

circumstances of her departure from Hong Kong. The ship motions were modelled again using the wave profiles encountered, but this time with a reduced GM of 6.72 metres, and it was found that the conditions under which large rolls would occur did not fundamentally alter. With a reduction of about 3.5 metres to a GM of 4.2 metres, rolling at 30° would still have occurred if the vessel was sailing at only 1 or 2 knots. The report concluded that the threat of violent rolling therefore remained latent but did admit that such a reduction in GM would have resulted in markedly lower transverse acceleration – it was this that effectively catapulted the Master and lookout across the bridge. In any event, such a GM reduction was not possible due to the cargo volume and circumstances of the vessel's departure from Hong Kong. The vessel was forced by the local Authorities to leave port in a condition, due to insufficient cargo, that was far removed from that intended in the actual ship design.

It should be noted that effective roll damping can only be achieved at adequate speed. The crew had no way of recognising that the slow speed was contributing to the rolling. If the vessel had been proceeding at about 7 knots, the rolling motion would have been damped noticeably. Such an evaluation by the crew requires specific calculations and importantly, selecting a higher speed may have led to parametric rolling or critical resonance.

It seems therefore, the report asserted, that we must generally accept the fact that large vessels can roll violently in certain conditions and that this can only be mitigated in the design stage. In terms of design, it would seem that larger bilge keels are one of the more obvious solutions.
