Death of Third Engineer due to burn injuries

CASE STUDY

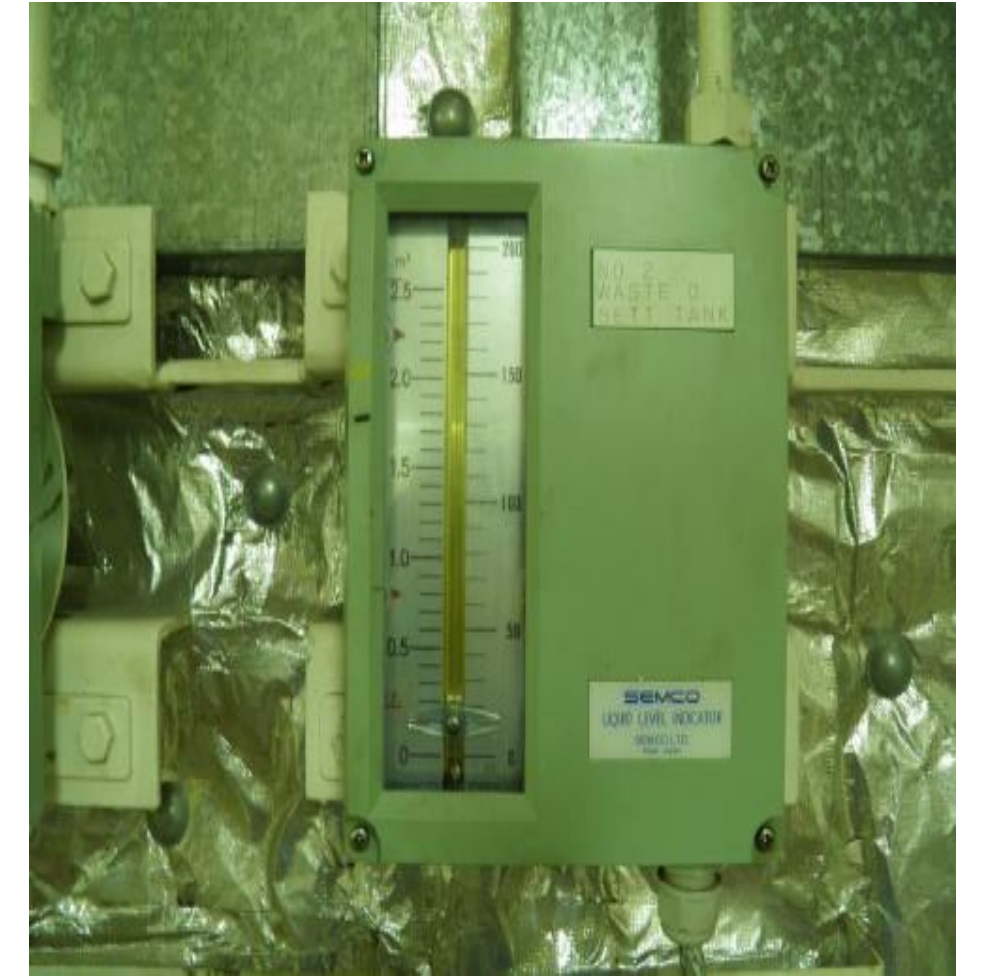
- During transfer of sludge to No. 2 “Waste Oil Settling Tank” (WOS) it was observed that the level gauge of the tank was malfunctioning
- The Chief Engineer (C/E) decided that the WOS should be cleaned the next day and the level indicator to be repaired
- The C/E prepared a “Job Hazard Analysis” (JHA) for the tank cleaning operation in accordance with the ship’s Safety Management System Manual, and the 2/E, assisted by the 3/E was assigned to the job

The malfunctioning level gauge

- **Planned Maintenance System (PMS)** – This did not address the foreseeable jamming of the level gauges with sludge oil. The provision of an appropriate and regular regime for cleaning the tank would have helped avoid the need for this unplanned and hazardous task

Implement a PMS requirement for periodic cleaning of the WOS tanks to avoid the jamming of level gauges

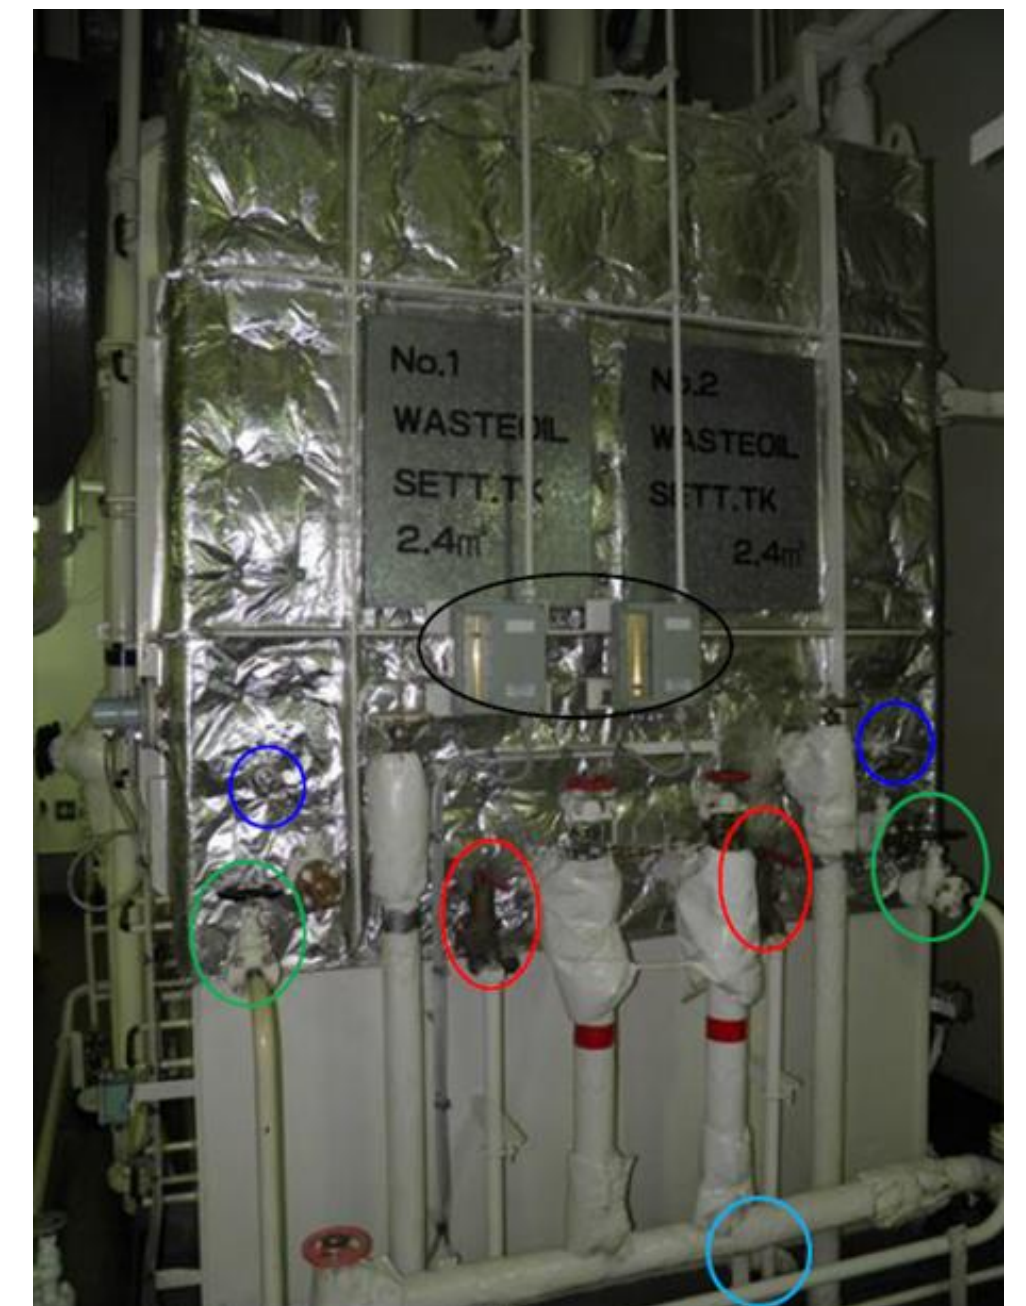
- The 2/E opened the WOS **drain valve** to drain off the sludge by gravity to the “Bilge Separator Oil Tank” (BSO tank) for about 10 minutes
- To confirm it was empty, the 3/E tried to turn the wire wheel of the scale reduction device on the top of the WOS and reported it was working
- Lastly, the 2/E opened the **self-closing water drain valve**, where Only a small quantity was observed before stopping
- Based on above the 2/E concluded that the WOS was empty

Blue: thermometer
Green: drain to BSO Tank
Red: self-closing valves
Light Blue: scupper
Black: level gauges
Source: HBMCI

- **Sounding pipe** – The tank was not fitted with a sounding pipe as an alternative means when the level gauge malfunctioned. Although not a requirement, this would have allowed the two engineers to verify the contents of the tank

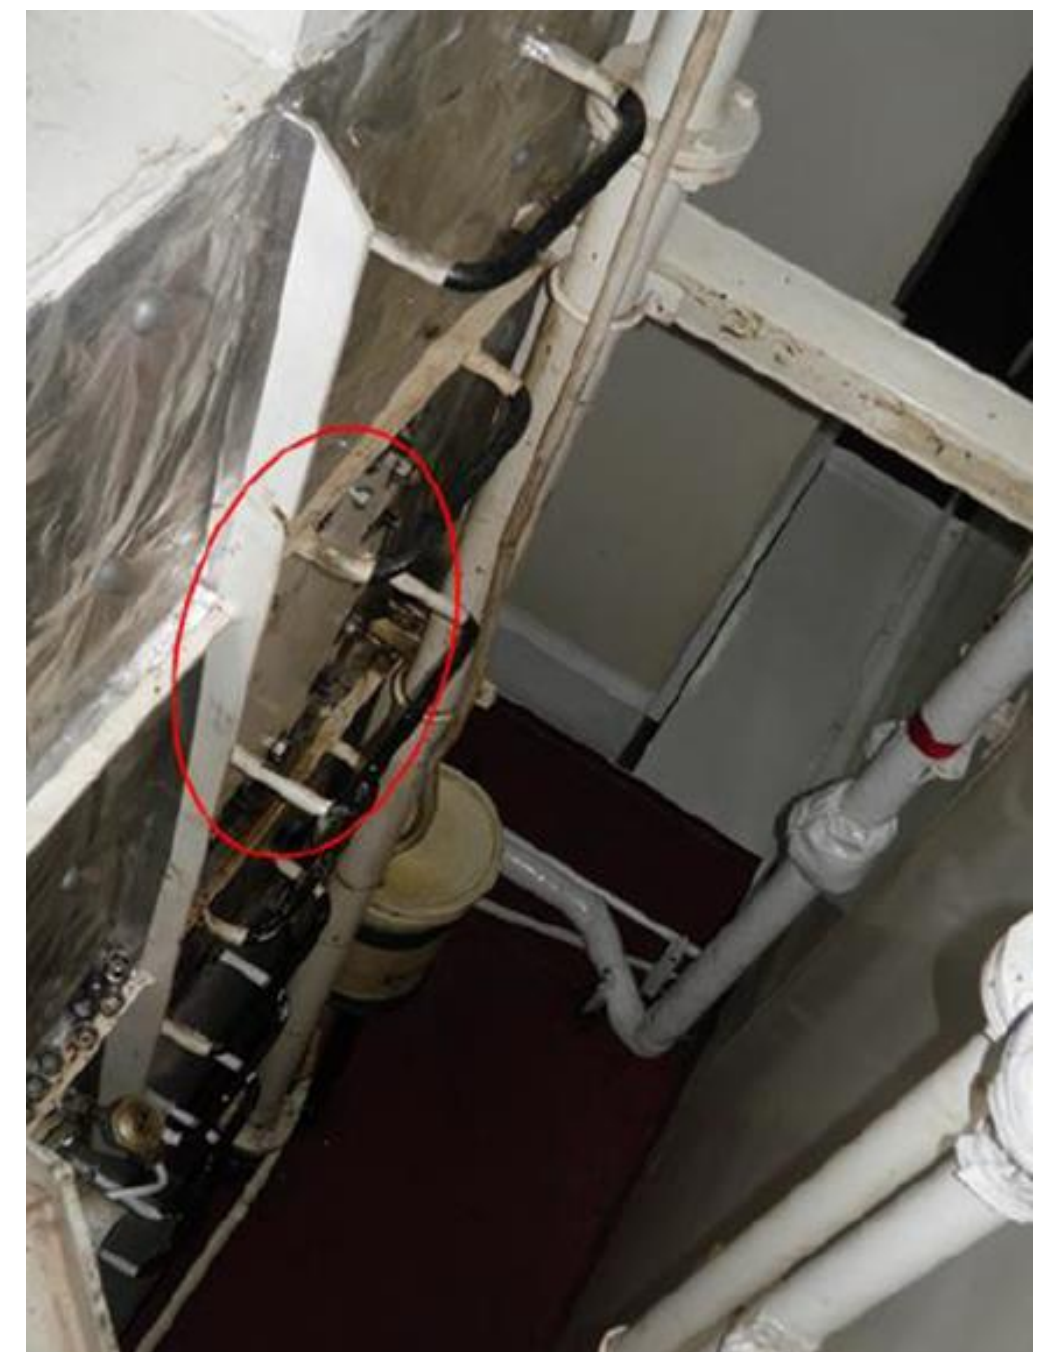
- Using a small folding ladder the 3/E started removing the manhole cover which was located about two metres above the floorplates
- Using an air impact wrench he removed most of the nuts from the manhole apart from four
- He loosened the last 4 bolts by a half turn. As no oil leakage from the was observed, he loosened the remaining nuts further
- Without removing the nuts, he pulled the cover which detached from the seat
- This resulted in hot oil of approx. 86°C splashing from the manhole bottom onto the 3/E

The manhole located two meters from the floor

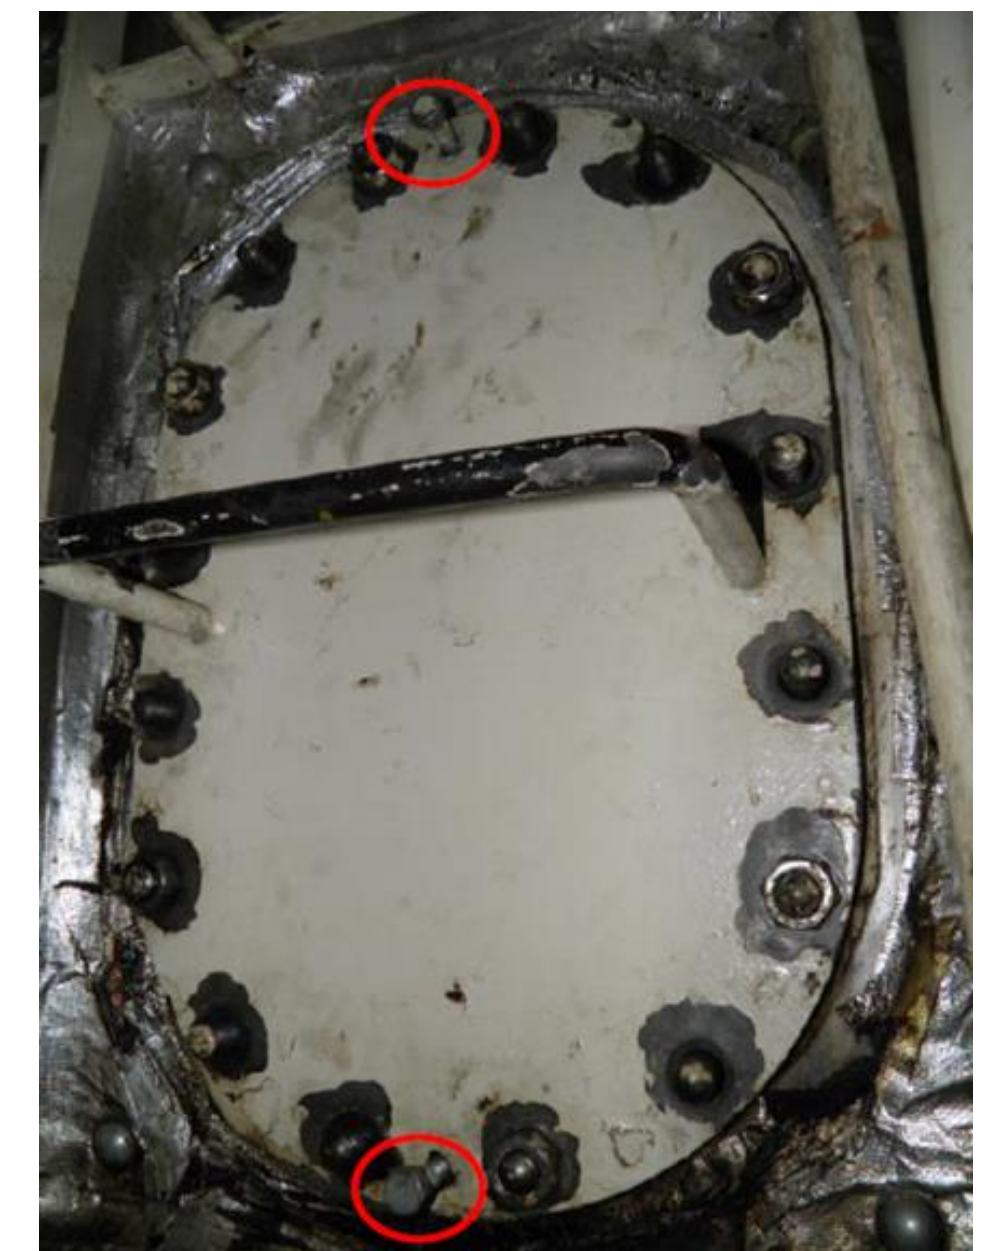
*The manhole cover of the tank and the two jackscrews fitted on the top and bottom side.
Source: HBMCI*

- **Stop Work** – A successful Stop Work Authority (SWA) program could enable the crew to use their authority to stop work in case of an apparent unsafe condition or behaviour and prevented this accident
- **Safe practices for the opening of the manhole** – The common practice identified in the investigation report to safely remove this type of manhole cover is to:
 - Remove all nuts except four crosswise;
 - Slightly loosen the four nuts by no more than ½ turn;
 - Tighten the jackscrews to detach the cover from the seat;

If a leakage is observed, the cover may be easily secured back by loosening the jackscrews and re- tightening the nuts

If no leakage is observed, loosen the nuts another ½ turn and tighten the jackscrews

If there is still no leakage, continue to loosen the four crosswise nuts and remove the cover
