### DEATH OF THIRD ENGINEER DUE TO BURN INJURIES

THE THIRD ENGINEER (3/E) ON BOARD A CAPESIZE BULK CARRIER WAS SPLASHED BY HOT SLUDGE WHILE OPENING THE MANHOLE COVER OF A SETTLING TANK. ALTHOUGH HE WAS SUBSEQUENTLY EVACUATED TO A SHORESIDE HOSPITAL BY HELICOPTER, HE TRAGICALLY DIED 12 DAYS LATER.

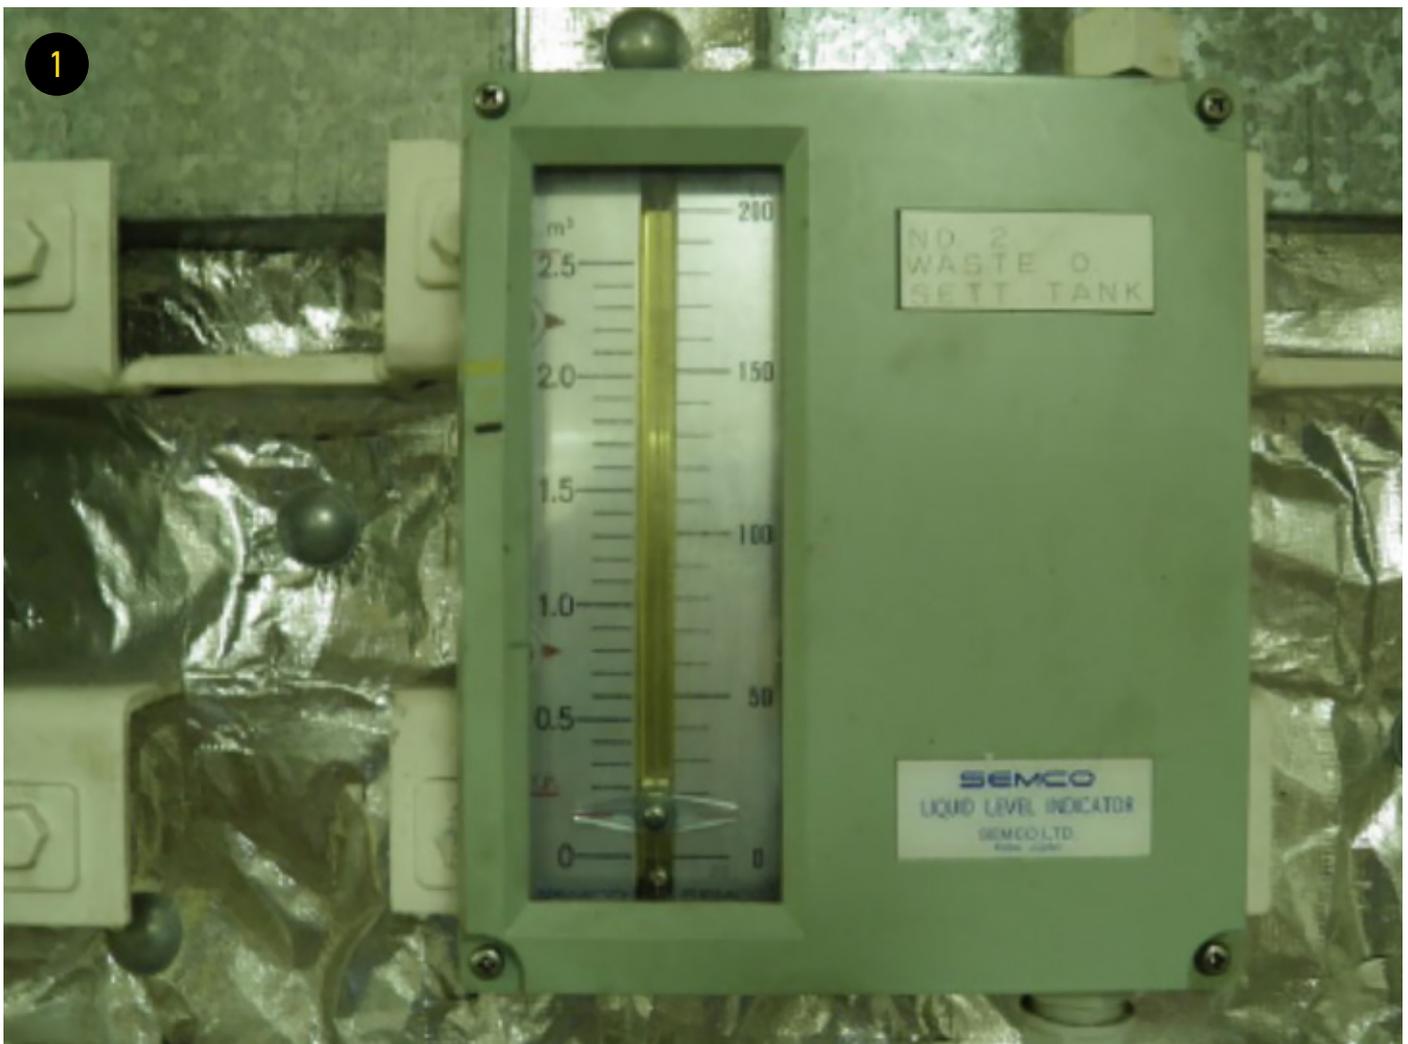
**FIGURE 1** THE LEVEL GAUGE OF NO.2 WASTE OIL SETTLING TANK. SOURCE: HBMCI

The vessel, built in 2010, was anchored off a Brazilian port waiting to enter and commence loading. While at the anchorage, the Second Engineer (2/E) transferred about 1.8 m<sup>3</sup> of sludge from the “Bilge Separator Oil Tank” (BSO Tank) to No.2 “Waste Oil Settling Tank” (No.2 WOS Tank) using the sludge pump. After the transfer, it was observed that the level gauge of the No.2 WOS Tank (Figure 1) was not indicating the correct quantity. The transferred quantity was then confirmed by sounding the BSO Tank, and it was concluded the level gauge in No.2 WOS Tank had malfunctioned.

The vessel's Planned Maintenance System (PMS) did not address the foreseeable and preventable jamming of the level gauges with sludge oil by providing guidelines for periodic routine maintenance/tank cleaning. The provision of an appropriate and regular regime for cleaning the tank would have helped avoid the need for this unplanned and hazardous task.

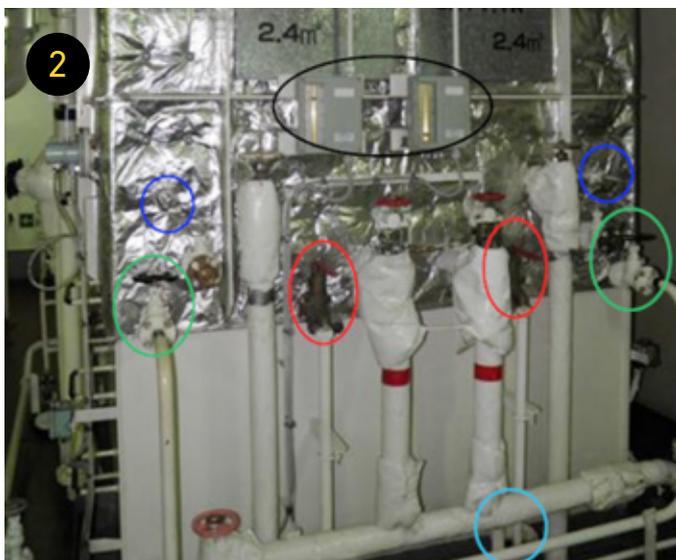
**FIGURE 2 THE TWO WASTE OIL SETTLING TANKS.**  
 BLUE: THERMOMETER GREEN: DRAIN TO BSO TANK  
 RED: SELF-CLOSING VALVE LIGHT BLUE: SCUPPER  
 BLACK: LEVEL GAUGES SOURCE: HBMC I

The WOS Tank was not fitted with a sounding pipe as an alternative means when the level gauge malfunctioned. Although not a requirement, had a sounding pipe been fitted, this would have allowed the two engineers to verify the contents of the tank.

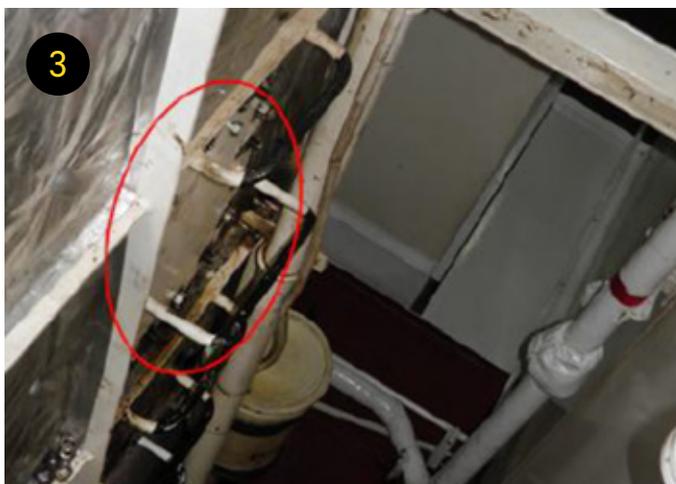
**FIGURE 3 THE MANHOLE AT THE AFT SIDE OF THE TANK**  
 ALMOST ONE METRE FROM THE BULKHEAD AND TWO  
 METRES FROM THE FLOOR. SOURCE: HBMC I

Based on the above, the 2/E was convinced that the tank was empty and told the 3/E to proceed with opening the manhole. The 3/E used a small folding ladder to reach the manhole cover (Figures 3) and (Figure 4, next page), located about two metres above the floorplates, and started removing the cover nuts using an air impact wrench. The 3/E removed most of the nuts from the manhole apart from four, which he then loosened by a half turn. As he did not observe any oil leakage from the cover seat, he loosened the remaining nuts further. Then, without removing the nuts, he pulled the cover which detached from the seat. However, hot oil at a temperature of approximately 86°C started splashing from the manhole bottom onto the 3/E, standing on the ladder.
