DEATH OF AN ELECTRICIAN DUE TO ELECTROCUTION

AN OIL TANKER WAS ON PASSAGE WHEN THE SHIP'S ELECTRICIAN, WHO HAD BEEN WORKING ALONE, WAS FATALLY ELECTROCUTED WHILE PERFORMING MAINTENANCE OF THE INERT GAS SCRUBBER ELECTRICAL SYSTEM (FIGURE 1).

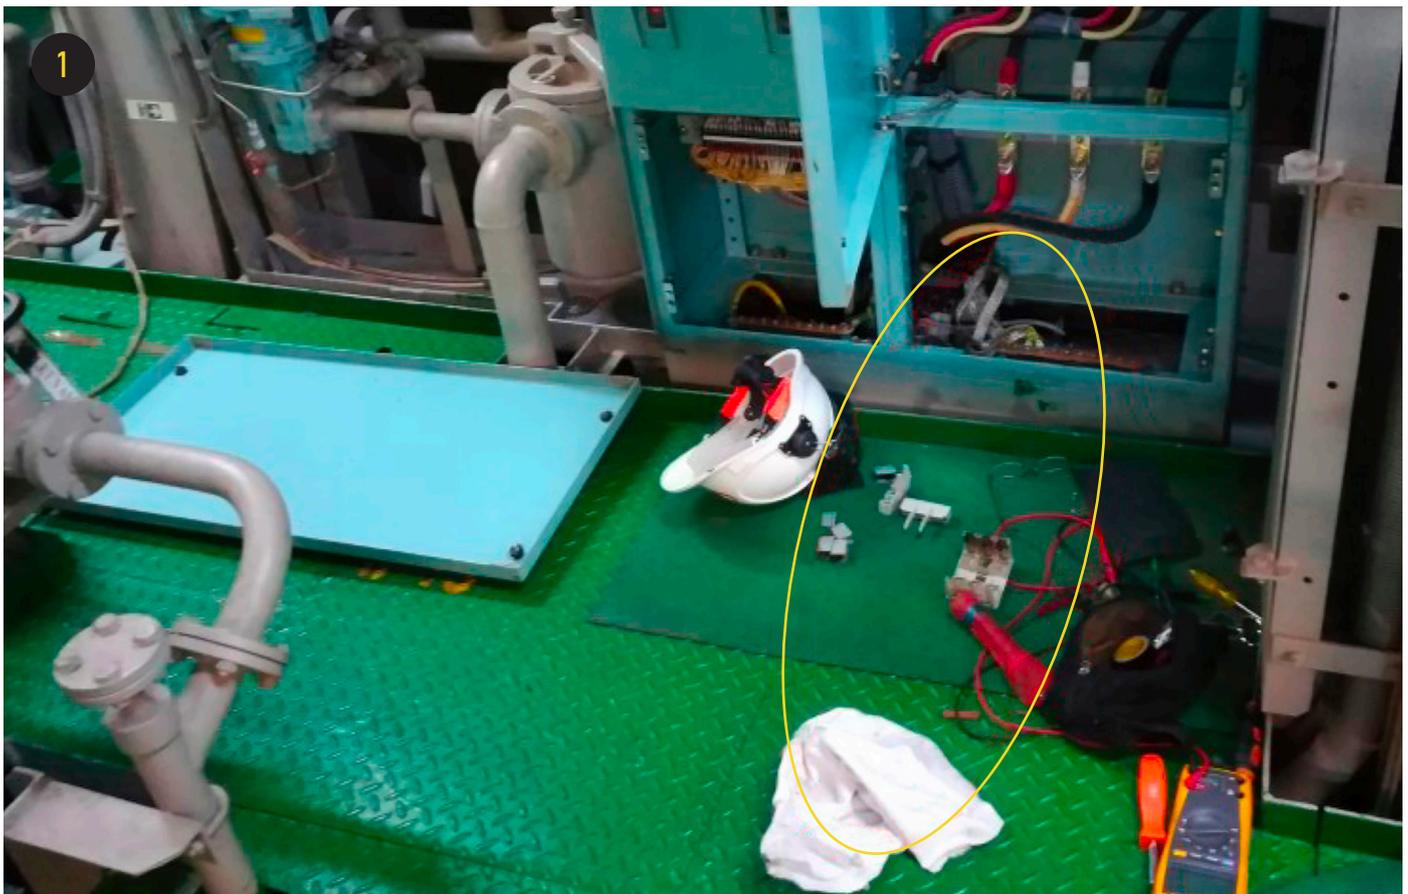
FIGURE 1 LOCATION OF THE ELECTRICIAN WHEN FOUND.
SOURCE INVESTIGATION REPORT BY REPUBLIC OF THE MARSHALL ISLANDS MARITIME ADMINISTRATOR

On arriving at the LGSP cabinet, the cadet found the electrician lying on the deck with his head and hands inside the lower section (**FIGURE 1**). The cadet then removed the electrician, who was reported to be unconscious and unresponsive, from the LGSP cabinet by pulling on his safety shoes. The electrician's tools, safety helmet and rubber gloves were on the deck in front of the cabinet (**FIGURE 4**). The door for the IG scrubber pump starter panel was fully open, and the lower panel covering the 440V power terminals had been removed and placed to the left of the LGSP cabinet (**FIGURE 1**).

- Although it did not contribute to the incident, the cadet could also have been electrocuted when he immediately pulled the electrician from the LGSP cabinet. A more correct response would have been to ensure that the power was isolated and that the electrician's body was not energized due to contact with the live terminals.

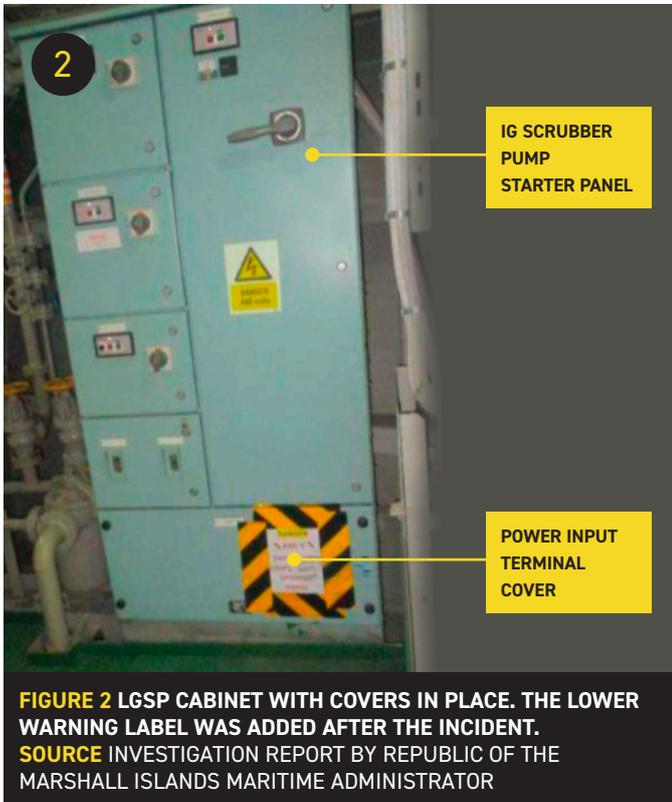
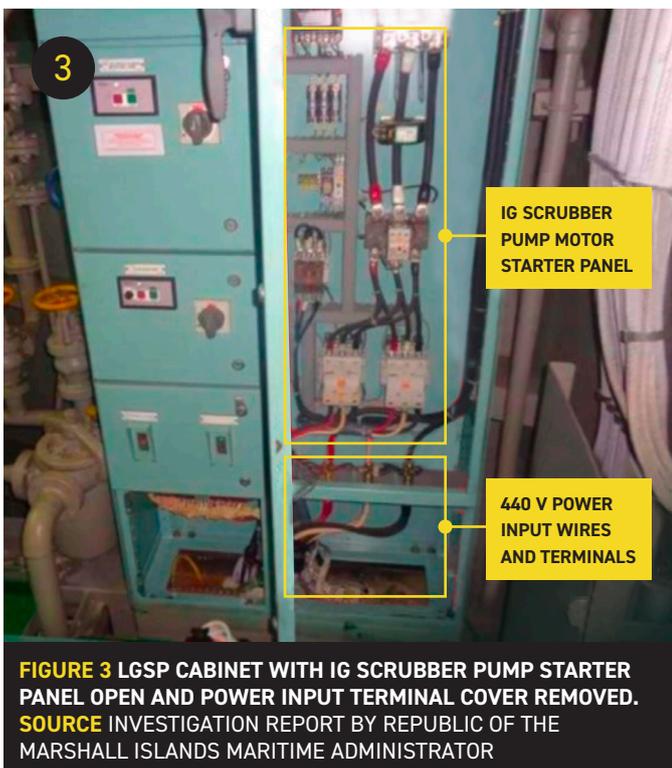
The IG scrubber pump starter panel was located on the engine room's bottom platform inside a local group starter panel (LGSP) cabinet. The LGSP cabinet had several sections: the upper sections held starter controls for various types of machinery, while the lower section contained the 440V power terminals (**FIGURE 2**). The cover over the power terminals was fully removable (**FIGURE 3**). Unlike other starter cabinets on the ship, the LGSP cabinet had no horizontal divider between the upper and lower section. Also the three power cable terminals in the lower section did not have covers over the power terminals to prevent accidental contact. The pump starter panel door could only be opened after turning the main power breaker lever to the off position, which de-energized the equipment in the panel.

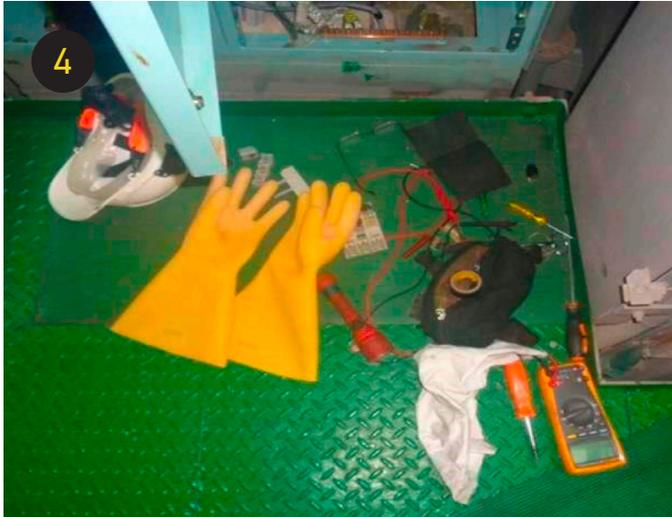
FIGURE 4 TOOLS AND SAFETY HELMET ON DECK WHERE THE ELECTRICIAN WAS FOUND.

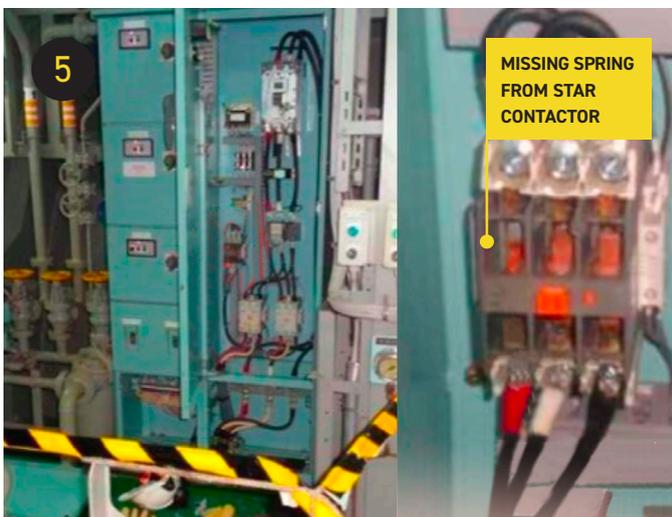
FIGURE 5 IG SCRUBBER PUMP STARTER CONTACTS AND THE MISSING STAR CONTACTOR SPRING.

The main circuit breaker supplying power to the pump starter (inside the IG scrubber pump starter panel) was found in the off (open) position. The star contactor for the pump starter was missing a spring and cover locking pin (**FIGURE 5**). These were found on the cabinet's lower framing and deck. The investigation presumed that the electrician inadvertently touched the energized 440V power terminals in the cabinet's lower section while retrieving the star contactor spring or the cover locking pin.

- An effective and timely scheduled maintenance would have resulted in recording and rectifying the missing physical safety barriers within the LGSP cabinet and prevented the electrician from accidental contact with energized circuits.
