SCAFFOLDING FALL CAUSES SERIOUS INJURIES

THIS CASE STUDY IS DRAWN FROM THE INVESTIGATION REPORT 328-MO-2017-001 PUBLISHED BY THE AUSTRALIAN TRANSPORT SAFETY BUREAU (ATSB) AT:
https://www.atsb.gov.au/media/5775607/mo-2017-001_final.pdf

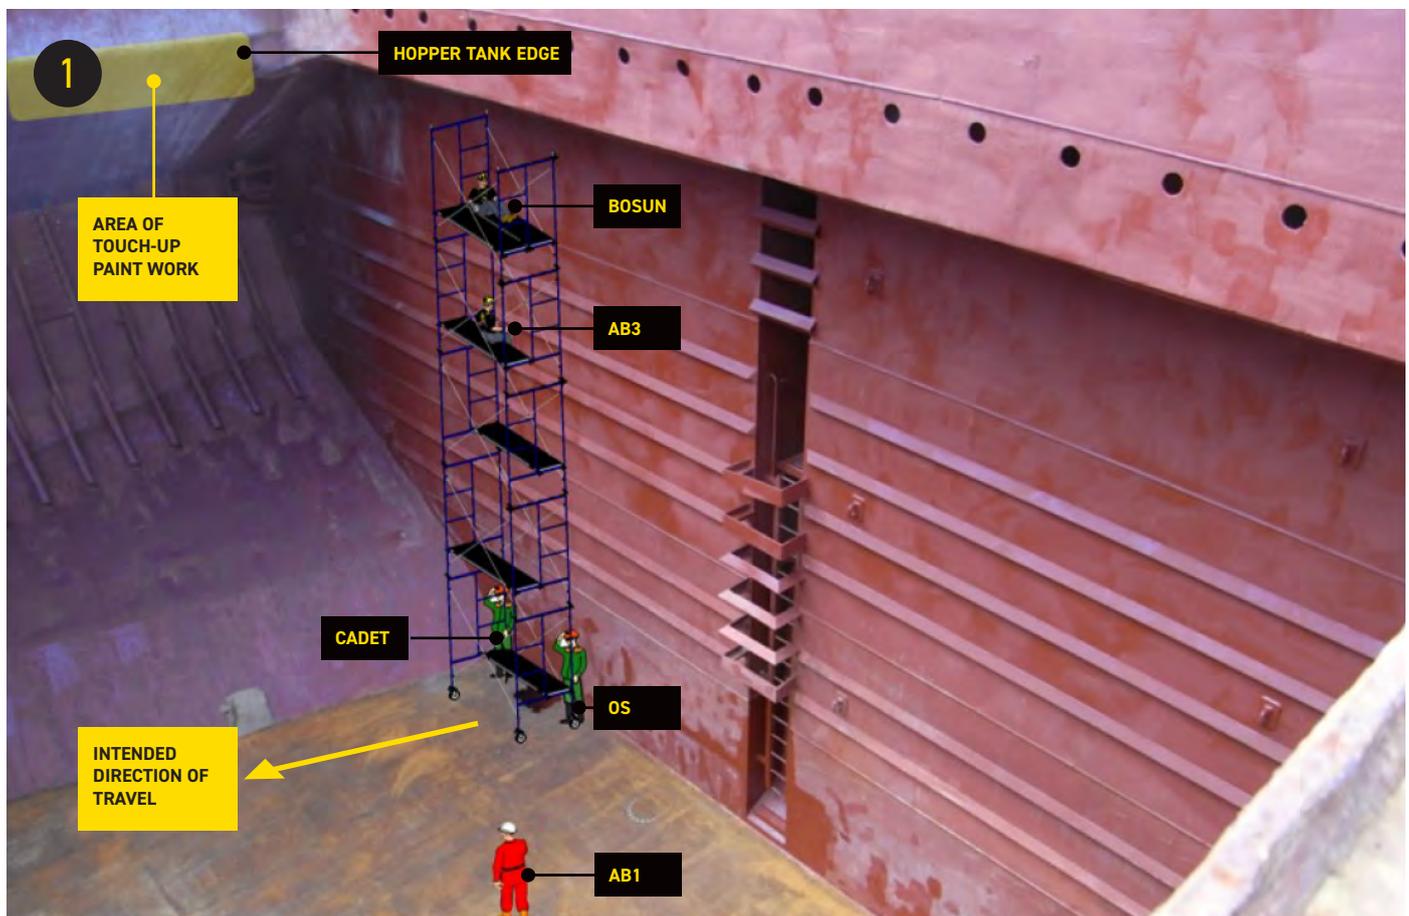
TWO CREW MEMBERS ON BOARD A GEARED BULK CARRIER WERE CARRYING OUT ROUTINE PAINTING IN THE CARGO HOLDS USING A MOBILE SCAFFOLD TOWER TO GAIN ACCESS TO THE UPPER HOLD STRUCTURE. WHILE THE SCAFFOLD TOWER WAS BEING REPOSITIONED (**FIGURE 1**), IT BECAME UNBALANCED AND TOPPLED FORWARD ONTO THE DECK. THE TWO CREW MEMBERS, WHO HAD REMAINED ON THE UPPER TIERS OF THE SCAFFOLDING WHILE IT WAS BEING MOVED, SUSTAINED SERIOUS INJURIES FROM THE FALL AND HAD TO BE EVACUATED TO A HOSPITAL ASHORE FOR TREATMENT.

FIGURE 1 HOLD NO.4 SHOWING THE POSITION OF SCAFFOLD TOWER, CREW MEMBERS AND DIRECTION OF MOVEMENT.
SOURCE: AUSTRALIAN TRANSPORT SAFETY BUREAU (ATSB)

After they had finished on the aft bulkhead, the bosun decided to touch up the hopper tank edge (**FIGURE 1**). He instructed the OS and cadet to move the scaffold tower forward so that they could reach the topside tank surface; the AB3 was aware the tower would be moved.

The cadet and OS released the tower securing lines and went down into the hold to move the tower. At about 1410 they released the wheel brakes and started to push the structure forward. The tower moved about 0.5m when it suddenly toppled forward on to the deck bringing down the bosun and AB3 with it.

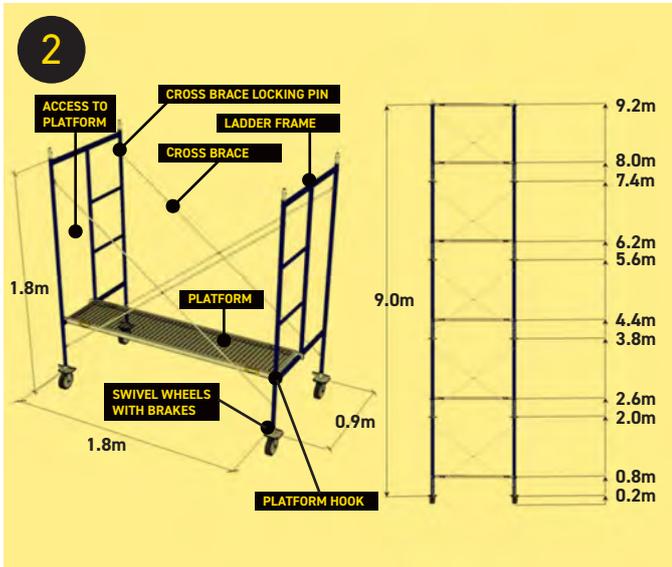
FIGURE 2 SCAFFOLD CONSTRUCTION COMPONENTS AND DIMENSIONS. SOURCE: AUSTRALIAN TRANSPORT SAFETY BUREAU (ATSB)

This required them to use the ship's portable modular scaffold tower (**FIGURE 2**) in order to access the upper aft bulkhead and topside tank about 6 to 9m above the tank top.

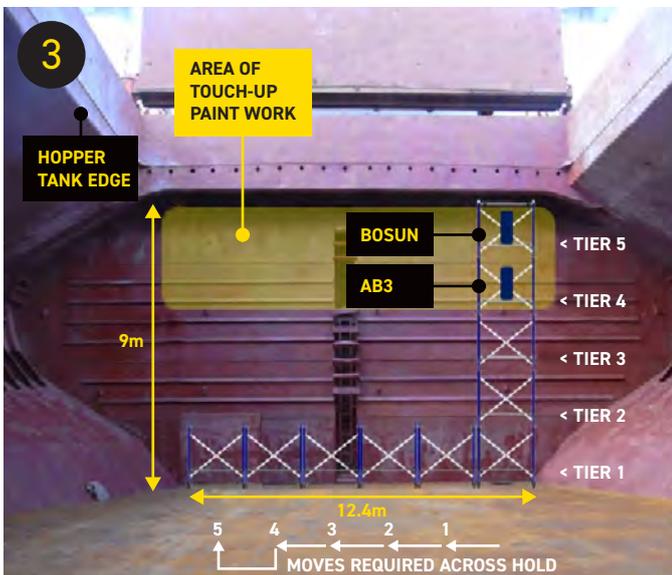
At midday the bridge watch duty changed over and at about 1300 the bosun, AB1 (who had replaced AB2, who was now on duty on the bridge), AB3, the cadet and the OS went to hold No.4. The C/O was resting in preparation for his bridge watch at 1600. The scaffold tower was assembled (**FIGURE 3**) and the associated equipment prepared. As before, the bosun and AB3 painted from the scaffold tower and the remaining crew members assisted. The task started in the port aft corner of the hold.

A similar work sequence to that in hold No.1 was followed. However, this time when the scaffolding was moved, the bosun and AB3 remained on the tower while the OS and cadet repositioned it. Unlike in the morning, neither the bosun nor AB3 wore safety harnesses or used safety lines.

FIGURE 3 HOLD NO.4 SHOWING HOW THE SCAFFOLD TOWER MOVES FROM PORT TO STARBOARD AND THE POSITIONS OF CREW MEMBERS ON THE TOWER VIEWED FROM FORWARD. SOURCE: AUSTRALIAN TRANSPORT SAFETY BUREAU (ATSB)

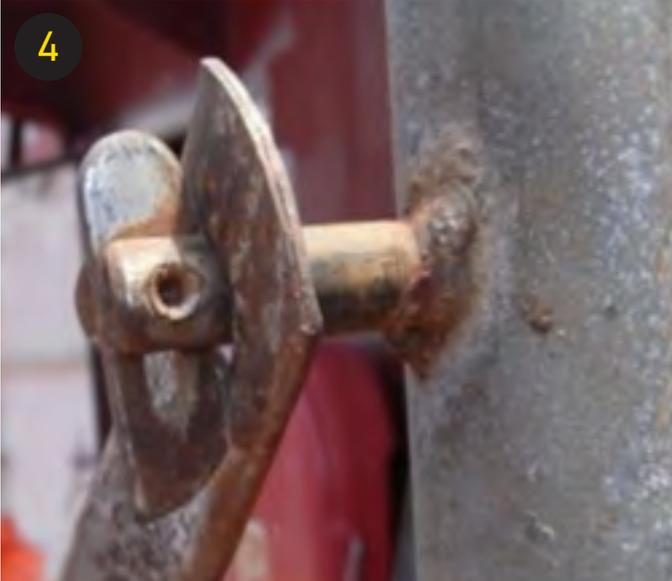
FIGURE 4 LOOSE SCAFFOLDING CROSS BRACE LOCKING PINS ALLOWING TRAVEL UP TO 40 MM.
SOURCE: AUSTRALIAN TRANSPORT SAFETY BUREAU (ATSB)

Subsequent inspection of the scaffolding identified that it had no manufacturer's identification plate, and all components showed signs of regular use, wear and tear, damage (**FIGURES 4 AND 5**) and some repairs.

- **Although the incident could not be directly attributed to any of the identified defective scaffold tower components, these would have exacerbated the instability of the structure. Scaffolding should always be in good condition and fit for purpose. It should also comply with relevant standards and be suitable for the work to be carried out.**

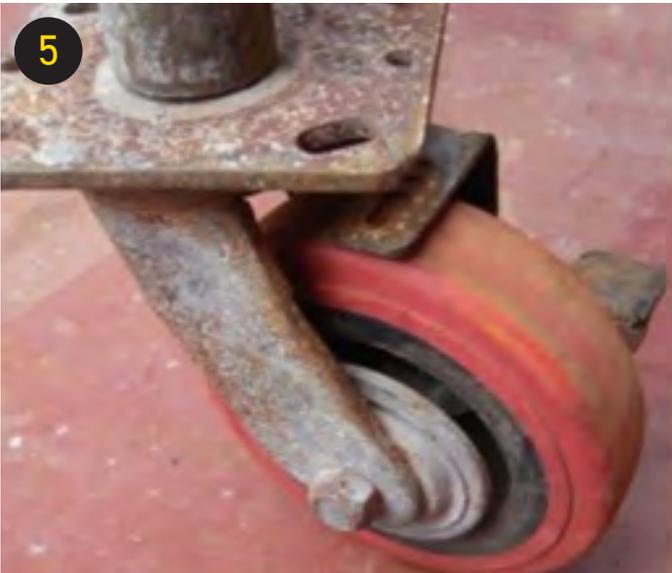
FIGURE 5 INOPERATIVE SCAFFOLDING SWIVEL WHEEL BRAKES ON THREE OF THE FOUR WHEELS.
SOURCE: AUSTRALIAN TRANSPORT SAFETY BUREAU (ATSB)
