Fatal crush incident

BACKGROUND

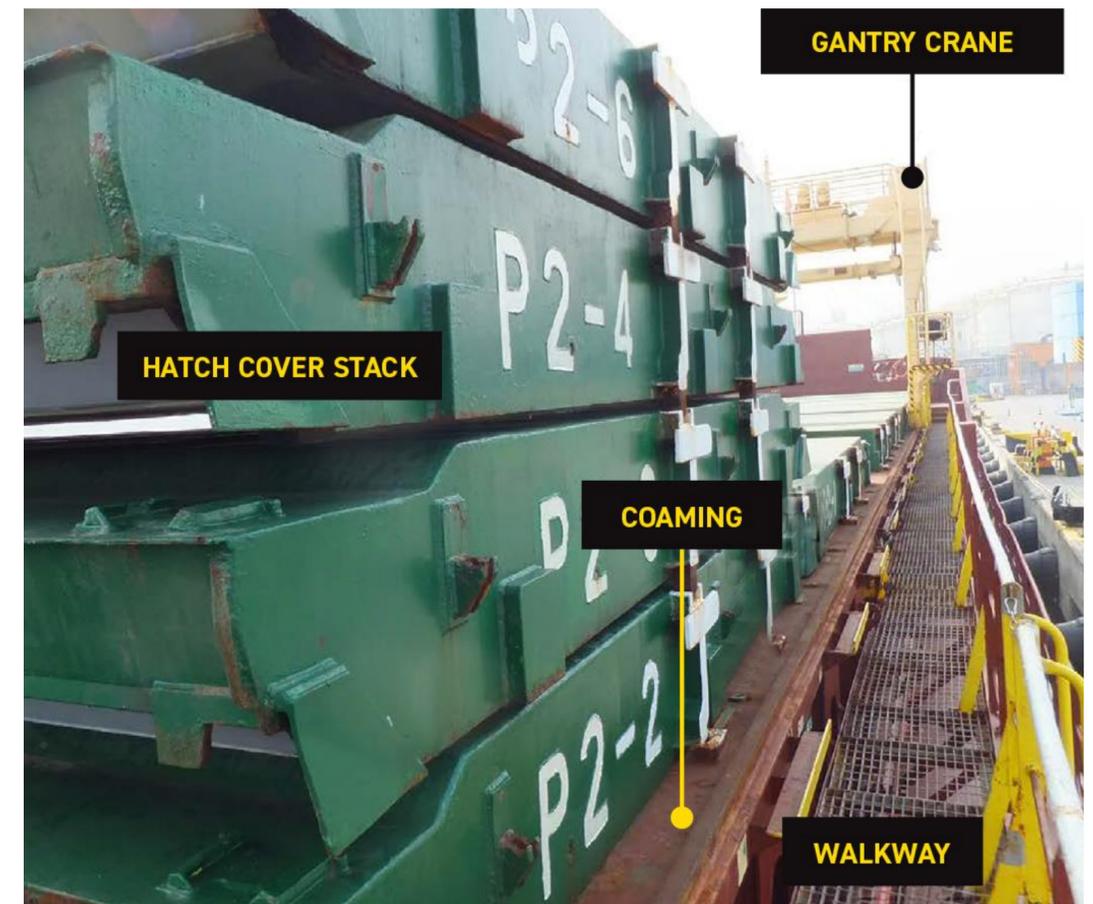
Starboard walkway looking forward showing stack of hatch covers and gantry crane

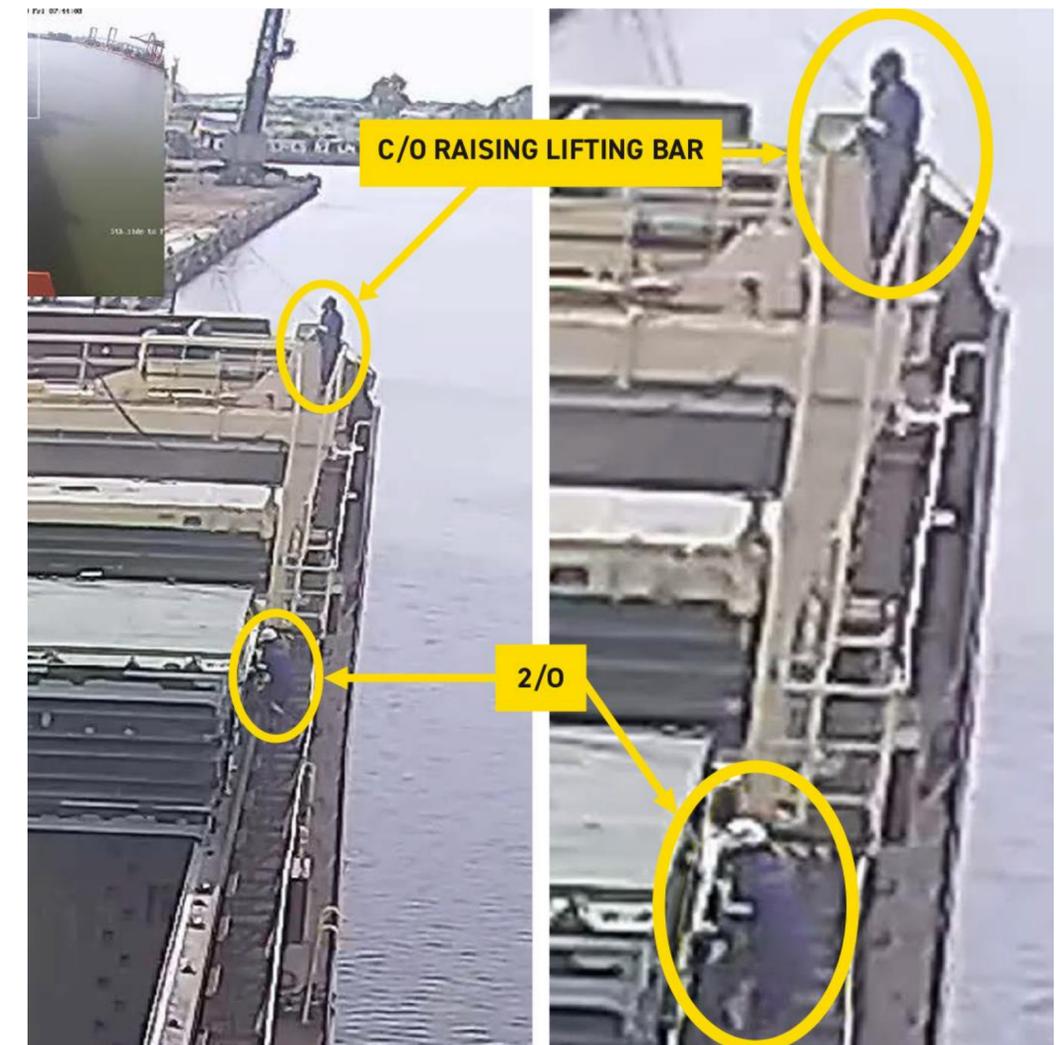
Zoomed closed-circuit television (CCTV) screenshot looking forward showing the 2/O climbing onto the cargo hold hatch coaming

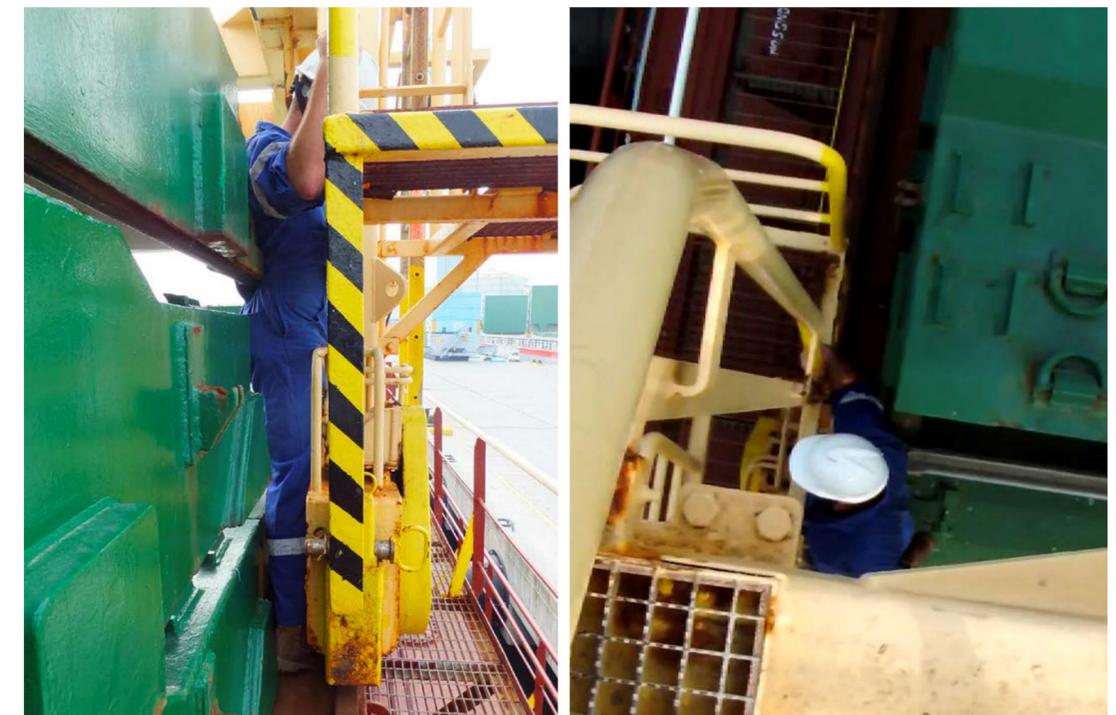
Reconstruction showing a crew member in the gap between the ladder platform and stacked hatch covers

- **Incident cause** – The 2/O was crushed while he was trying to walk between the gantry crane and a stack of hold hatch covers when the C/O began to move the gantry crane aft at the same time. This reduced the gap between the crane's ladder platform and covers to around 130mm, trapping the 2/O.

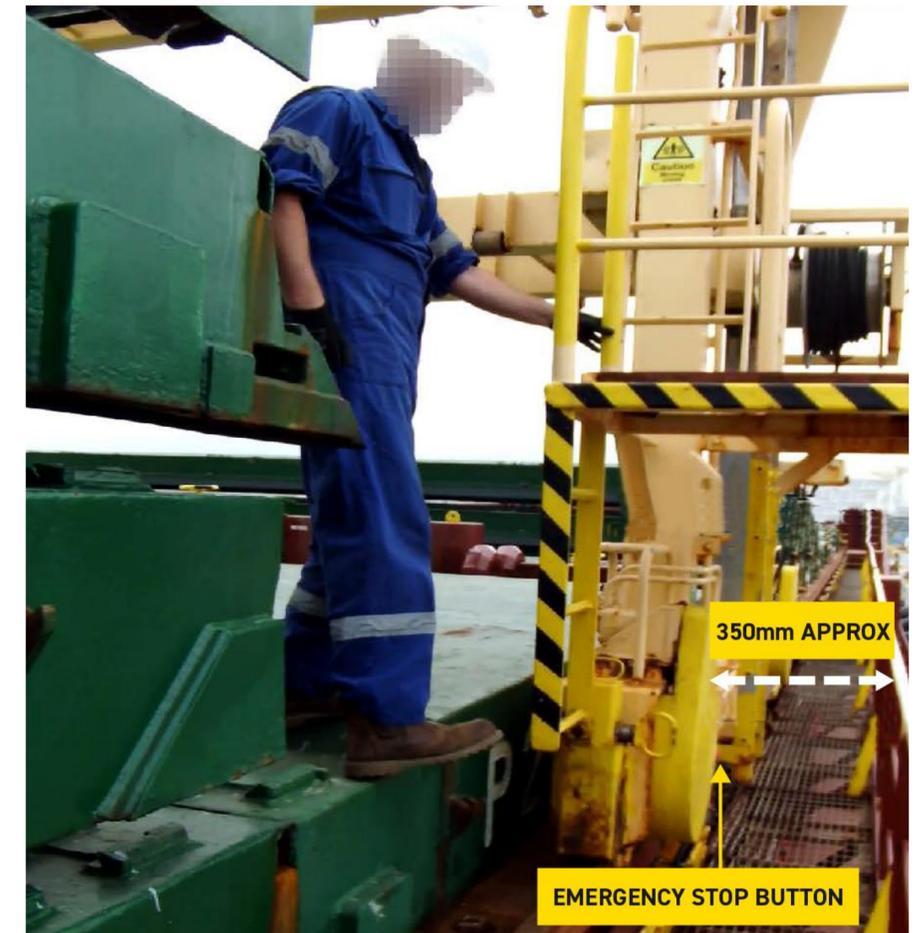
Access to starboard emergency stop button

- **Emergency stops** – The crane's deck level emergency stop buttons could only be operated from the walkways and could not be reached by the 2/O before and after he became trapped.
