CHEMICAL BURNS INCIDENT

THE THIRD OFFICER (3/O) OF A CHEMICAL TANKER WAS SPLASHED WITH CAUSTIC SODA WHILE PREPARING THE SHIP'S CARGO TANKS READY FOR LOADING A CARGO OF CAUSTIC SODA (FIGURE 1). TO PREPARE THE CARGO TANKS FOR LOADING RESIDUES FROM A CARGO SAMPLE OF CAUSTIC SODA HAD TO BE REMOVED FROM THE TANKS FOR WHICH A MOBILE PNEUMATIC DRIVEN PUMP WAS USED. WHILE THE CAUSTIC SODA WAS BEING PUMPED OUT, THE HOSE PARTED FROM THE PRESSURE SIDE OF THE PUMP CAUSING THE 3/O TO BE SPATTERED WITH THE CORROSIVE SOLUTION WITH A SMALL QUANTITY ENTERING HIS EYES.

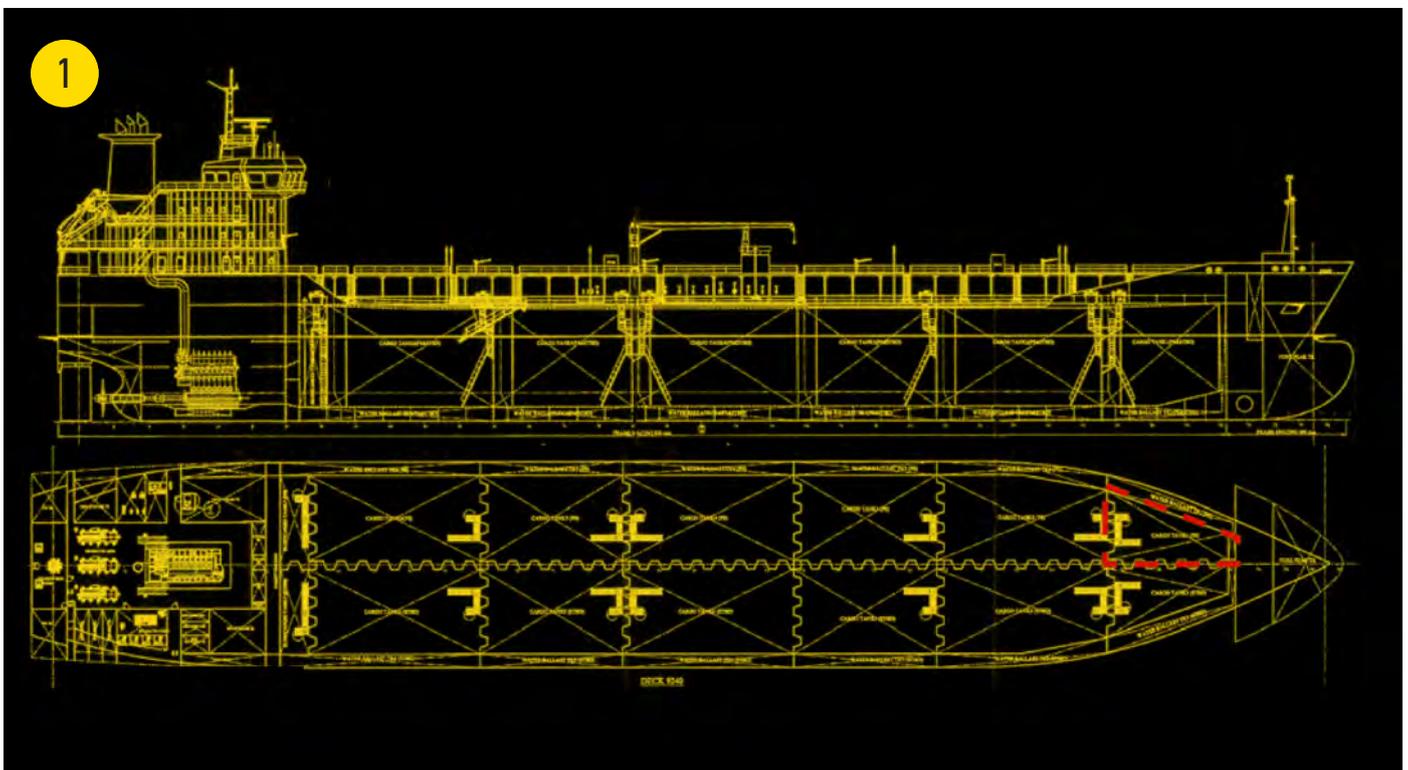
FIGURE 1 GENERAL ARRANGEMENT PLAN SHOWING THE LOCATION OF TANK NO.1 PORT IN RED.
SOURCE: FEDERAL BUREAU OF MARITIME CASUALTY INVESTIGATION (BSU)

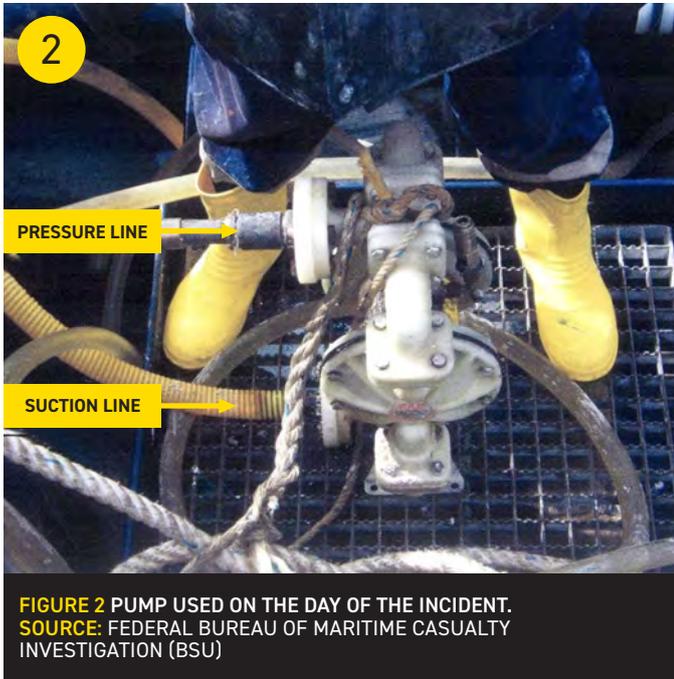
FIGURE 2 PUMP USED ON THE DAY OF THE INCIDENT.
SOURCE: FEDERAL BUREAU OF MARITIME CASUALTY INVESTIGATION (BSU)

Early on 30 July the ship relocated back to the roadstead and on 1 August the crew prepared to clean the cargo tanks one more time. This required two crew members to enter tank no. 1 port and remove the residues of the caustic soda that had been used as a cargo sample using a mobile pump. A polypropylene pneumatic driven pump with a pumping capacity of 520 l/min at a maximum working pressure of 8 bar (**Figure 2**) was prepared. Meanwhile a tank cleaning team consisting of the 3/O and an ordinary seaman (O/S) donned Personal Protective Equipment (PPE) consisting of a cotton overall, a rubberised jacket, safety boots, protective gloves, goggles and a safety helmet (**Figure 3**) and prepared to enter the tank.

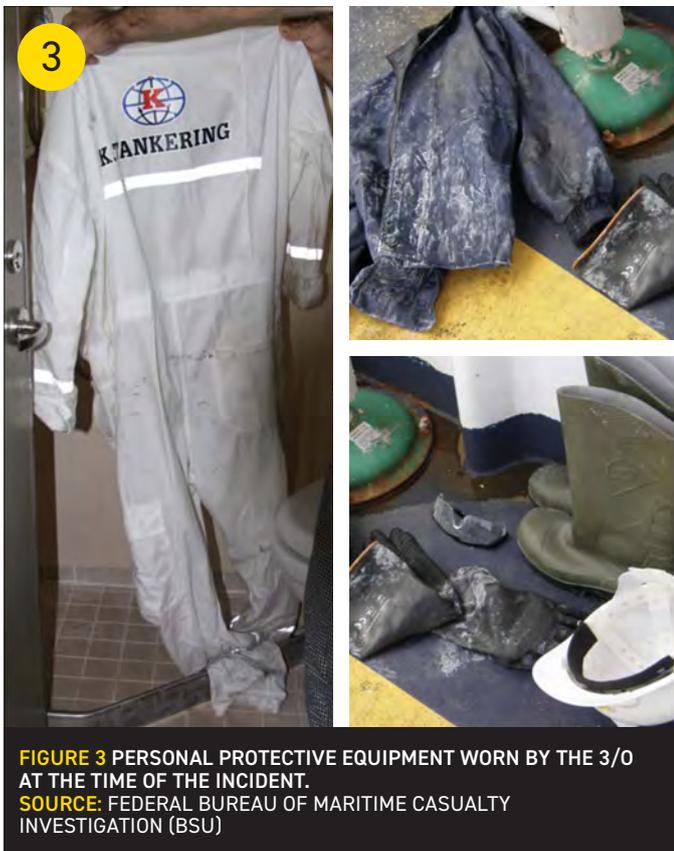
FIGURE 3 PERSONAL PROTECTIVE EQUIPMENT WORN BY THE 3/O AT THE TIME OF THE INCIDENT.
SOURCE: FEDERAL BUREAU OF MARITIME CASUALTY INVESTIGATION (BSU)

- The goggles worn by the 3/O at the time of the incident were open at the sides, allowing the caustic soda to enter his eyes more or less freely, while the cotton overalls were also not of a suitable standard for handling caustic soda. The use of tight-fitting goggles or a face shield (or both), as well as clothing made of chemical-resistant material, would have provided a more effective level of protection in accordance with the requirements of The International Code for the Construction and Equipment of Ships carrying Dangerous Chemicals in Bulk (IBC Code).

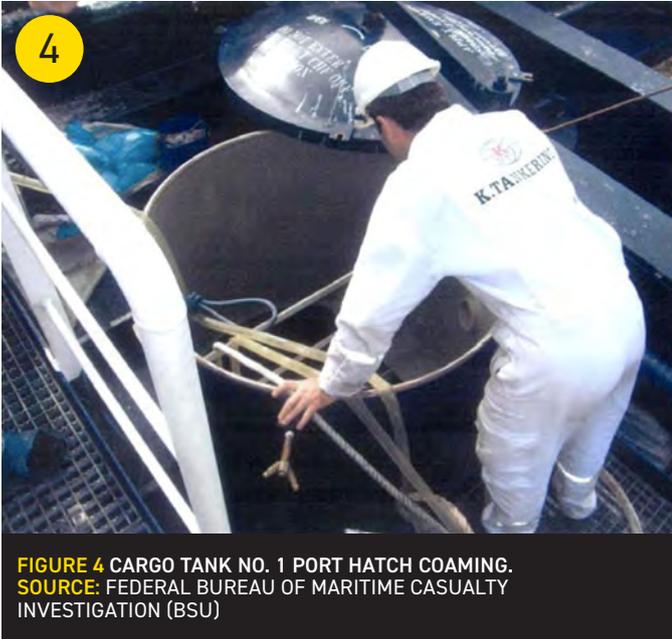
FIGURE 4 CARGO TANK NO. 1 PORT HATCH COAMING.
SOURCE: FEDERAL BUREAU OF MARITIME CASUALTY INVESTIGATION (BSU)

At about 1430 local time, the tank cleaning team entered cargo tank no. 1 port on its port side (**Figure 4**). The bosun was located at the coaming of the entry hatch to the cargo tank and the master was located at the forward part of the vessel near the tank entrance.

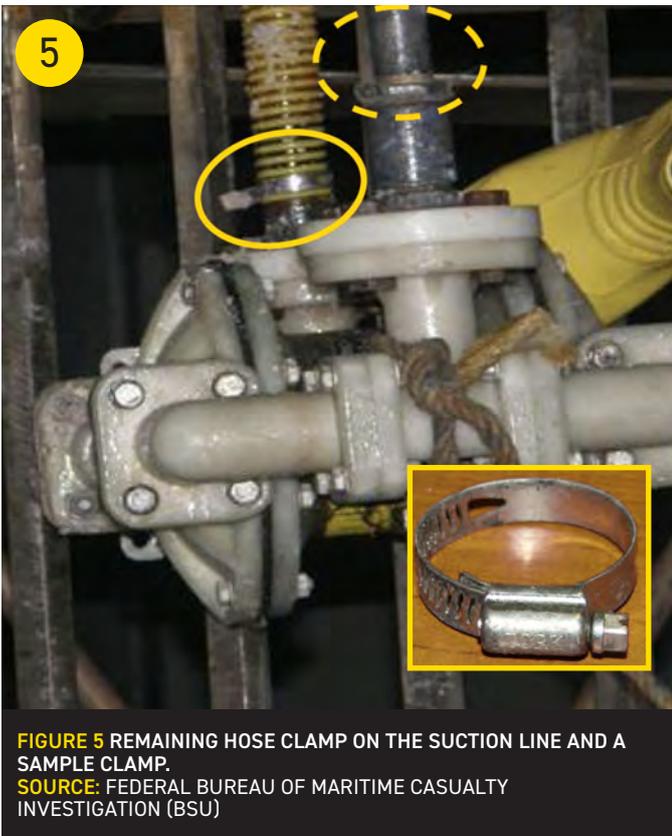
FIGURE 5 REMAINING HOSE CLAMP ON THE SUCTION LINE AND A SAMPLE CLAMP.
SOURCE: FEDERAL BUREAU OF MARITIME CASUALTY INVESTIGATION (BSU)

While the caustic soda was being pumped out from inside the tank, the hose clamp securing the pressure hose to the pump parted and caustic soda was released into the cargo tank (**Figure 5**). This resulted in the 3/O being spattered with caustic soda, with a small quantity entering his eyes. Alerted by the 3/O's screams, the O/S requested assistance using his portable radio. The 3/O was safely escorted out of the cargo tank and onto the deck where the master and the bosun took him to his cabin where they conducted first aid by rinsing his eyes with water, while shore assistance was requested.

- The investigation was unable to establish the actual cause of the hose clamp parting from the mobile pump as the investigators were unable to locate the clamp following the incident. Therefore it remains uncertain whether a case of material fatigue caused the clamp to part. Nonetheless, all equipment should always be inspected prior to use to ensure it is fit for purpose.
