Fall of a Heavy Object, resulting in injury

BACKGROUND

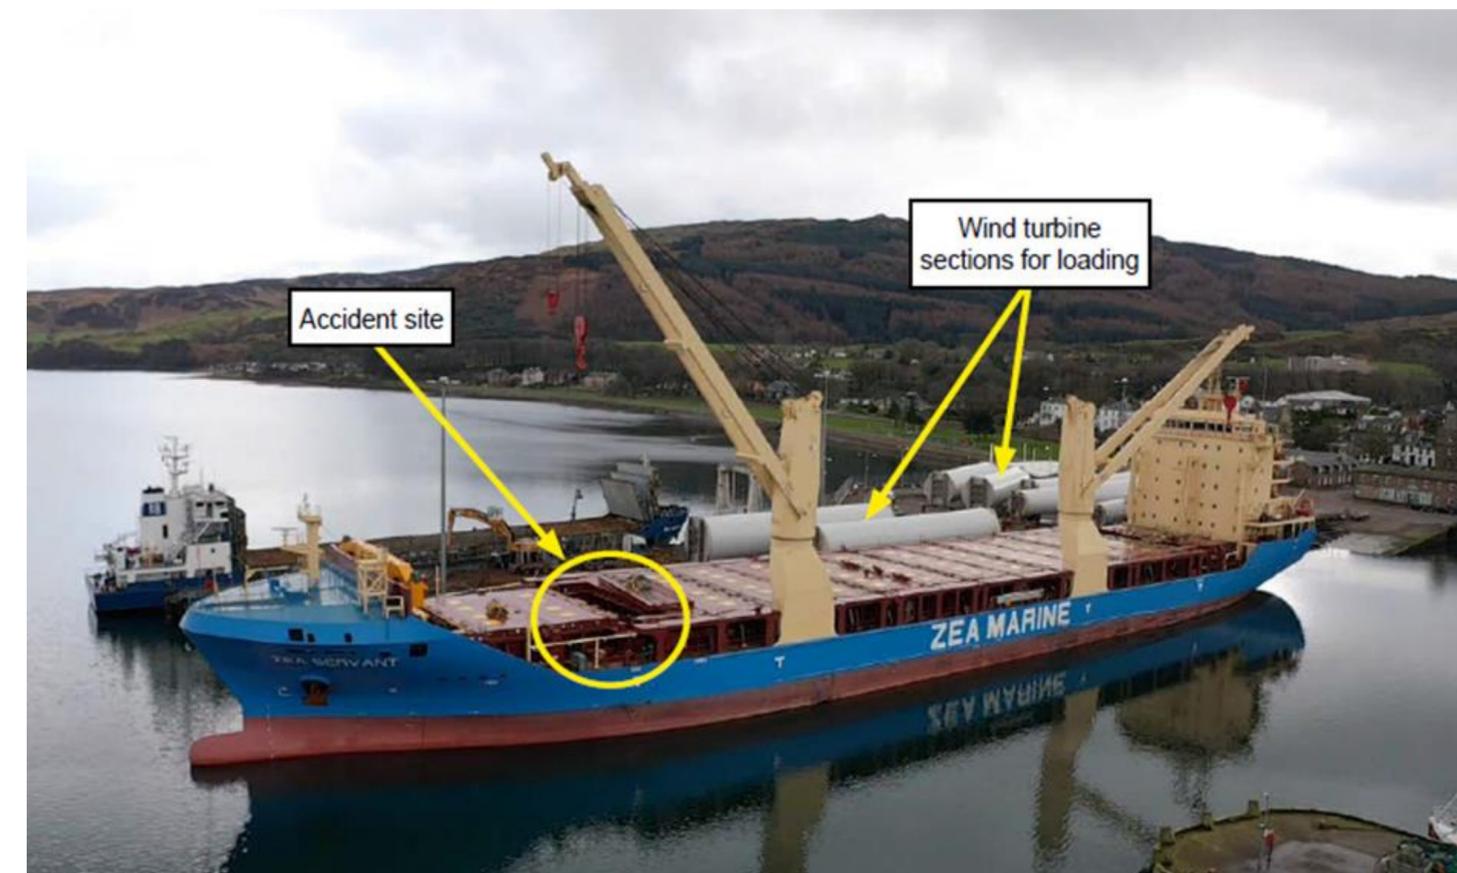
The ship in berth, showing accident site and wind turbine sections for loading.

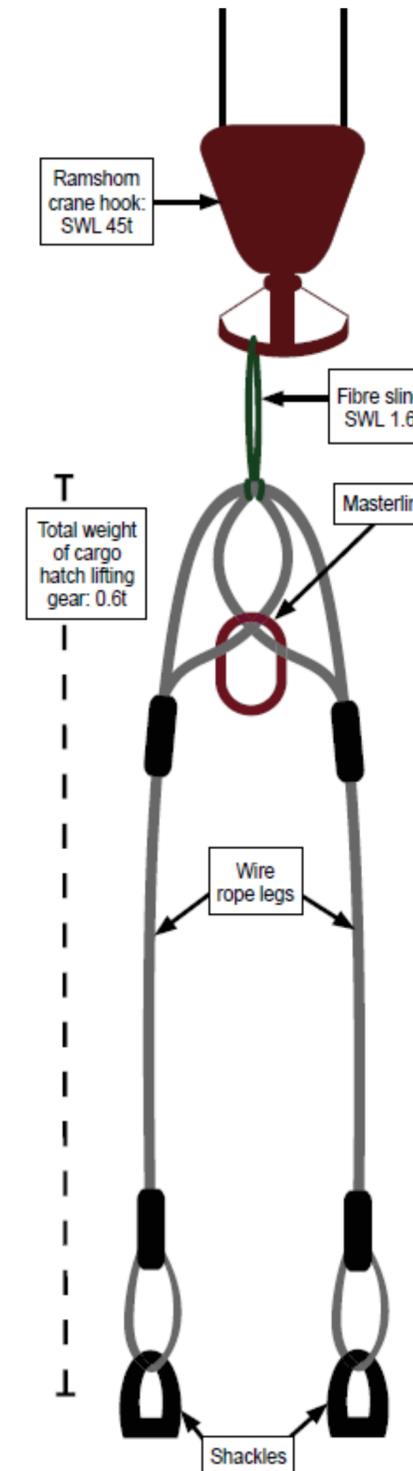
- The lifting gear was made up of two slinging sets; each set weighed 0.6t and consisted of two 17m long, 52mm diameter wire rope legs with shackles, joined together with a master link. It was connected to the crane hook by a fibre sling with SWL of 1.6t.
- The ship's Safety Management System (SMS) did not contain a specific risk assessment or a procedure for the stowage and handling of the lifting gear, nor any guidance for the conduct of a lifting plan and the identification of fall zones.
- As there was no procedure to follow, the crew had adopted their own method of carrying out the lifting operation. The crew had used the same method on at least five previous occasions and had experienced similar snagging events. When these had occurred, the deck crew had manually freed the gear after the crane had stopped hauling.

The lifting gear, attached to crane hook with fibre sling.

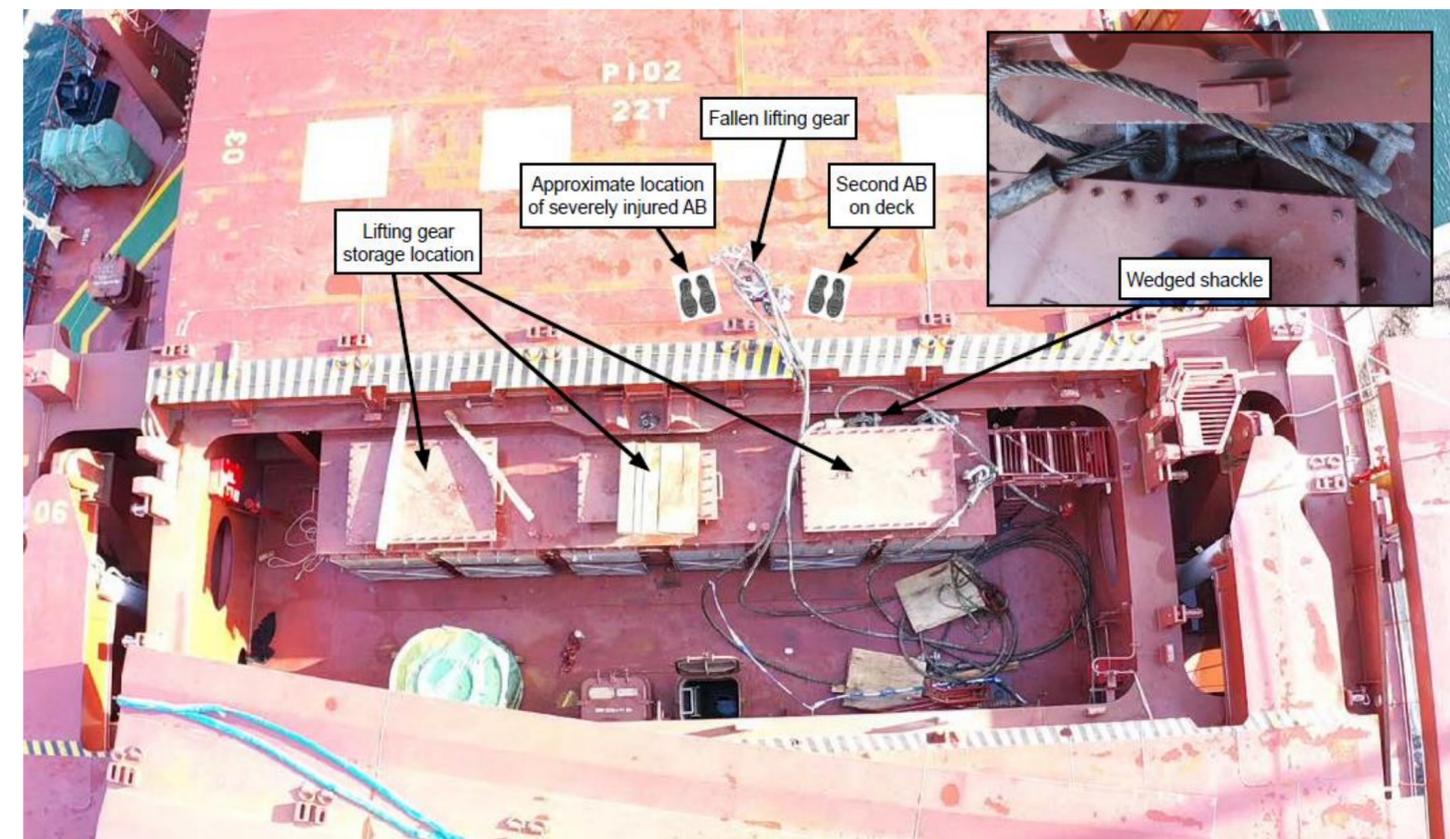
Ventilation duct space and incident site; inset: close-up of wedged shackle.

- With the two A/Bs remaining close to the edge of the hatch the C/O ordered the crane driver to start heaving again.
- Shortly after the lifting operation recommenced, a shackle at the lower end of the load became snagged on a ventilation trunk coaming.
- The C/O immediately instructed the crane driver to stop, but at the same time the fibre sling parted and the lifting gear fell to the deck, striking both A/Bs.
- One of the A/Bs suffered a severe head injury while the other suffered a minor hand injury. Ambulance paramedics were soon on the scene and treated both A/Bs before transferring them to a local hospital.
- The A/B who had suffered the serious head injury was later transferred to a dedicated neurological injury unit, before eventually being repatriated.

- **Dedicated Storage Area** – The ship had not been built with a dedicated storage area for the lifting gear, therefore the crew had developed a local arrangement. A formal risk assessment process would have identified it as an unsuitable location.

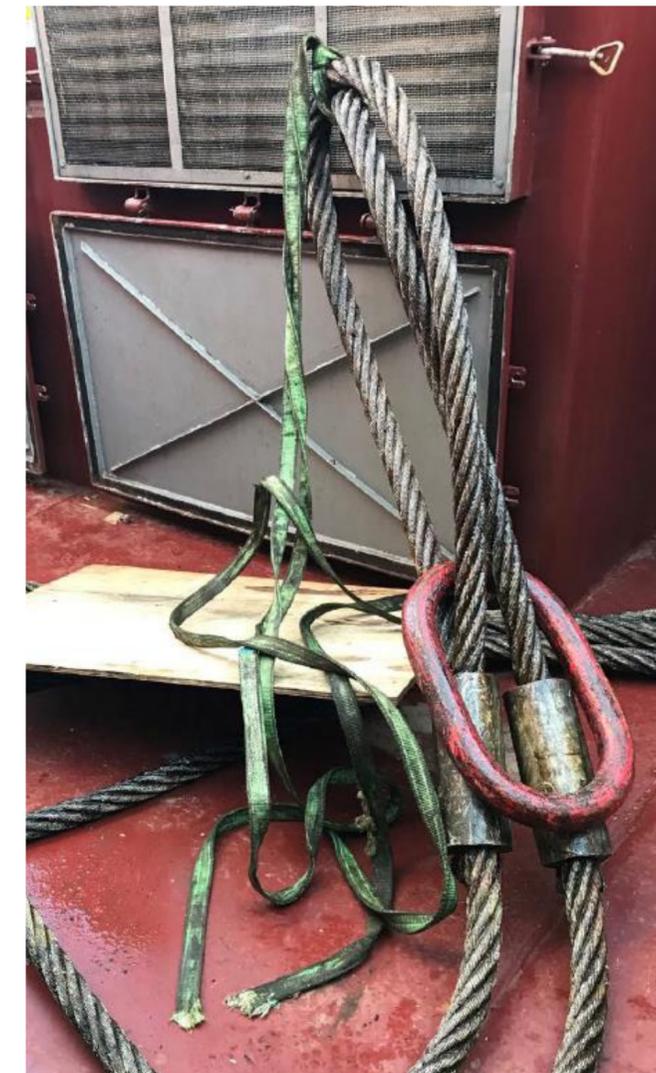
Broken fibre sling (after the accident).

- After the accident the parted fibre sling and five other similar slings from the ship were examined at an expert testing centre. The report of these tests stated that all six slings would have failed a visual inspection as they were soiled and had illegible identification markings.
