Cargo Fumigant Poisoning Leading to a Fatality

### BACKGROUND

Source: Investigation report by The Bahamas Maritime Authority

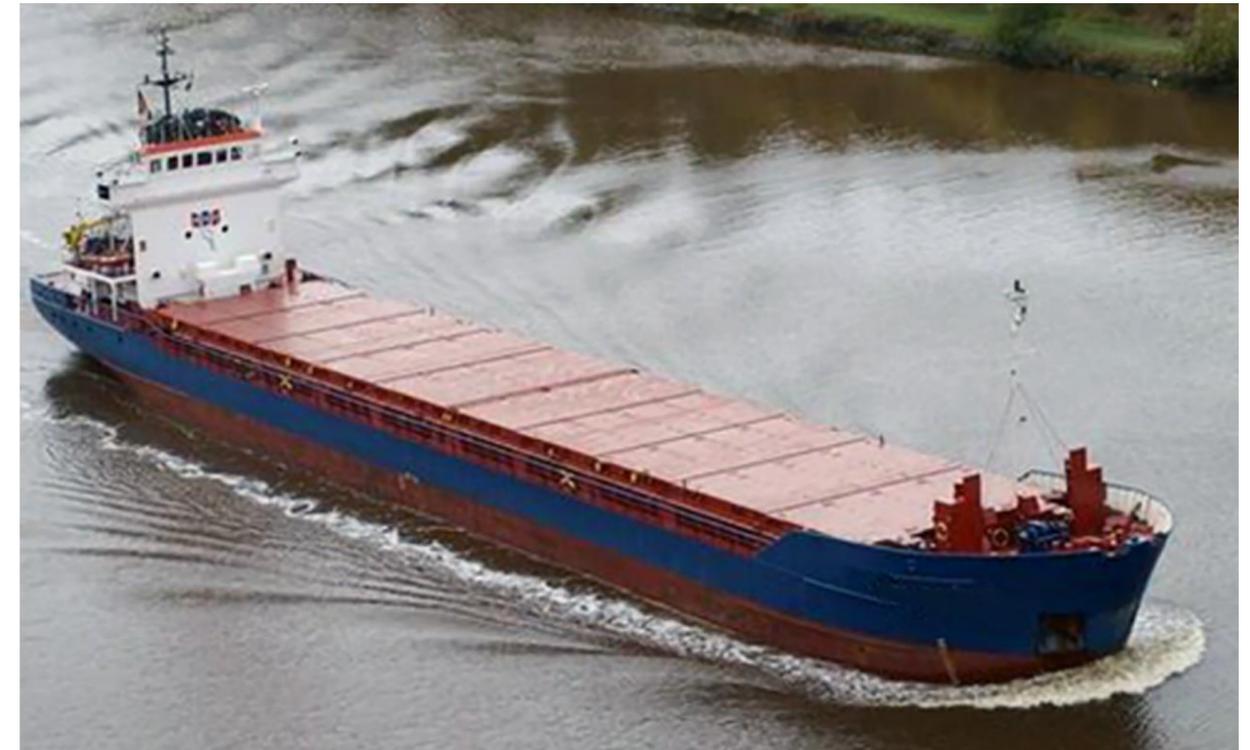
*The ship*

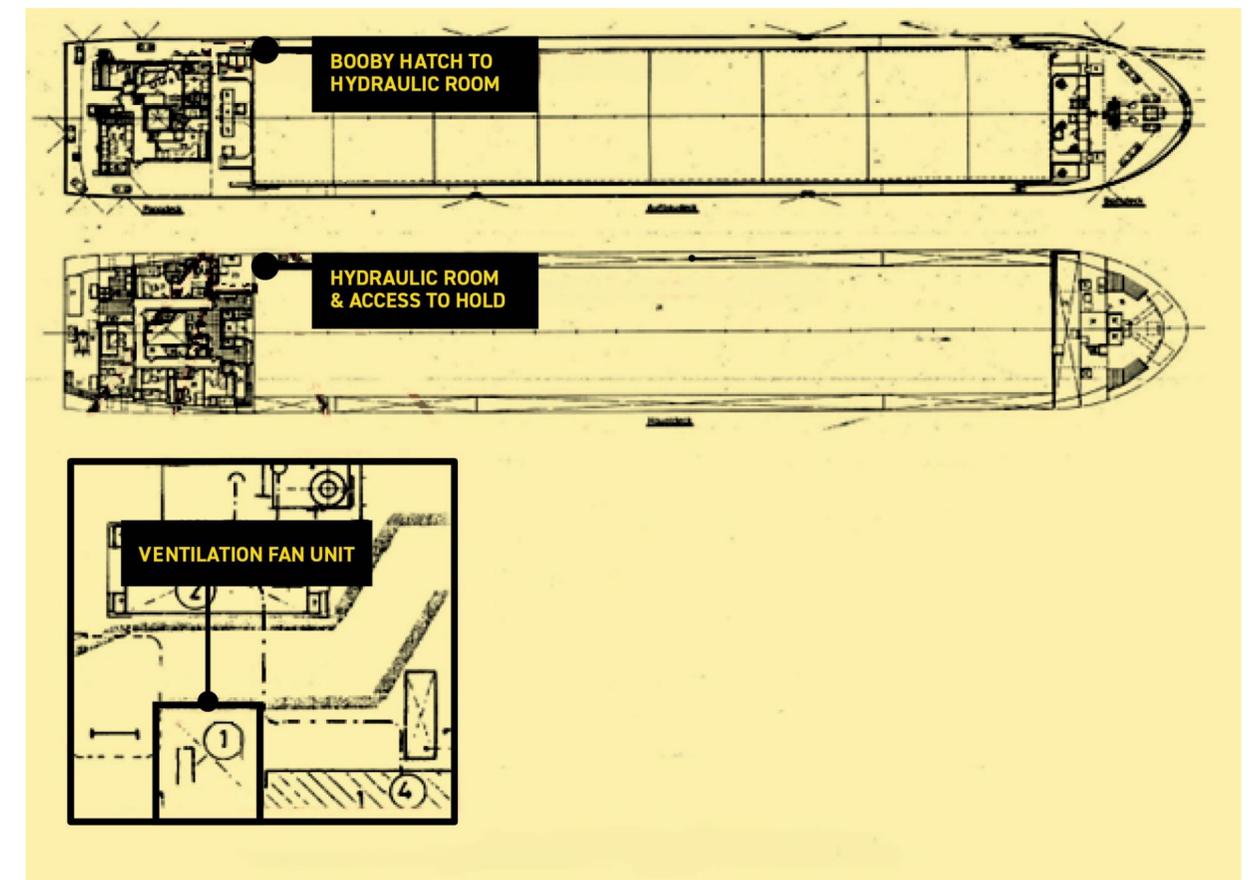
- After the incident an investigation using pressure checks and smoke testing revealed that the door leading from the hydraulic room to the cargo hold was misaligned and could not be made gas-tight. In addition, the ventilation fan and trunking for the accommodation's sanitary spaces running through the hydraulic room were not airtight. There were also two uncapped stubs of pipe between the hydraulic room and the accommodation space.

*Aft access to cargo hold through the hydraulic room*

Although some of the defects such as misaligned hydraulic room doors were easily noticeable, they had not been rectified in good time. The periodical checks and maintenance routines had not been effective due to apparent gaps in technical and safety management combined with an ineffective safety culture, which enabled these issues to remain uncorrected.
