CARGO FUMIGANT POISONING LEADING TO A FATALITY

A SMALL SHIP WAS CHARTERED TO CARRY A CARGO OF CORN ON A SHORT HAUL VOYAGE IN EUROPE. ON COMPLETION OF LOADING, ALUMINIUM PHOSPHIDE WAS PLACED IN THE HOLDS TO FUMIGATE THE CARGO IN TRANSIT. ON THE SECOND DAY OF THE VOYAGE, WHILE THE SHIP WAS EXPERIENCING HEAVY WEATHER, HYDROGEN PHOSPHIDE GAS (PH₃) ENTERED THE ACCOMMODATION AREA VIA A HYDRAULIC ROOM. THE FUMIGANT WAS NOT DETECTED IN TIME TO AVERT LETHAL LEVELS OF EXPOSURE. SEVERAL MEMBERS OF THE CREW WERE OVERCOME WITH ONE CREW MEMBER DYING AND THREE OTHERS HAVING TO BE EVACUATED.

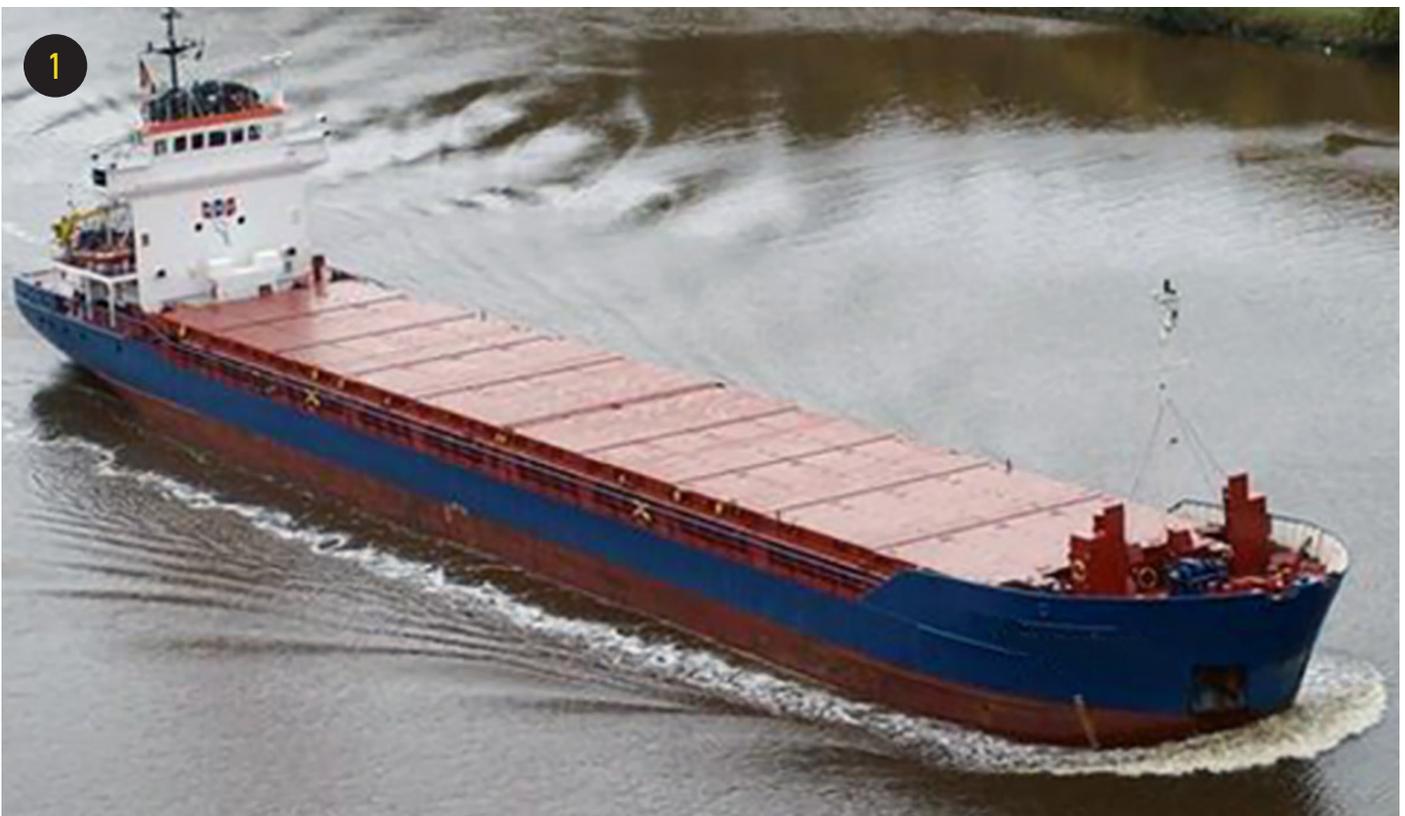
FIGURE 1 THE SHIP
SOURCE: INVESTIGATION REPORT BY THE BAHAMAS MARITIME AUTHORITY

The ship (**FIGURE 1**) was a 3,000 tonnes DWT general cargo vessel, built in 1994, with a single box-shaped cargo hold equipped with movable bulkheads. The accommodation consisted of two decks, of which the lower was below the main deck level. The forward bulkhead of this deck was next to the cargo hold.

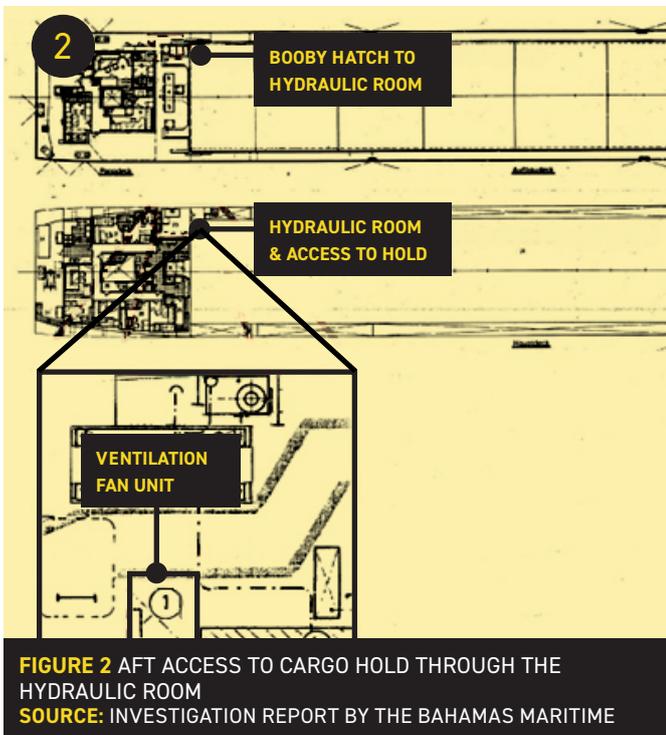
Access to the cargo hold was gained through a booby hatch at the front and through a hydraulic room aft (**FIGURE 2**). The hydraulic room shared two bulkheads with the accommodation space. The ventilation of the cargo hold was arranged via ducts forward and aft. The aft ventilation duct passed through the accommodation space and was adjacent to the engine room air intakes.

After the incident an investigation using pressure checks and smoke testing revealed no leaks on the cargo hold's aft bulkhead or in the ventilation duct. However, the following issues were identified in the hydraulic room:

- The door leading from the hydraulic room to the cargo hold was misaligned and could not be made gas-tight, even with all dogs adjusted.
- A ventilation fan and the associated trunking running through the hydraulic room was not airtight. This ventilation system extracted air from the accommodation's sanitary spaces and vented on deck. With the fans stopped, a smoke generator located in the hydraulic room filled the accommodation space in under a minute.
- There were also two uncapped stubs of unused small diameter pipe running between the hydraulic room and the accommodation.

- The hydraulic room/hold door was not gas or watertight. This had not been identified as part of the ship's planned maintenance schedule.
- Only one crew member (the C/O) was provided with training by the fumigator-in-charge. In turn, the C/O's briefing for the crew did not adequately highlight the risk of the operation or the symptoms of poisoning, to sufficiently alert the crew when taken ill. Furthermore, at least two crew members were not present at that briefing.
