### ACCIDENTAL RELEASE OF A LIFEBOAT

A REFRIGERATED CARGO SHIP HAD BERTHED IN SOUTHAMPTON TO DISCHARGE A CARGO OF FRUIT. ON THE DAY OF ARRIVAL THE LOCAL PORT STATE AUTHORITIES HAD BOARDED THE SHIP IN ORDER TO CONDUCT A PORT STATE CONTROL (PSC) INSPECTION, WHICH INCLUDED A LIFEBOAT DRILL. WHILE SECURING THE LIFEBOAT AFTER THE DRILL, THE SHIP'S BOSUN SUSTAINED MINOR INJURIES, AS THE FORWARD END OF THE LIFEBOAT FELL FROM ITS DAVIT DUE TO IT NOT BEING CORRECTLY RESET WHEN IT WAS HOISTED FROM THE WATER (FIGURE 1).

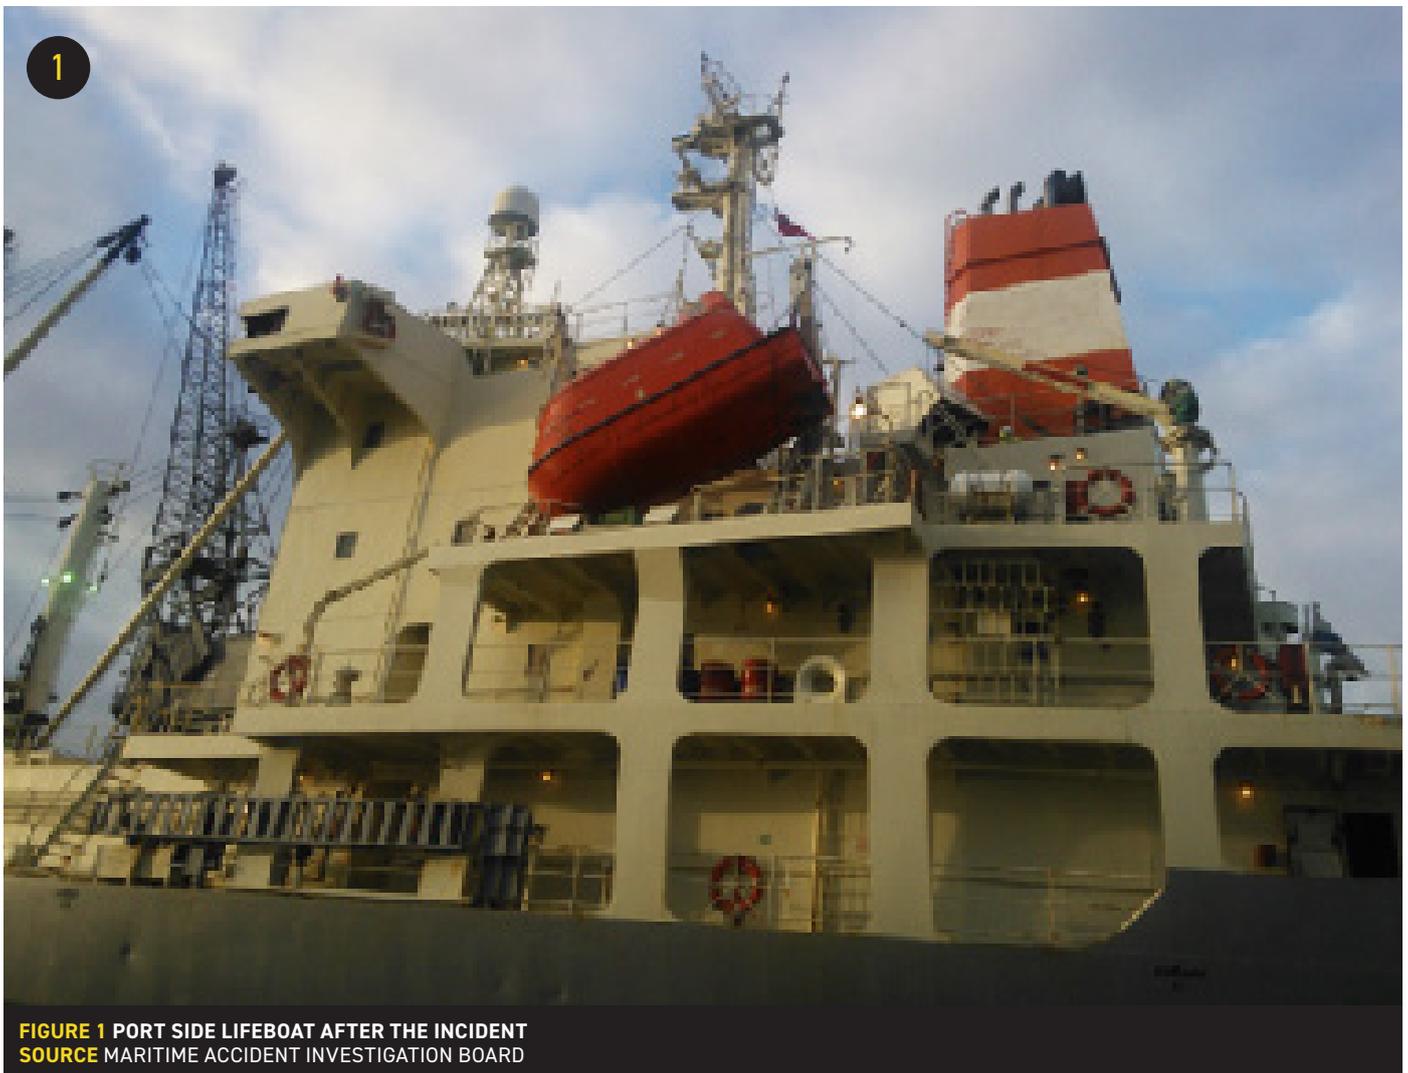
**FIGURE 1** PORT SIDE LIFEBOAT AFTER THE INCIDENT  
**SOURCE** MARITIME ACCIDENT INVESTIGATION BOARD

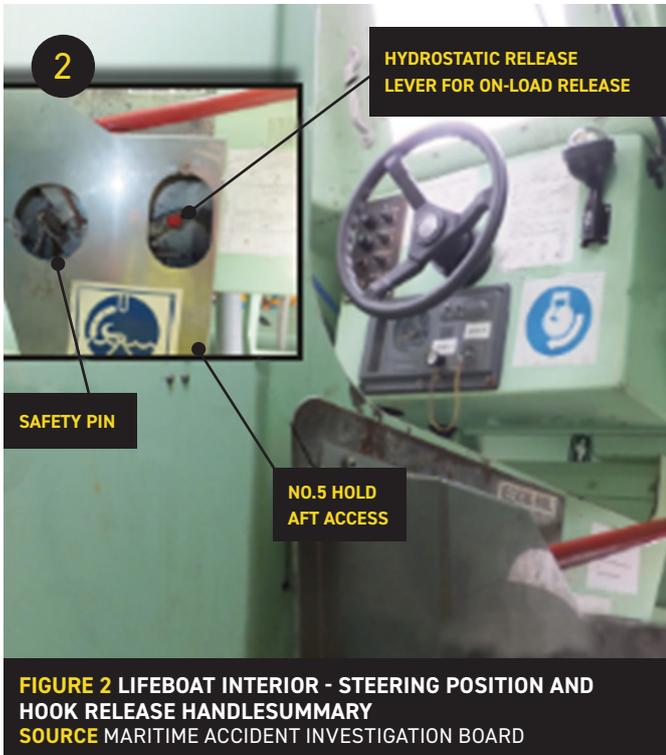
The C/O used a portable Very High Frequency (VHF) radio to instruct the crewman operating the lifeboat davit winch on the embarkation deck to release the brake and lower the lifeboat into the water. When the lifeboat was in the water its engine was started and the C/O pulled the hook release handle (**FIGURE 2**) to free the boat from the davit suspension links. However, the hooks failed to open. The C/O pulled the release handle again, and this time the hooks opened and released the lifeboat from the davit suspension links. The C/O took the helm and manoeuvred the lifeboat clear of the ship and sailed around for about 10 minutes before returning and bringing the lifeboat alongside the ship in order to be lifted. During the preparation to be hoisted the lifeboat crew experienced difficulties resetting the hook release gear and two crewmen were required to pull on the hook release handle to force it into a position in which the safety pin could be inserted.

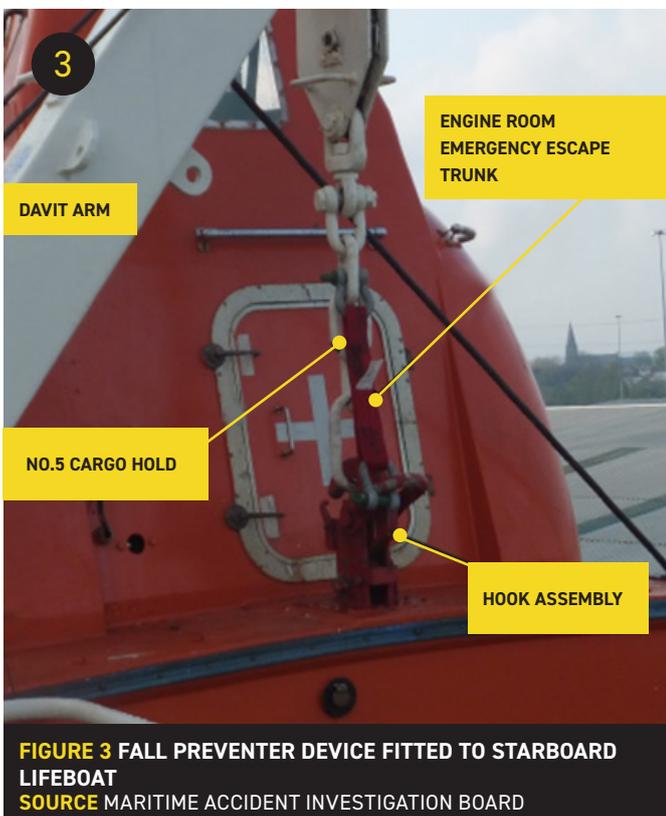
With the lifeboat in position below the davit arms, several attempts had to be made by the lifeboat crew before the davit suspension links were finally connected to the lifeboat hooks. Once engaged, the hooks were checked by the C/O, who then instructed the crew to connect the Fall Preventer Devices (FPD)\* (**FIGURE 3**) to the forward and aft hooks. After both FPDs had been secured the lifeboat was lifted from the water, though some of the lifeboat crew were not convinced that the hooks had been correctly reset.

\*The FPD comprised a synthetic sling with a shackle at each end, which was connected between the suspension link and the hook maintenance shackle of the forward and aft hook assemblies.

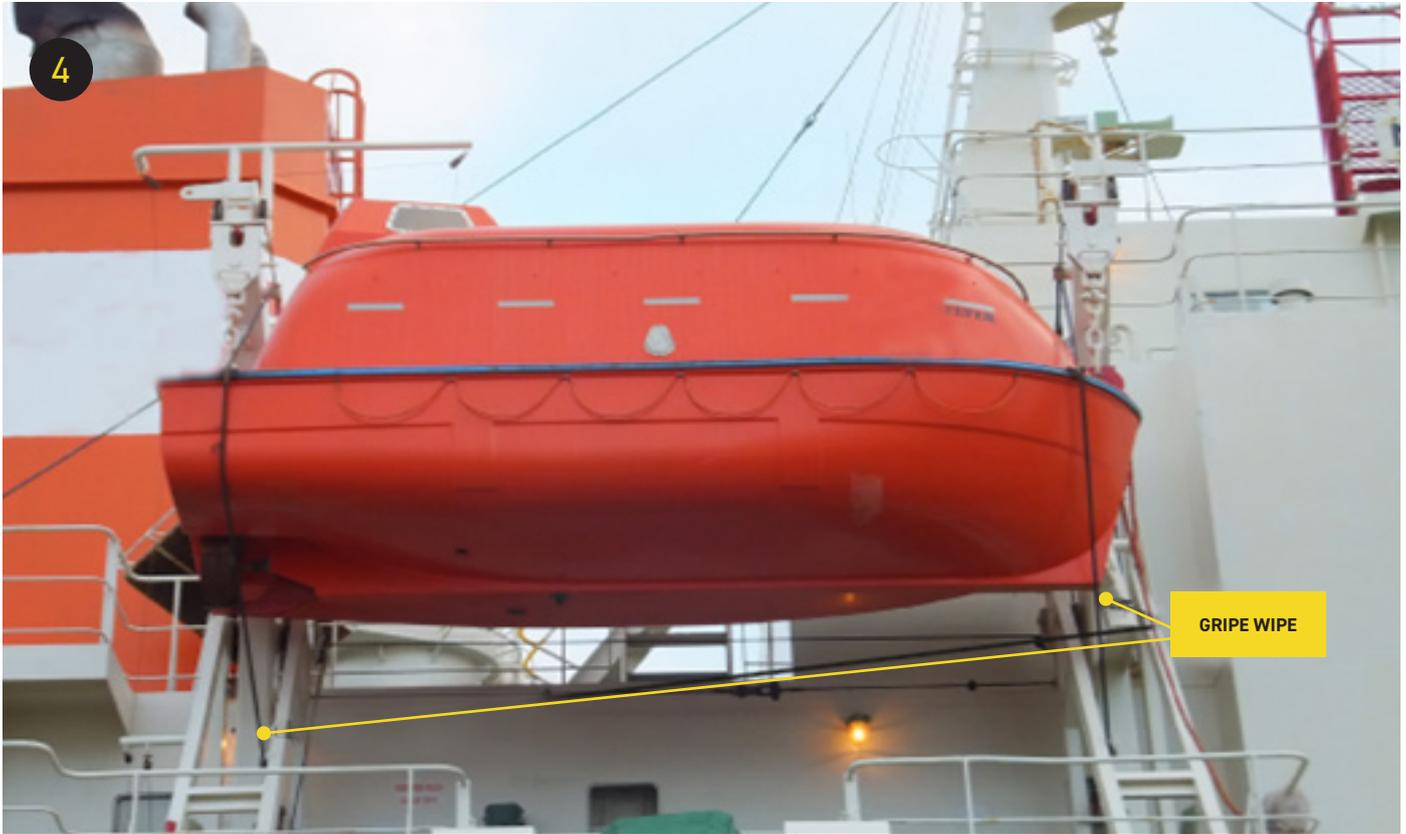
**FIGURE 4 GRIPE WIRES (ON STARBOARD LIFEBOAT)**  
**SOURCE** MARITIME ACCIDENT INVESTIGATION BOARD

After the break the C/O instructed the ship's bosun and two crewmen to secure the lifeboat. The two crewmen boarded the lifeboat to assist in positioning the gripe wires forward and aft. The bosun instructed the men in the boat not to release the FPDs until he had connected the gripes to the davit arms (**FIGURE 4**). The aft gripe had been secured and the bosun was connecting the forward gripe when the C/O came to the lifeboat and instructed the men in the boat to release both FPDs. As soon as the forward FPD shackle pin was removed, the hook opened and the forward end of the boat fell onto the handrails on the deck below (**FIGURE 4**), striking and injuring the bosun as it fell.
