CREW WATCH

APRIL 2022

WARNING OIL SPILL ON DECK

PILOT LADDERS THE DANGERS INVOLVED

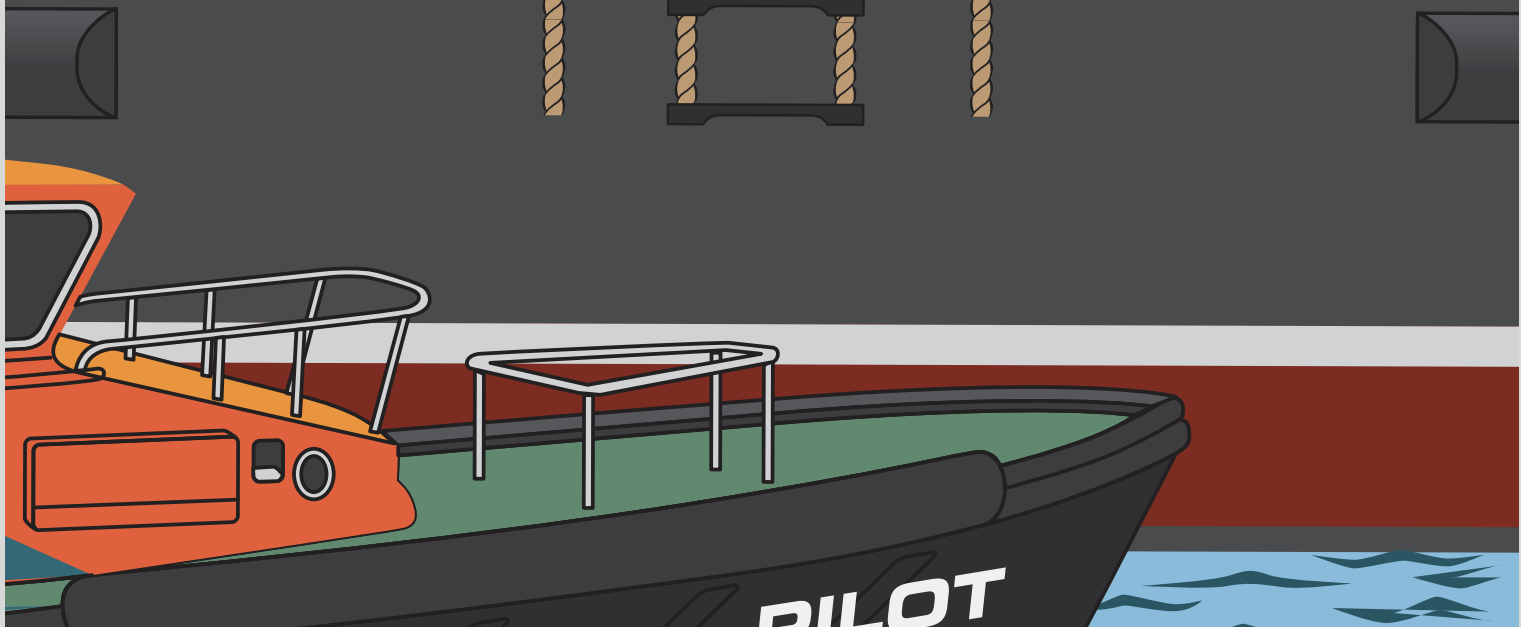
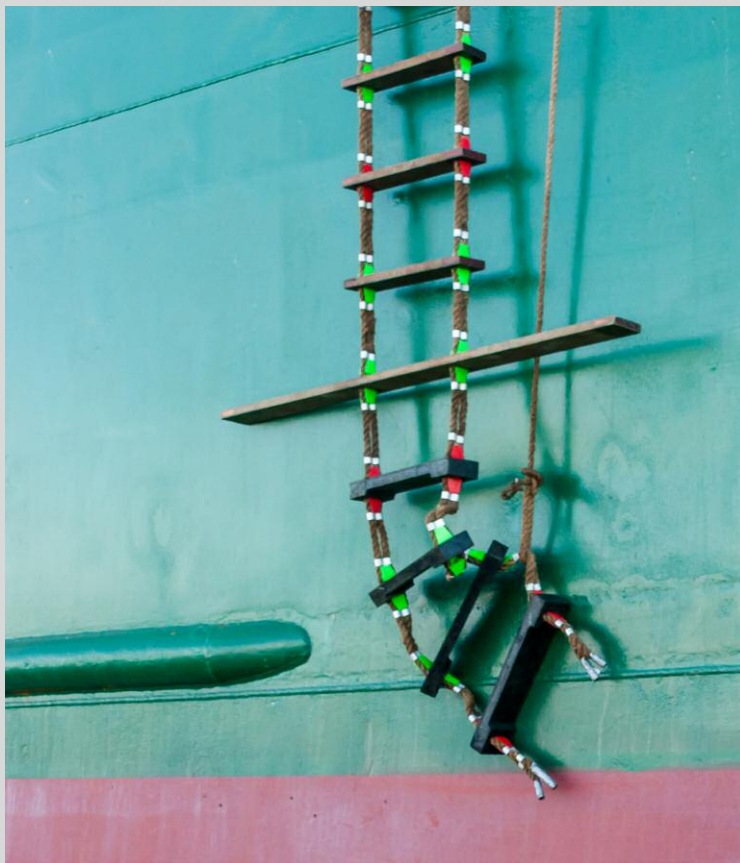
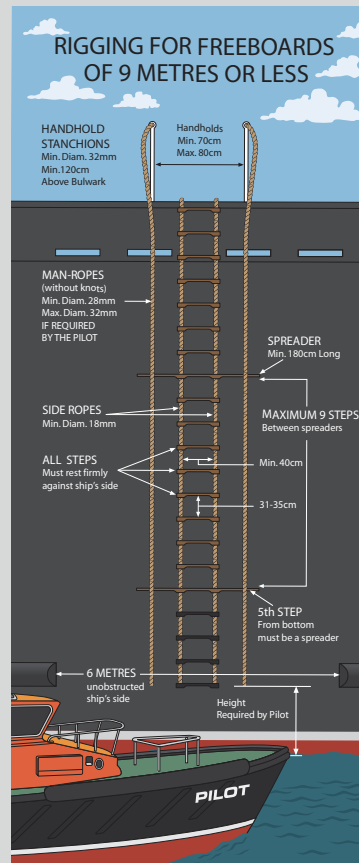
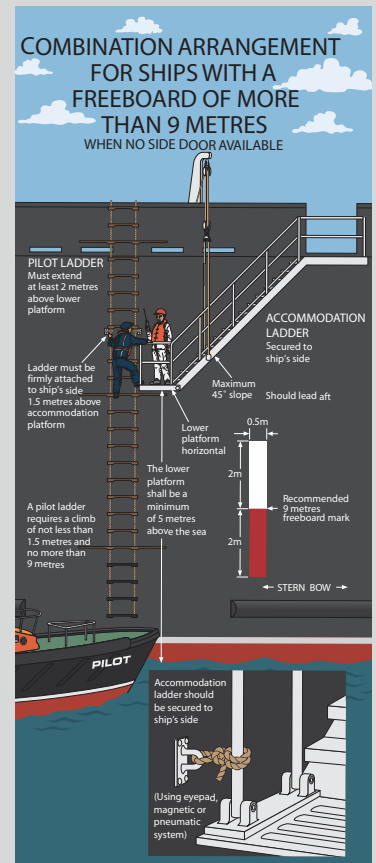
THE CLUB HAS RECENTLY EXPERIENCED SEVERAL INCIDENTS WHERE CREW OR THIRD PARTIES HAVE LOST THEIR GRIP WHILE USING THE SHIP'S PILOT LADDER, FALLING INTO THE WATER OR ONTO THE QUAYSIDE BELOW. UNFORTUNATELY THESE INCIDENTS ALL RESULTED IN FATALITIES WHICH COULD HAVE BEEN AVOIDED HAD THE RIGHT SAFETY MEASURES BEEN IMPLEMENTED.

None of these incidents actually involved a pilot. Rather, it was a member of the crew or a third party using the pilot ladder, either while measuring the ship's draught or while personnel were being transferred between two ships. So, despite its name, a pilot ladder is often used for several other purposes other than the safe transfer of a pilot to and from a ship. If the ladder is not used as intended, or shortcuts are taken during use, it can be very dangerous.

These recent incidents can be linked to crew complacency and highlight situations where shortcuts were taken to achieve the work goal – at the expense of safety. It is very likely that those involved had often watched the pilot climb up and down the pilot ladder without any problems, leading

them to underestimate the risks involved. As these incidents show, such complacency can be fatal.

WORKING OVER THE SIDE – Whenever the pilot ladder is used or rigged for any other purpose than its intended transfer use, it should be regarded as a “working over the side” situation. As when working aloft or in enclosed spaces, working over the side should be controlled by a Permit to Work (PtW) system as part of the ship’s Safety Management System (SMS). The PtW must ensure that all associated risks are identified and properly mitigated e.g. using proper Personal Protection Equipment (PPE); making sure lifesaving appliances are at the work location in case someone falls overboard; and supervision of the work task by a senior officer.

PROPER RIGGING – The pilot ladder must be rigged and constructed in accordance with regulation V/23 of the SOLAS convention and IMO Resolution A.1045(27) (see the article on pilot transfers in Risk Watch January 2020 – <http://ow.ly/u5RN30sfjimp>). When properly rigged, the pilot ladder should hang vertically and rest along the shipside. Attempting to hold the ladder at an angle (e.g. between two vessels) must be avoided as it’s very hard to hold the ladder at this angle rather than flat against the side, which can easily lead to a fall from the ladder. Holding the ladder at an angle also makes it less stable if there are sudden swells or gusts of wind.

PPE – Proper PPE must be worn as set out in the PtW for working overside. This should include life vest, safety shoes and gloves to ensure a good grip when climbing the ladder. Even when the ladder is hanging straight down against the hull, it can be very strenuous to hold on to it for a prolonged period of time e.g. when reading the ship’s draught, and so a safety harness should also be worn, always safely connected to a fall arrest system onboard.

MAINTENANCE – The pilot ladder, and all other necessary equipment, should be of an approved type, be kept in a good working condition and be maintained in accordance with the manufacturer’s recommendations. The steps of the ladder must be in good condition with no cracks and must have an efficient non-slip surface.
