INCIDENT CAUSED BY CHEMICAL REACTION OF FERTILISER

A 23,401 GT multi-purpose carrier was about to anchor after leaving port carrying a cargo of various types of fertiliser in bulk as well as general cargoes. During the anchoring manoeuvre white smoke was noticed emitting from cargo hold no.3. After a failed attempt to extinguish the suspected fire using the ship's fixed CO₂ system and with the risk of an explosion due to the decomposition of the fertilizer, the ship was evacuated and later declared a total loss.

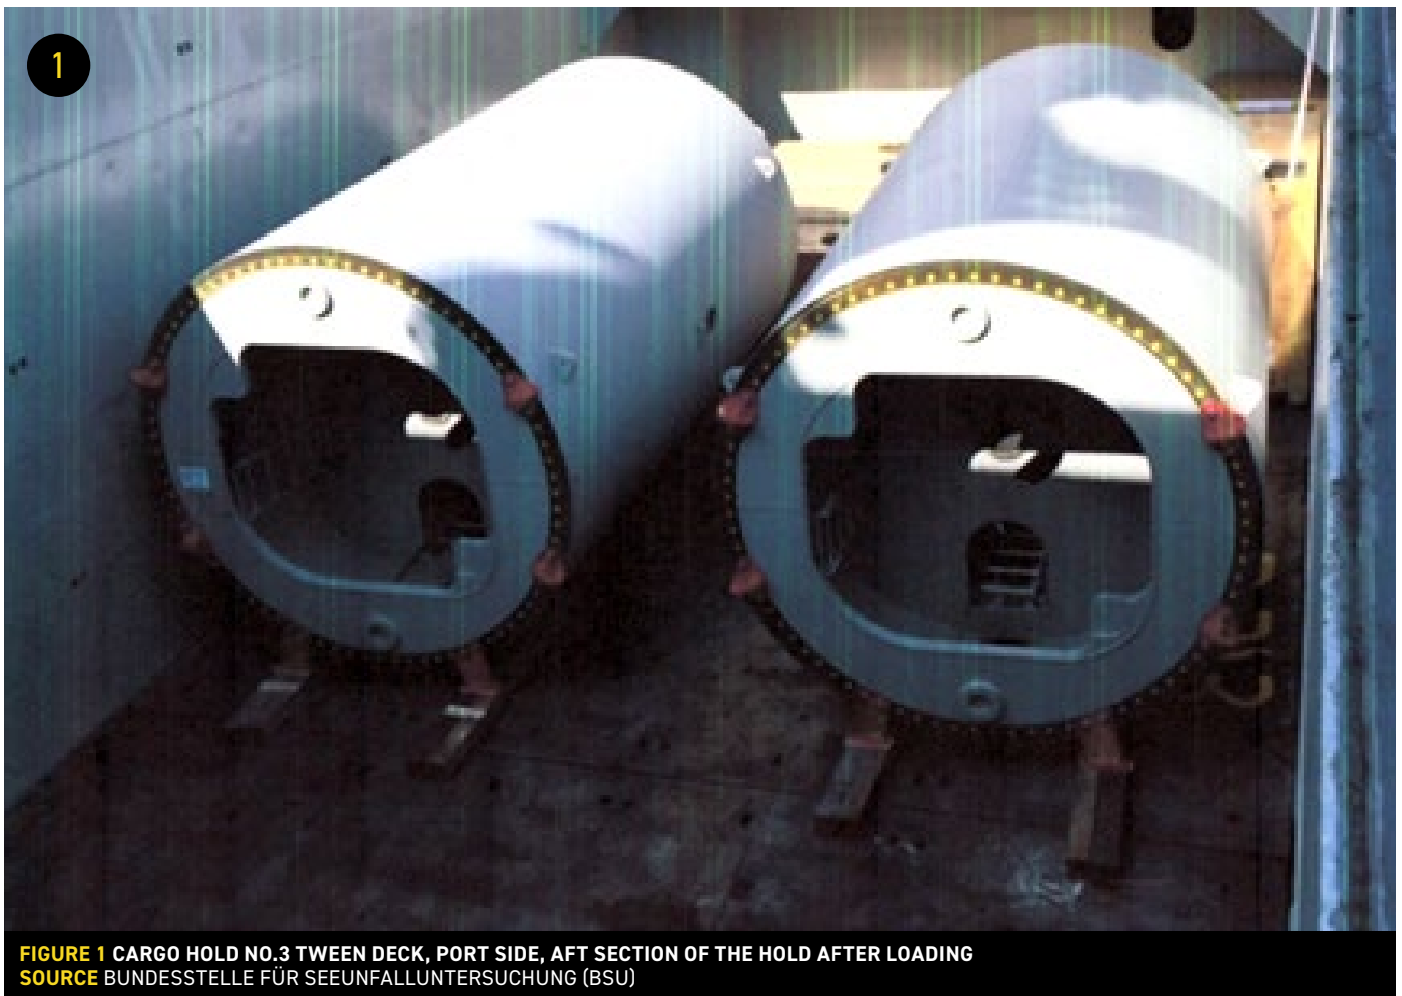
FIGURE 1 CARGO HOLD NO.3 TWEEN DECK, PORT SIDE, AFT SECTION OF THE HOLD AFTER LOADING
SOURCE BUNDESSTELLE FÜR SEEUNFALLUNTERSUCHUNG (BSU)

After loading a cargo consisting of various types of fertiliser in the lower holds no. 2 to 5, and various general cargoes in hold no. 1 and on the tween decks of holds no. 3 and 4 (**FIGURE 1**), the ship was proceeding to anchorage before continuing its voyage.

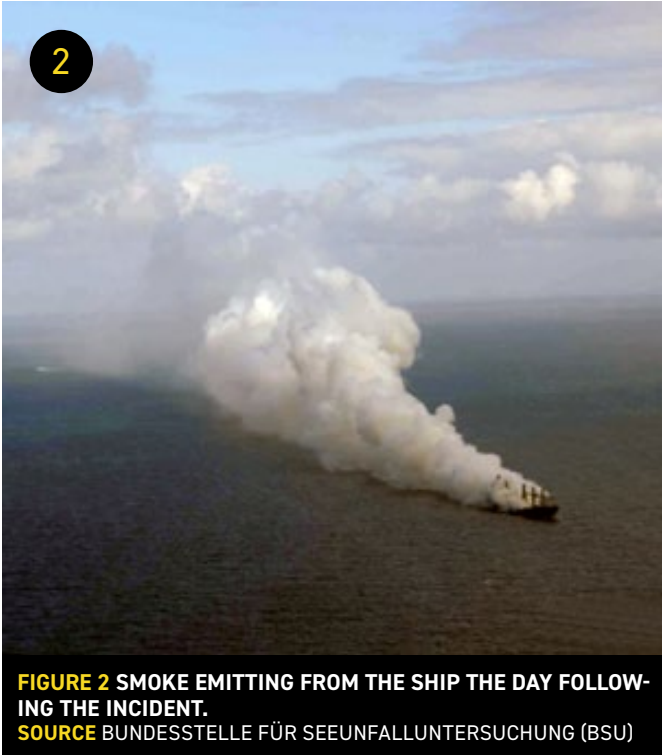
Three firefighting ships in total had been ordered to the scene and tasked with cooling and suppressing the cloud of smoke coming from the damaged ship. Over the next couple of days the three ships managed to flood hold no. 3 and successfully stop the suspected exothermal self-sustaining decomposition of the ammonium nitrate based fertiliser in the hold (FIGURE 2).

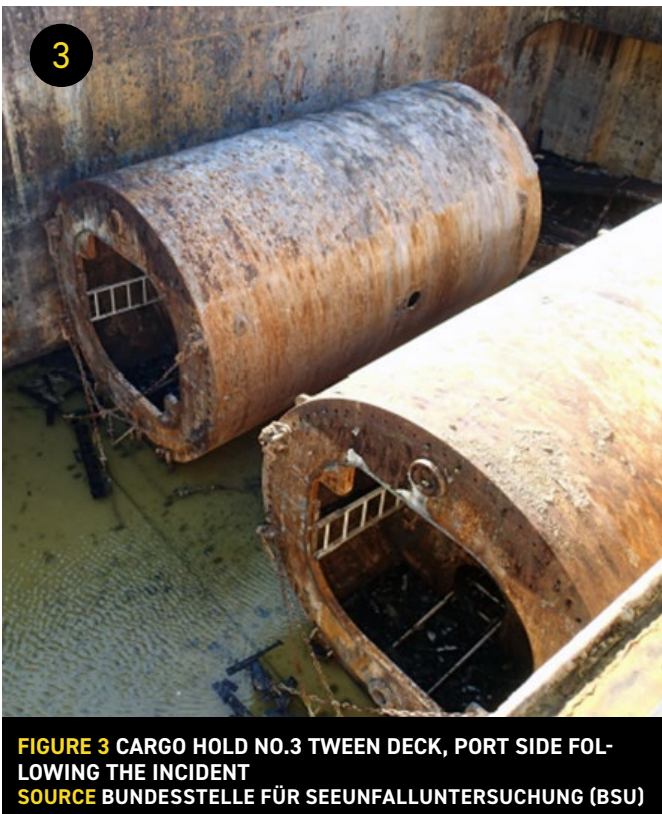
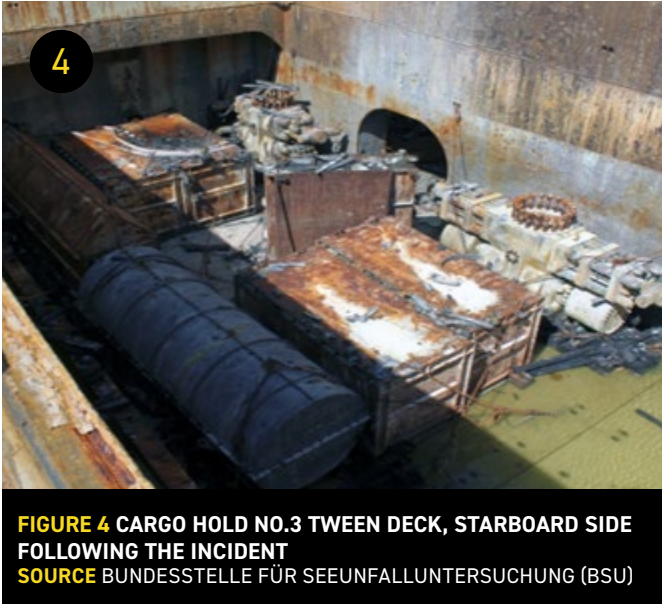
The damaged ship was later towed away for unloading and declared a constructive total (FIGURES 3 & 4). The incident did not result in any fatalities or serious injuries. However, as a precaution the crew and firefighting team were taken to hospital for observation after being exposed to the smoke and fumes.
