ACCIDENTAL RELEASE OF A LIFEBOAT

A REFRIGERATED CARGO SHIP HAD BERTHED IN SOUTHAMPTON TO DISCHARGE A CARGO OF FRUIT. ON THE DAY OF ARRIVAL THE LOCAL PORT STATE AUTHORITIES HAD BOARDED THE SHIP IN ORDER TO CONDUCT A PORT STATE CONTROL (PSC) INSPECTION, WHICH INCLUDED A LIFEBOAT DRILL. WHILE SECURING THE LIFEBOAT AFTER THE DRILL, THE SHIP'S BOSUN SUSTAINED MINOR INJURIES AS THE FORWARD END OF THE LIFEBOAT FELL FROM ITS DAVIT DUE TO IT NOT BEING CORRECTLY RESET WHEN IT WAS HOISTED FROM THE WATER (**FIGURE 1**).

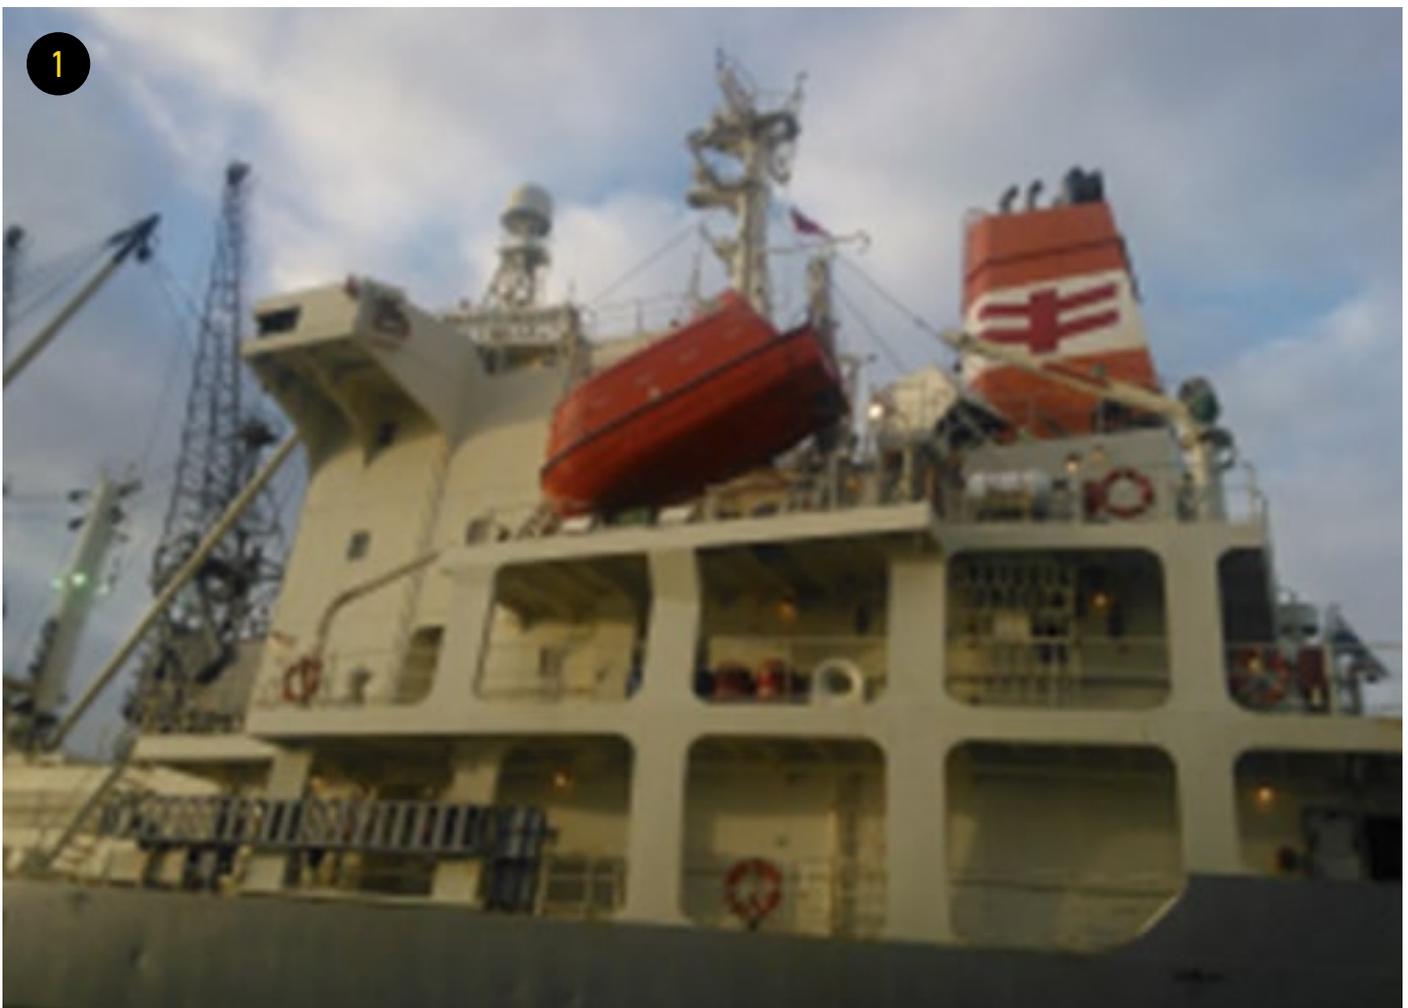
FIGURE 1 PORT SIDE LIFEBOAT AFTER THE INCIDENT
SOURCE MARITIME ACCIDENT INVESTIGATION BOARD

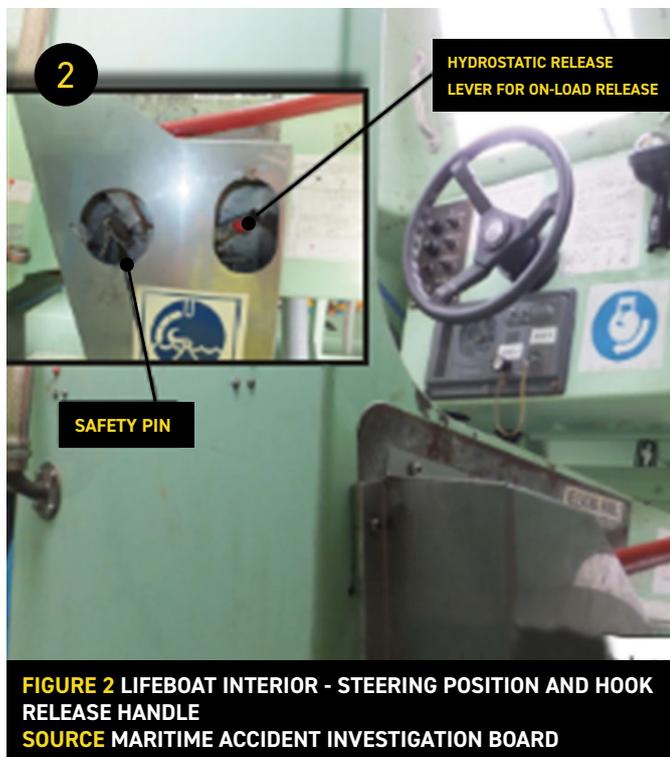
The C/O used a portable Very High Frequency (VHF) radio to instruct the crewman operating the lifeboat davit winch on the embarkation deck to release the brake and lower the lifeboat into the water. When the lifeboat was in the water its engine was started and the C/O pulled the hook release handle (**FIGURE 2**) to free the boat from the davit suspension links. However, the hooks failed to open. The C/O pulled the release handle again and this time the hooks opened and released the lifeboat from the davit suspension links. The C/O took the helm and manoeuvred the lifeboat clear of the ship and sailed around for about ten minutes before returning and bringing the lifeboat alongside the ship in order to be lifted. During the preparation to be hoisted the lifeboat crew experienced difficulties resetting the hook release gear and two crewmen were required to pull on the hook release handle to force it into a position in which the safety pin could be inserted.

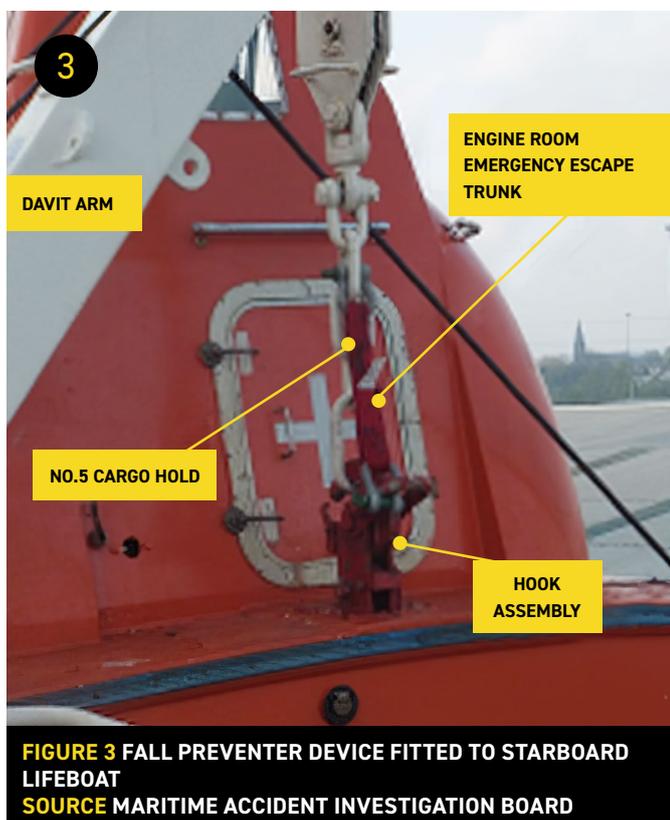
With the lifeboat in position below the davit arms, several attempts had to be made by the lifeboat crew before the davit suspension links were finally connected to the lifeboat hooks. Once engaged, the hooks were checked by the C/O, who then instructed the crew to connect the Fall Preventer Devices (FPD)* (**FIGURE 3**) to the forward and aft hooks. After both FPDs had been secured the lifeboat was lifted from the water, though some of the lifeboat crew were not convinced that the hooks had been correctly reset.

*The FPD comprised a synthetic sling with a shackle at each end, which was connected between the suspension link and the hook maintenance shackle of the forward and aft hook assemblies.

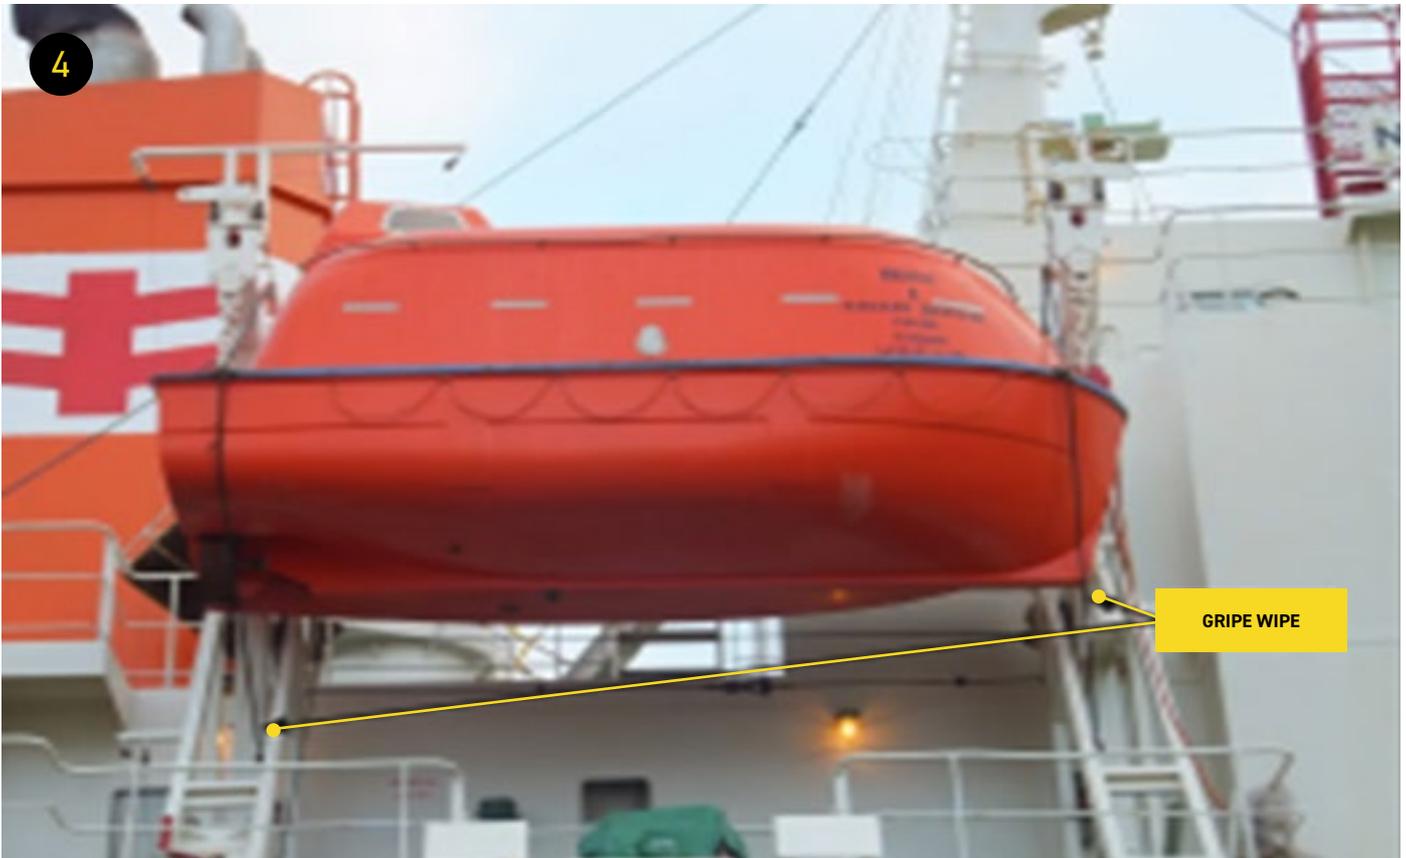
FIGURE 4 GRIPE WIRES (ON STARBOARD LIFEBOAT)
SOURCE MARITIME ACCIDENT INVESTIGATION BOARD

After the break the C/O instructed the ship's bosun and two crewmen to secure the lifeboat. The two crewmen boarded the lifeboat to assist in positioning the gripe wires forward and aft. The bosun instructed the men in the boat not to release the FPDs until he had connected the gripes to the davit arms (FIGURE 4). The aft gripe had been secured and the bosun was connecting the forward gripe when the C/O came to the lifeboat and instructed the men in the boat to release both FPDs. As soon as the forward FPD shackle pin was removed, the hook opened and the forward end of the boat fell onto the handrails on the deck below (FIGURE 4), striking and injuring the bosun as it fell.
