HEAVY WEATHER LEADING TO A FATALITY

A FULLY CELLULAR 1,400 TEU / 25,000 GT CONTAINER SHIP WAS ON A VOYAGE FROM MELBOURNE TO FREEMANTLE, AUSTRALIA, WHEN WATER WAS FOUND IN AN UNDERDECK PASSAGE. IT TRANSPIRED THAT DURING HEAVY WEATHER THE HATCH ACCESS LID ON THE FORECASTLE DECK LEADING TO THE FORECASTLE STORE HAD BEEN RIPPED OFF AND DUMPED ON THE WINDLASS, ALLOWING WATER INGRESS INTO THE FORECASTLE. WHILE ATTEMPTING TO RIG A TEMPORARY ARRANGEMENT TO STOP FURTHER WATER INGRESS, A LARGE WAVE CRASHED ONTO THE FORECASTLE DECK, INJURING THREE CREW MEMBERS. THE CHIEF OFFICER WAS SEVERELY INJURED AND SUCCUMBED TO HIS INJURIES BEFORE MEDICAL ASSISTANCE FROM ASHORE COULD ARRIVE.

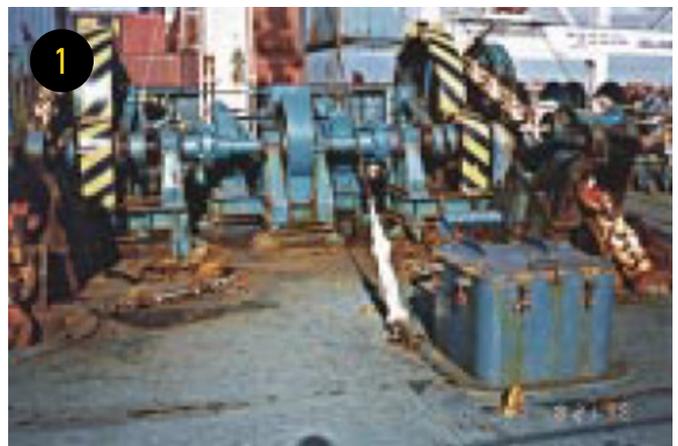
FIGURE 1 WINDLASS AND FORECASTLE STORE ACCESS HATCH SOURCE MARINE INCIDENT INVESTIGATION UNIT - AUSTRALIA

The repair party found that the access hatch cover to the forecastle store had been torn off and was lying on top of a gypsy. Ropes previously coiled abaft the windlass were found scattered around the deck. These were coiled and lashed before the issue of the damaged access hatch was addressed. The access hatch lid was found to be distorted and attempts to replace it proved fruitless. The chief officer then instructed the bosun to get some canvas with which they could make a temporary cover for the access. Due to the updraught emanating from the forecastle store through the access hatch coaming, securing the access with a canvas cover alone was found to be problematic. Therefore, the bosun was sent to get some plywood and he went back into the forecastle store. Meanwhile the two ABs refitted the spurling pipe covers which had also been washed off and then went to secure the damaged hatch lid under the windlass. Shortly afterwards, with the ABs standing either side of the damaged hatch lid ready to lift it, and the chief officer standing forward of them, facing aft (**FIGURE 2**), one of the ABs felt the bow notably lift and spotted a large wave approaching.

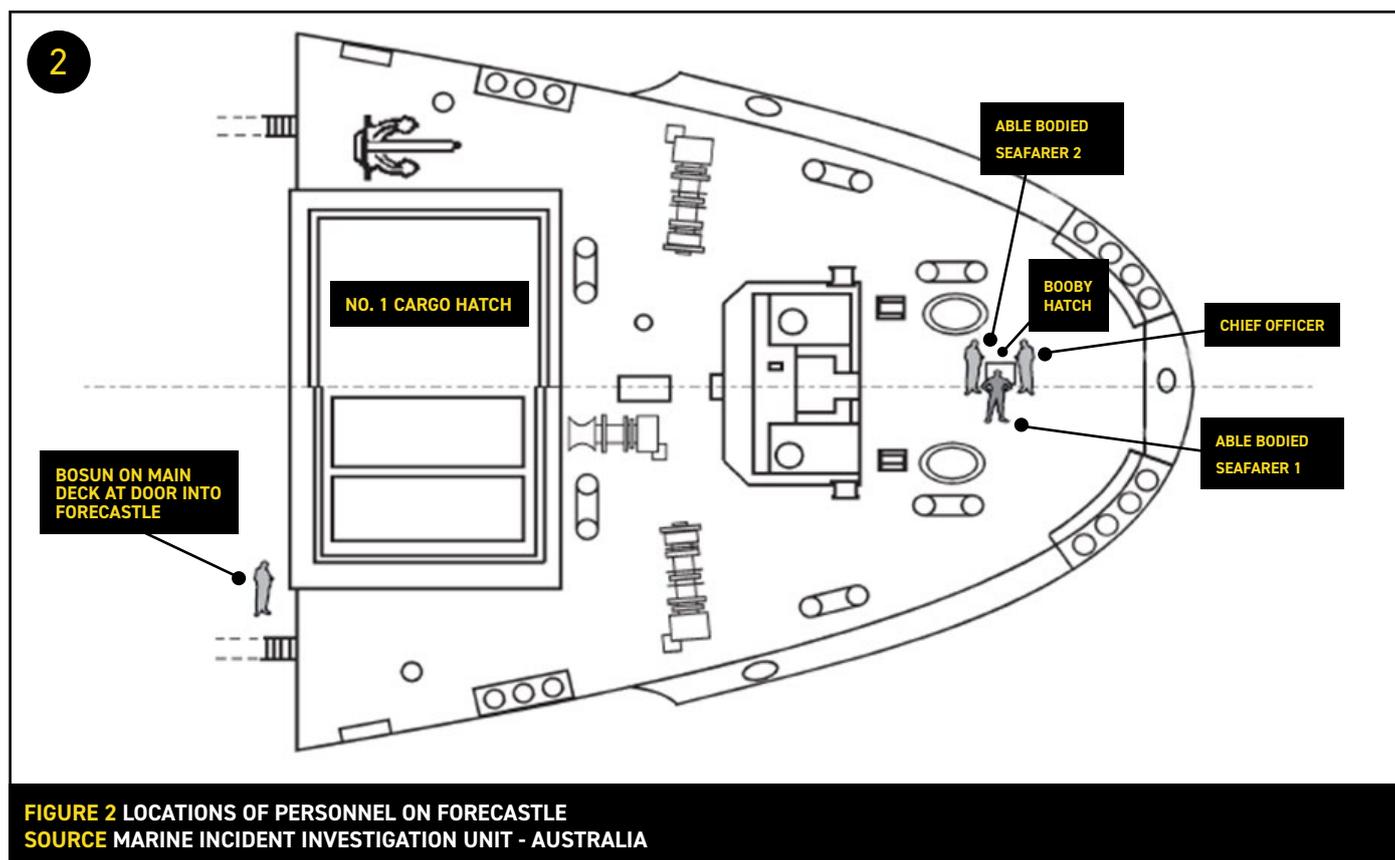
The AB shouted a warning and, although he held on tight to a forestay, the force of the wave which crashed onto the forecastle tore his grip from the forestay and washed him over the windlass and he crashed against a mooring winch behind. The other AB was washed against the windlass on the port side, suffering leg injuries, and the chief officer was washed under the windlass (**FIGURE 3**). Although stunned and having sustained a head injury, the AB who had been washed over the windlass called out to his colleagues and, upon receiving no reply, he believed they had been washed overboard.

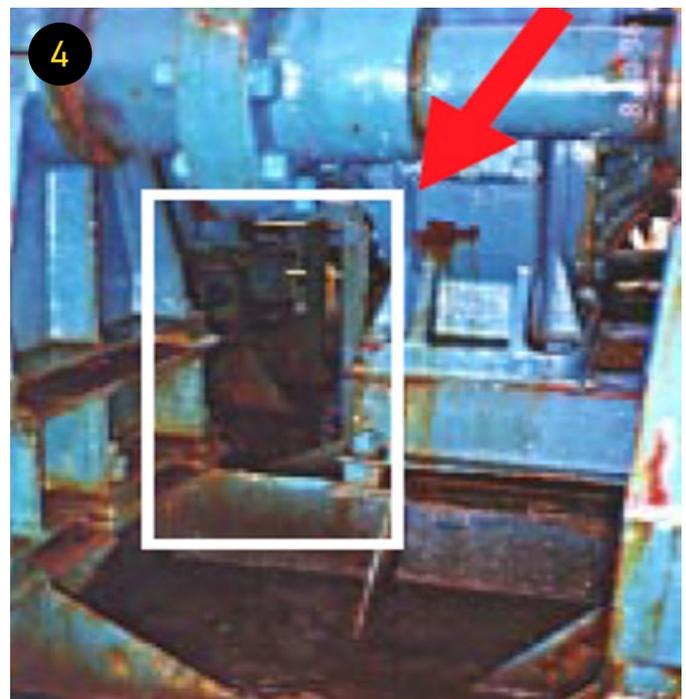
FIGURE 4 LOCATION WHERE THE CHIEF OFFICER WAS FOUND UNDER THE WINDLASS
SOURCE MARINE INCIDENT INVESTIGATION UNIT - AUSTRALIA

He went to find the bosun, who subsequently sent him to notify the bridge that they had personnel overboard. The bridge then sounded the man overboard alarm and commenced a Williamson turn. While the search for the two apparently missing men commenced, the second AB on the forecastle recovered slightly and found the chief officer under the windlass (**FIGURE 4**). He made his way to advise the bosun of the chief officer's location.

The chief officer was evacuated to the ship's hospital by stretcher, where it was found he had a broken leg and severe chest and head injuries. He succumbed to his injuries later that day.

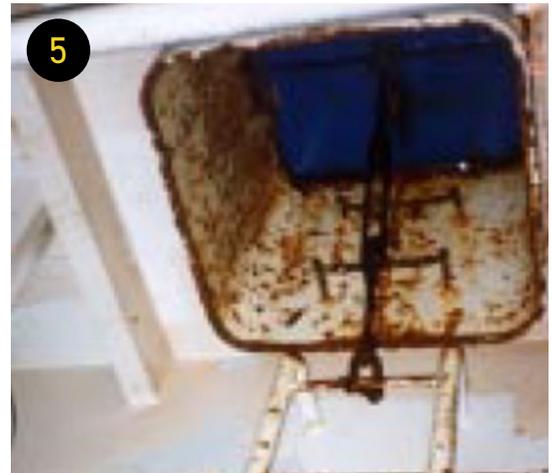
FIGURE 5 ADDITIONAL FORECASTLE ACCESS HATCH SECURING DEVICE
SOURCE MARINE INCIDENT INVESTIGATION UNIT - AUSTRALIA

- The securing dogs on the access hatch had been fitted by the bosun upon departure from Melbourne. However, they had only been secured hand tight. The access hatch cover hinges were on the aft side of the hatch and therefore any lack of tightness would have made the hatch susceptible to damage with each successive wave crashing across the access hatch. The hatch cover had also been torn off around six months previously, so to try and stop this happening again a pad eye had been welded on to the underside of the hatch with the aim to connect to a rung of the ladder underneath with a bottle screw (FIGURE 5). On this occasion the additional securing device had not been fitted. When the hatch cover was repaired in port following the fatal incident, the hatch was rotated 180° and the hinge fitted on the forward side of the coaming/hatch.
