RISK WATCH

Non-compulsory pilotage route claims another victim

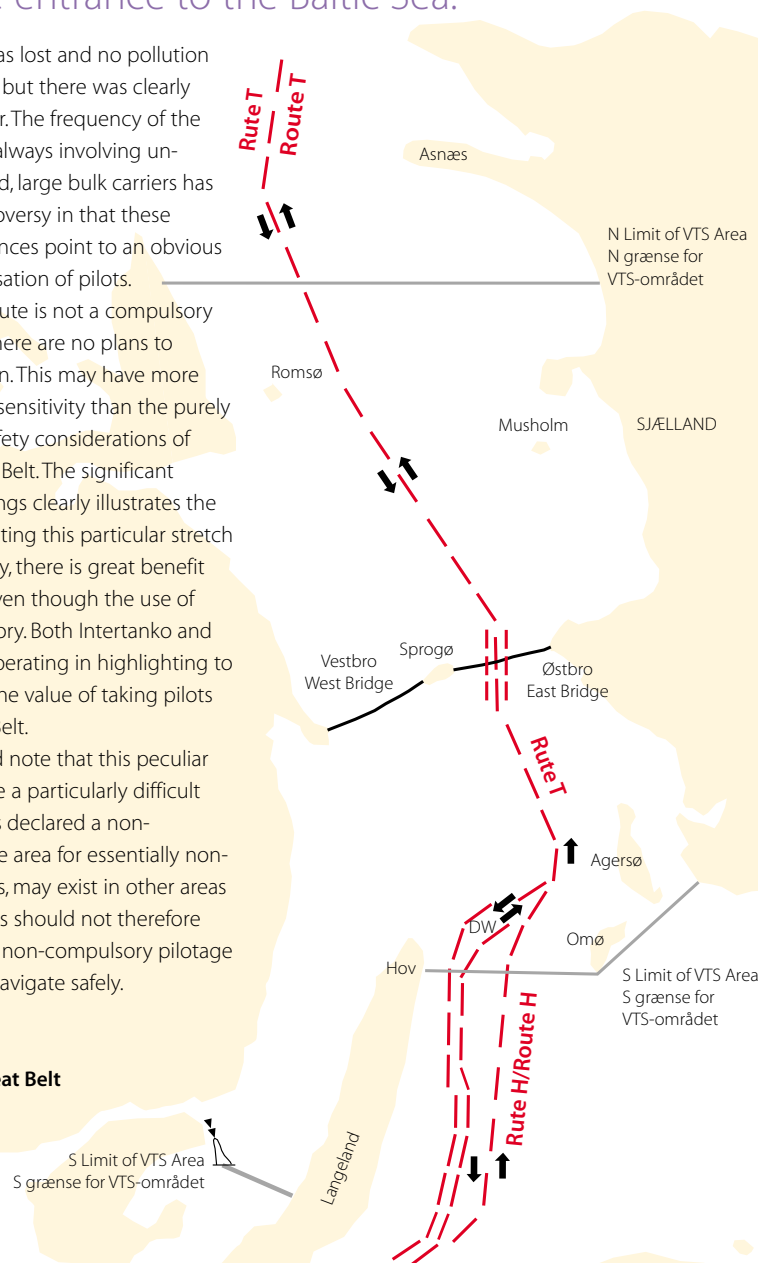
Diagram of the Great Belt

Members should note that this peculiar circumstance, where a particularly difficult area of navigation is declared a non-compulsory pilotage area for essentially non-navigational reasons, may exist in other areas of the world. Masters should not therefore always assume that non-compulsory pilotage areas are easier to navigate safely.

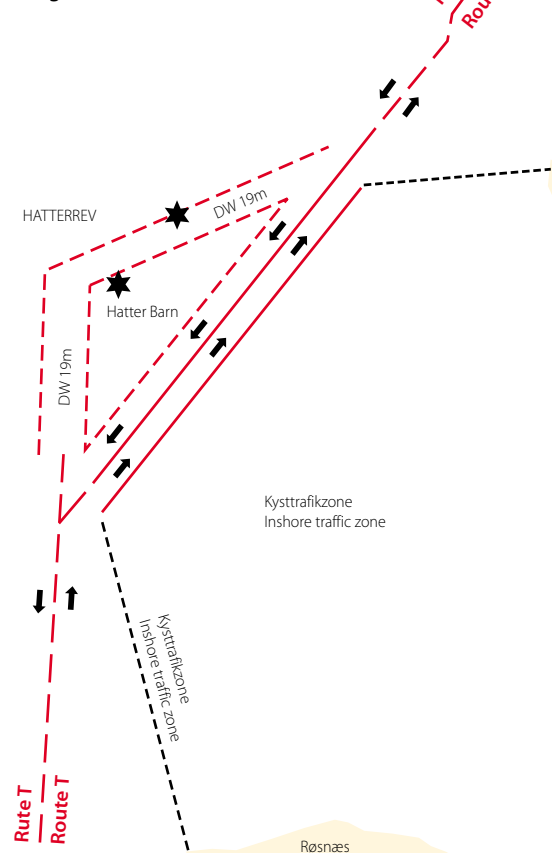
Diagram of the Hatter reef

One of our Member's ships recently became the 23rd in three years to run aground on the Hatter Reef at the entrance to the Baltic Sea.

Thankfully no life was lost and no pollution occurred as a result but there was clearly potential for disaster. The frequency of the groundings, nearly always involving un-piloted, north-bound, large bulk carriers has caused some controversy in that these common circumstances point to an obvious solution i.e. the utilisation of pilots. Nevertheless, the route is not a compulsory pilotage area and there are no plans to change this situation. This may have more to do with political sensitivity than the purely navigational and safety considerations of transiting the Great Belt. The significant number of groundings clearly illustrates the difficulties of navigating this particular stretch of water. Accordingly, there is great benefit in utilising a pilot even though the use of one is not compulsory. Both Intertanko and Intercargo are co-operating in highlighting to their membership the value of taking pilots through the Great Belt.

The Danish Maritime Authority report also suggested that the buoyage in the area could be improved. The Association understands that this may already have been undertaken with the addition of five low water markers and two light buoys.

A useful publication available from the Danish Maritime Authority website 'Navigation through Danish Waters' (www.frv.dk/en/ifm/navigation/navigation_ntdw.htm) includes the IMO Resolution MSC 138(76) Recommendation on Navigation through the Entrances to the Baltic Sea. Unfortunately, as its title suggests, this Resolution gives no guidance as to where pilotage should start and finish. Indeed, it appears that some Masters proceeding outbound from the Baltic consider the assistance of a pilot beneficial until passing the Great Belt Bridge, but that thereafter navigation is somewhat less difficult. In fact, it is the deep-water route guiding vessels through the Hatter Reef which appears to cause most difficulty. This requires a 60° turn at the Hatter Barn light into a channel which is less than five cables wide. This channel accommodates both north and south-bound vessels so the effective width available could be as low as 2 cables. It is evident that the turn has to be commenced early and at an appropriate speed. A recent Danish Maritime Authority investigation emphasised the usefulness of parallel indexing

in such situations as it allows the navigator to readily determine the correctness of the turn. Additionally, the passage planning should provide for 'alter course positions' to be identified by bearing and distance from local, fixed, navigational marks rather than latitude and longitude determined by GPS.

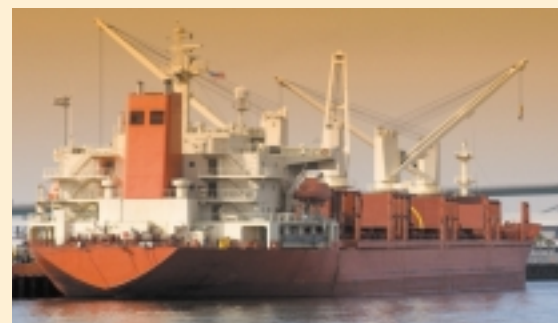
When wire ropes are not under load and bent around sheaves they tend to open up at the top of the crane turret and the jib head. It is in these areas that the salt laden marine atmosphere does its damage. Wire rope lubricant needs therefore to penetrate the inner cores of the wire and a thin lubricating oil such as Ensis Fluid will be more effective. The use of a thick layer of grease over the outer surface of a wire not only fails to achieve penetration but also serves as a serious deterrent to close inspection and is likely to trap moisture in the wire and accelerate corrosion.

The wire has to be cleaned before lubrication. Even if the right lubricant is used and applied properly it will carry the marine salt into the rope if it has not previously been cleaned.

- The ship should be fitted with a readily available standard galvanised wire rope.
- The wire should come from the factory already impregnated with lubricant.
- All wires should be delivered on a drum so they can be fitted properly and supplied with the correct type of lubricant.
- Wires should be visually inspected every time they are cleaned to determine whether they are sound and have not suffered damage or excessive wear.
