FATAL ACCIDENT DURING PILOT TRANSFER

AN INCIDENT ON A 2,825 GT GENERAL CARGO SHIP RESULTED IN THE FATALITY OF A SEA PILOT DURING A ROUTINE PILOT TRANSFER AS THE VESSEL WAS OUTBOUND.

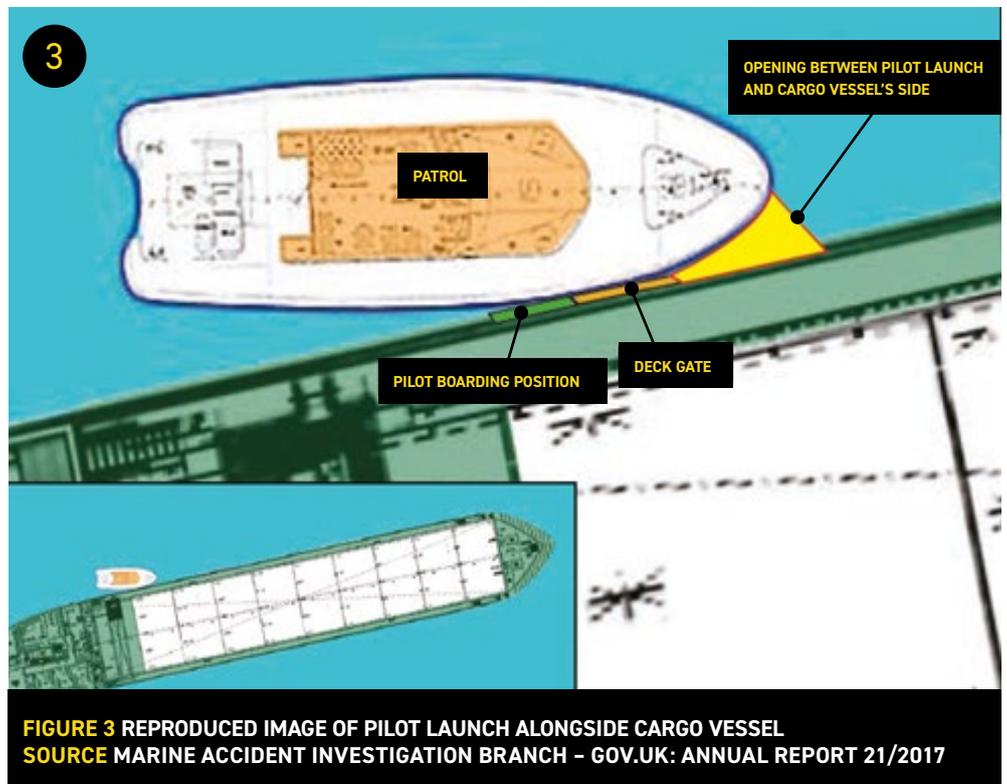
The cargo vessel was put on manual hand steering and the speed was reduced to 6-7 knots in preparation for the sea pilot boarding. The pilot launch boat then came alongside with its starboard bow resting against the vessel's hull just forward of the pilot ladder and in line with the deck gate.

FIGURE 3 REPRODUCED IMAGE OF PILOT LAUNCH ALONGSIDE CARGO VESSEL
SOURCE MARINE ACCIDENT INVESTIGATION BRANCH - GOV.UK: ANNUAL REPORT 21/2017

The vessel and pilot launch boat agreed to postpone the transfer until an inbound vessel had passed. Subsequently the vessel manoeuvred to create lee for the pilot launch to approach. As the wave height was about 2 metres the freeboard between the two vessels varied between 30cm to 130cm as the vessels moved up and down.

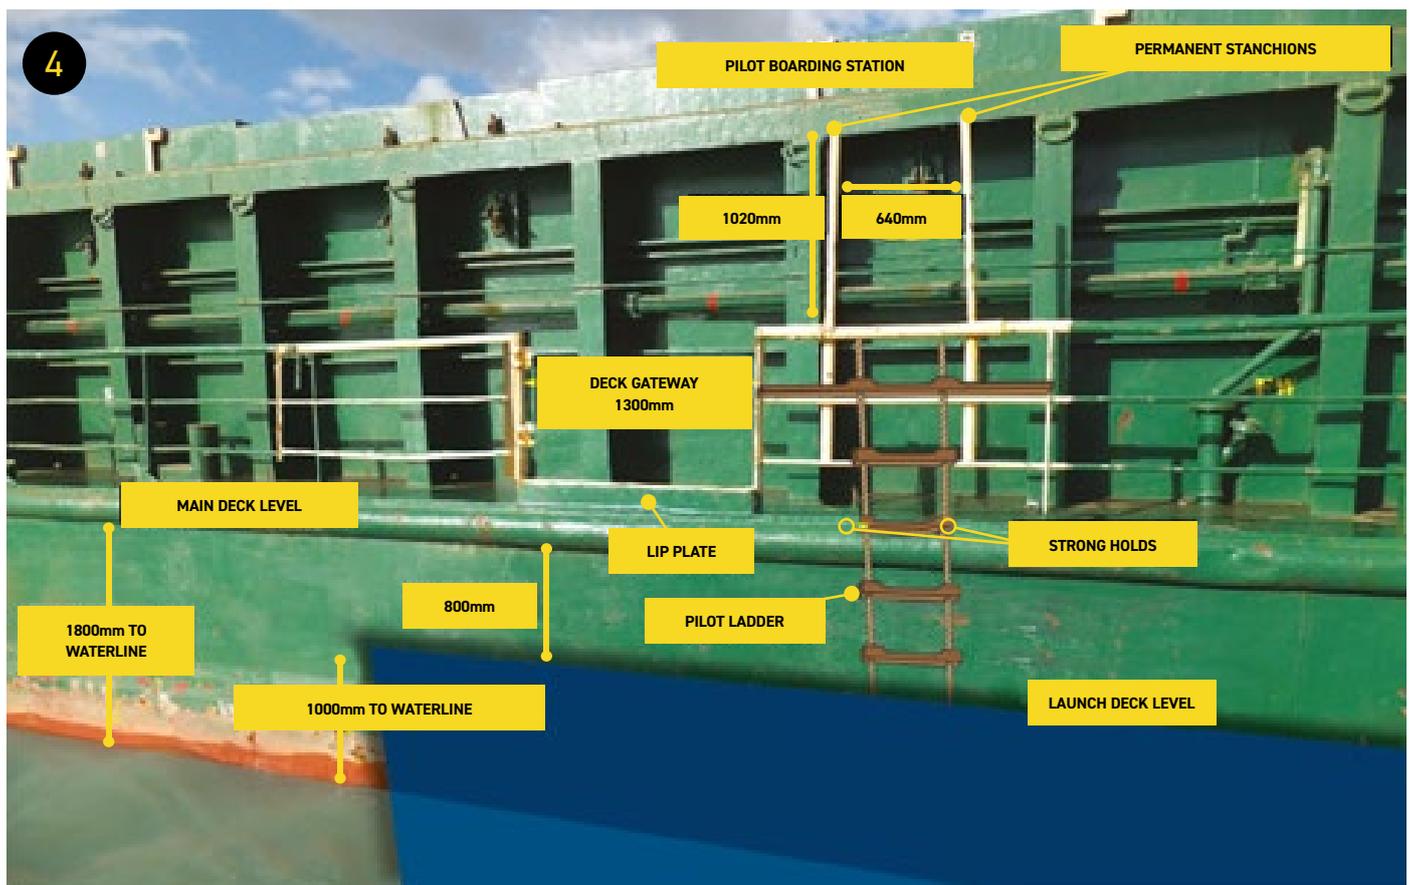
FIGURE 4 REPRODUCED IMAGE OF CARGO VESSEL'S DECK GATE AND PILOT BOARDING ARRANGEMENTS
SOURCE MARINE ACCIDENT INVESTIGATION BRANCH - GOV.UK: ANNUAL REPORT 21/2017

It was noted that the pilot ladder could be deployed over the top of the railings and be secured to the strongholds welded on the deck, similar to the function of a bulwark ladder, which could allow the boarding pilot to climb over the rail with the help of permanent stanchions. However, the bulwark ladder was not rigged at the time of incident and instead the deck gate was secured in a fully opened position.

The low freeboard between the two vessels with the short two step ladder may have given the false impression that access via the deck gate would be a safe option for boarding instead of a properly rigged pilot ladder.

The investigation found that the deck gate was not part of the designated pilot boarding station but the report did not mention whether the marking was properly done for the pilot boarding arrangements and whether the deck gate was included in the marking.

The investigation report did not identify the decision to leave the deck gate open, which was eventually used by the sea pilot to board the vessel, as the primary cause. However, if a responsible officer had been tasked to oversee preparations for the pilot boarding, it is possible that the officer may have identified the deck gate as being unsuitable. This may have meant the deck gate was closed and the bulwark ladder deployed instead.
