MISMANAGEMENT OF MEDICAL CONDITION ON BOARD

A TRAGIC INCIDENT UNFOLDED ON BOARD A BULK CARRIER, CLAIMING THE LIFE OF A CADET WHO HAD SPENT THREE MONTHS ON BOARD. THE 34-YEAR-OLD TRAGICALLY LOST HIS LIFE AFTER INHALING HYDROCARBON FUMES EMITTED FROM A BUNKER TANK VENT WHILE THE TANKS WERE BEING HEATED. THE SHIP'S MANAGEMENT TEAM INITIALLY MISJUDGED THE SEVERITY OF THE CADET'S ILLNESS, LEADING TO A CRITICAL DELAY IN PROVIDING THE NECESSARY MEDICAL TREATMENT AND ADVICE.

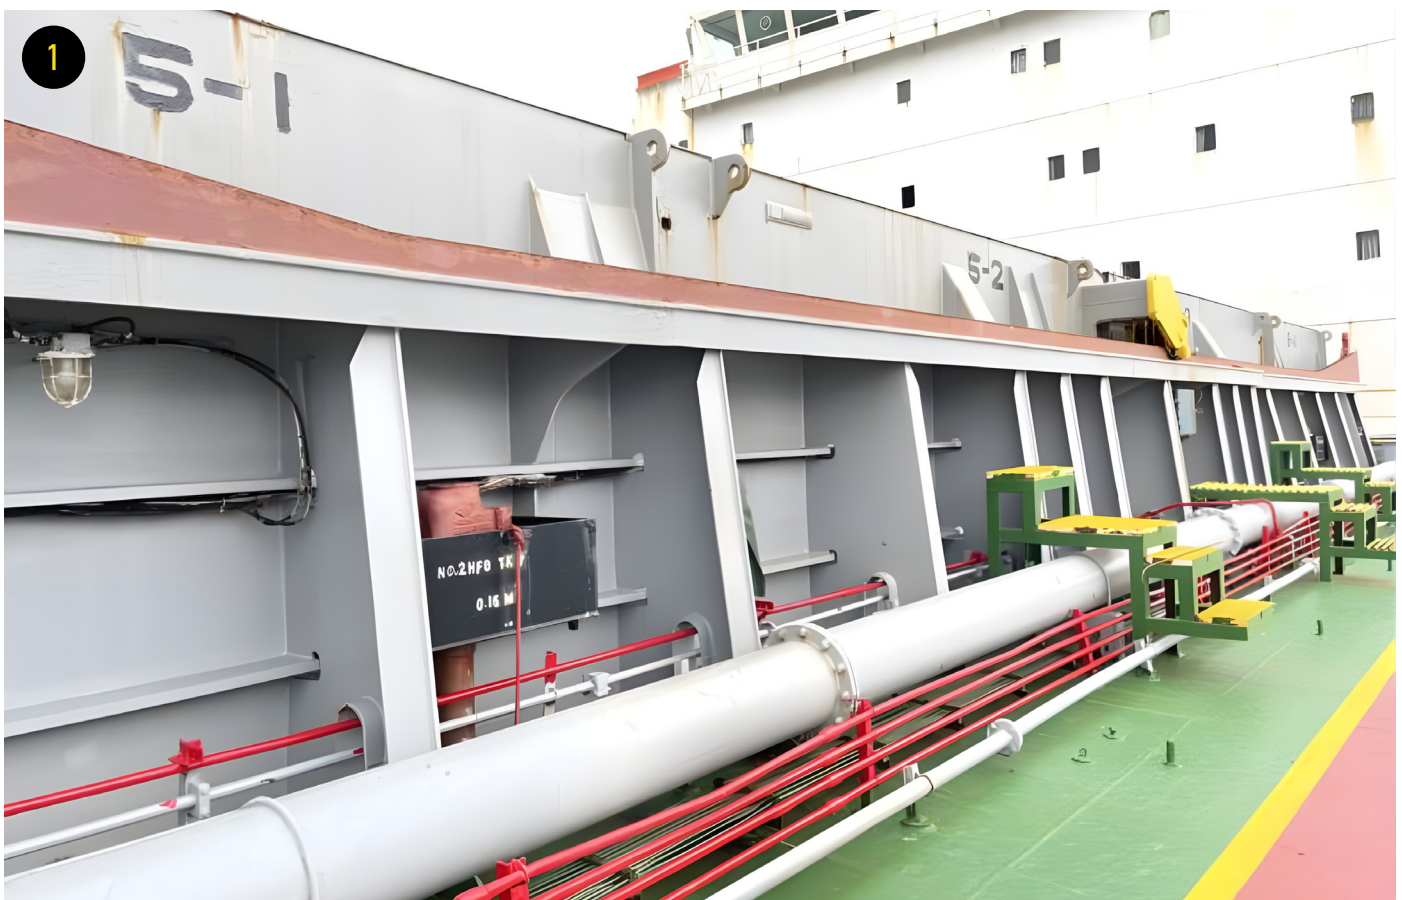
On 12 November 2022, aboard a bulk carrier off the western coast of Africa, a sequence of events unfolded that tragically led to the death of the deck cadet (DC). At the time of the incident, the ship was carrying approximately 46,000 MT of Nickel Ore, with the no. 5 cargo hold loaded to an estimated 47%. The ship had several Heavy Fuel Oil (HFO) tanks, including the no. 2 HFO tank (port), which emitted vapours from vents with approximately 170 MT low Sulphur fuel (0.49% of Sulphur content). The ship's chief officer (CO) tasked the fitter with conducting repairs in the no. 5 cargo hold, and both began preparations around 0800 hours. They noticed a strong smell of fumes emanating from a vent associated with the no. 2 HFO tank port.

FIGURE 1 VIEW OF THE FORWARD VENT FOR NO.2 HFO TANK (PORT)
SOURCE MARINE SAFETY INVESTIGATION REPORT - TSIB - MOT - SINGAPORE

The fitter was tasked by the chief officer to carry out some repair work inside no.5 cargo hold and the fitter prepared the items needed for the repair with the DC. When the bosun opened the hatch cover, both the fitter and the DC were waiting near no. 2 HFO tank port and noticed a strong smell of fumes from the vent of HFO tank. The DC lowered equipment required for repair into the hold standing on the raised steps aft of the HFO tank vent.

If the above procedures had been followed, they would have identified the DC's lack of experience as a risk. The DC should have accompanied another crew member with suitable experience. A responsible officer monitoring safety at the work site would have noticed the proximity of where equipment was lowered into the cargo hold to the bunker vent, which was venting fumes. A cease-task system or a similar mechanism could have allowed the fitter and DC to abort the task when they both sensed strong fumes and select an alternative access point to lower equipment into the hold.
