WARNING OF THE DANGERS OF FATIGUE AND POOR BRIDGE PROCEDURES

A GENERAL CARGO VESSEL RAN AGROUND ON SGEIR GRAIDACH SHOAL IN THE LITTLE MINCH ON THE WEST COAST OF SCOTLAND. LUCKILY THE CREW WERE SAFELY EVACUATED FROM THE SHIP BY THE LOCAL COASTGUARD, BUT THE VESSEL SUSTAINED EXTENSIVE DAMAGE AND WAS LATER DECLARED A CONSTRUCTIVE TOTAL LOSS. THE INCIDENT INVESTIGATION REPORT IDENTIFIED A NUMBER OF FACTORS CONTRIBUTING TO THE INCIDENT, WHICH PROVIDE VALUABLE INSIGHTS FOR MEMBERS. THE FACTORS INCLUDE FATIGUE, POOR BRIDGE PROCEDURES AND THE ISSUE OF SAFE MANNING LEVELS.

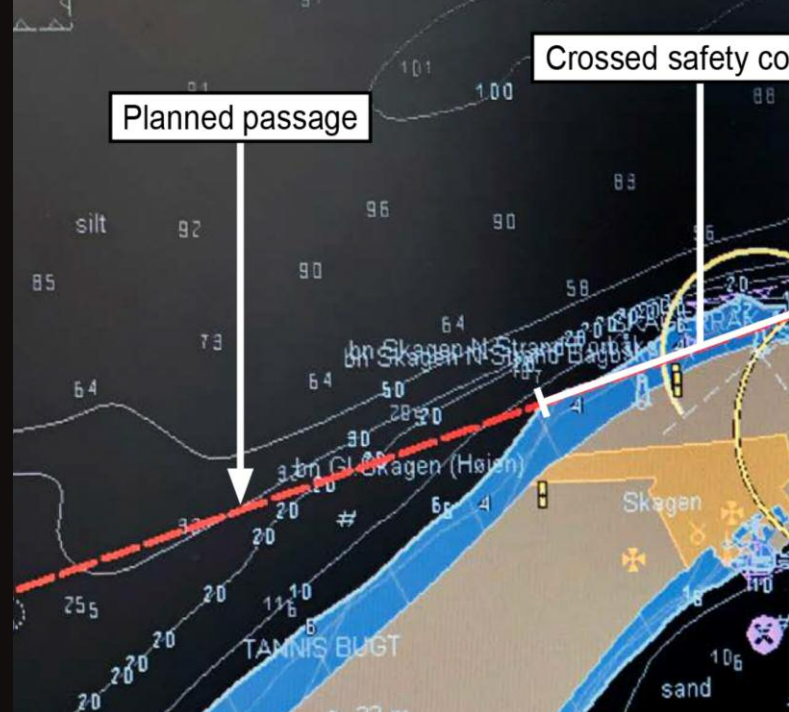
At 0058 the ship was making good a speed of 10.6 knots on a course of 032 degrees, approaching the reporting point for the start of the second TSS, near where the Little Minch ends and the North Minch begins. The chief officer contacted the SCOC to report the ship's position.

The International Maritime Organisation (IMO) recommends a route for north bound traffic within the TSS that passes between the islands of Fladda-chuain and Eileen Trodday. The ship's actual route was not the recommended route but instead followed a track running approximately 1nm north of the southern cardinal mark on Eugenie Rock (easily identifiable on the chart and positioned north of both the previously referenced islands).

Shortly after ending the VHF call, in accordance with the passage plan and having reached his next waypoint, the chief officer altered course 10 degrees to starboard. At 0141 two heavy impacts were felt on board and the ship ceased forward motion. Realising that the ship had grounded, the chief officer turned on the deck lights and put the engine telegraph to 'stop'. The ship had grounded on Sgeir Graidach rock, a charted hazard.

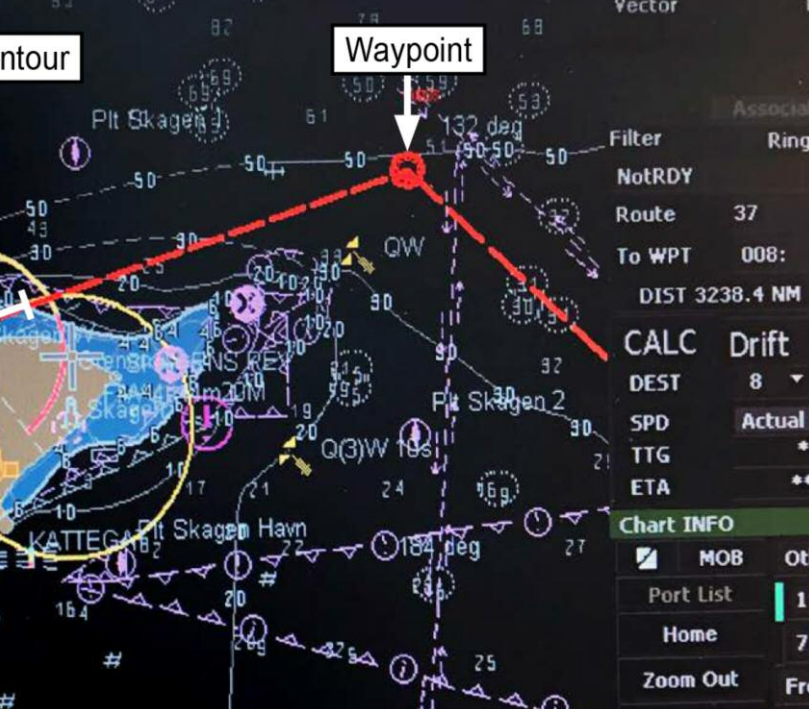
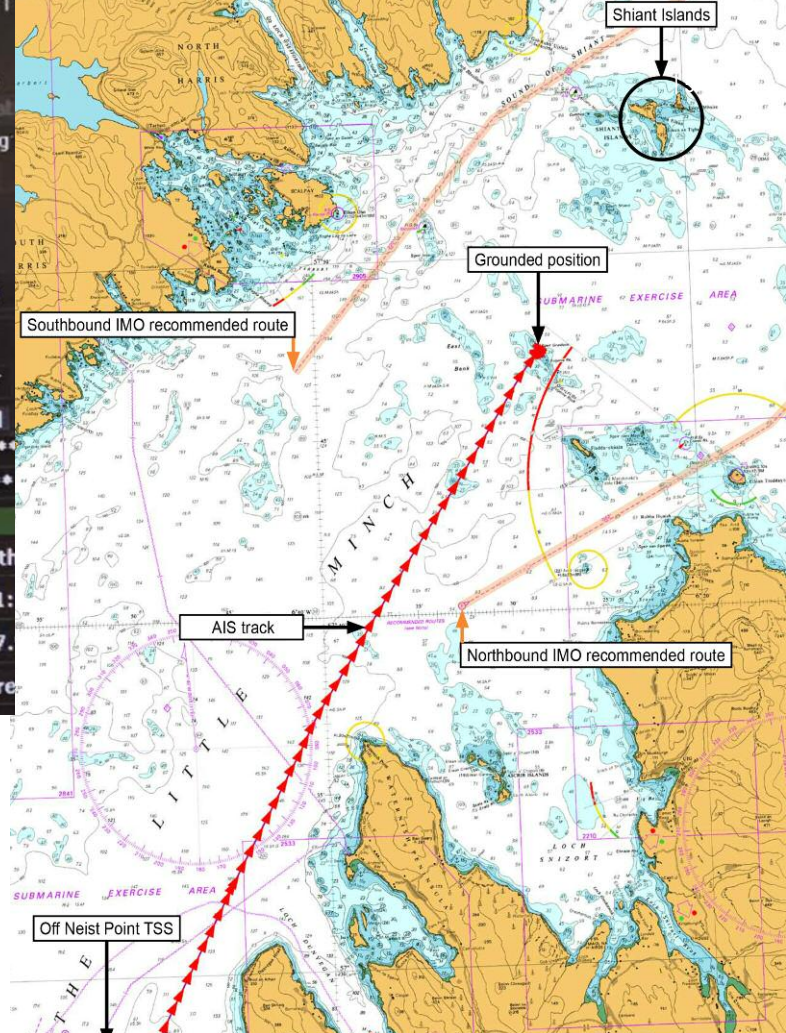
- The ship commenced the voyage without a completed passage plan and there was no comprehensive appraisal of the plan nor had it been independently checked.
- The ship's SMS did not stipulate the minimum under keel clearance (UKC) or provide guidance on its calculation and in this case no minimum UKC had been calculated at all.
- All the alarm audio buzzers on the ship's two ECDIS units were set to level 0 (no sound) and whilst the depth settings had been set, the track still passed through more than one area without sufficient UKC.

- The electronic chart cell covering the IMO recommended route through the northern TSS was not loaded into the ECDIS system and the passage planning had been undertaken using incorrectly scaled ENCs.

- If a safety check of the route been carried out prior to departure (it is not known whether this took place or not) it would have shown up 479 separate errors. A safety check for the leg of grounding alone showed 15 errors, which included 2 hazards (isolated dangers) and the crossing of a safety contour.

- To review the company's SMS procedures covering voyage planning and use of ECDIS and amend the SMS to include clear guidance on calculation of safe UKC and safety depth along with the correct application of safety contours and alert limit settings.
