### FATAL ACCIDENT DURING GANTRY CRANE OPERATIONS

A STEVEDORE ON BOARD A GENERAL CARGO SHIP WAS FATALLY CRUSHED BETWEEN THE GANTRY CRANE AND A HATCH COVER DURING CARGO DISCHARGE IN ANTWERP, BELGIUM. DESPITE NO ONE WITNESSING THE INCIDENT, IT IS BELIEVED THAT HE POSITIONED HIMSELF BETWEEN THE MOVING GANTRY CRANE AND THE HATCH COVER TO CHECK ON HIS TEAM'S PROGRESS WORKING IN THE HOLD.

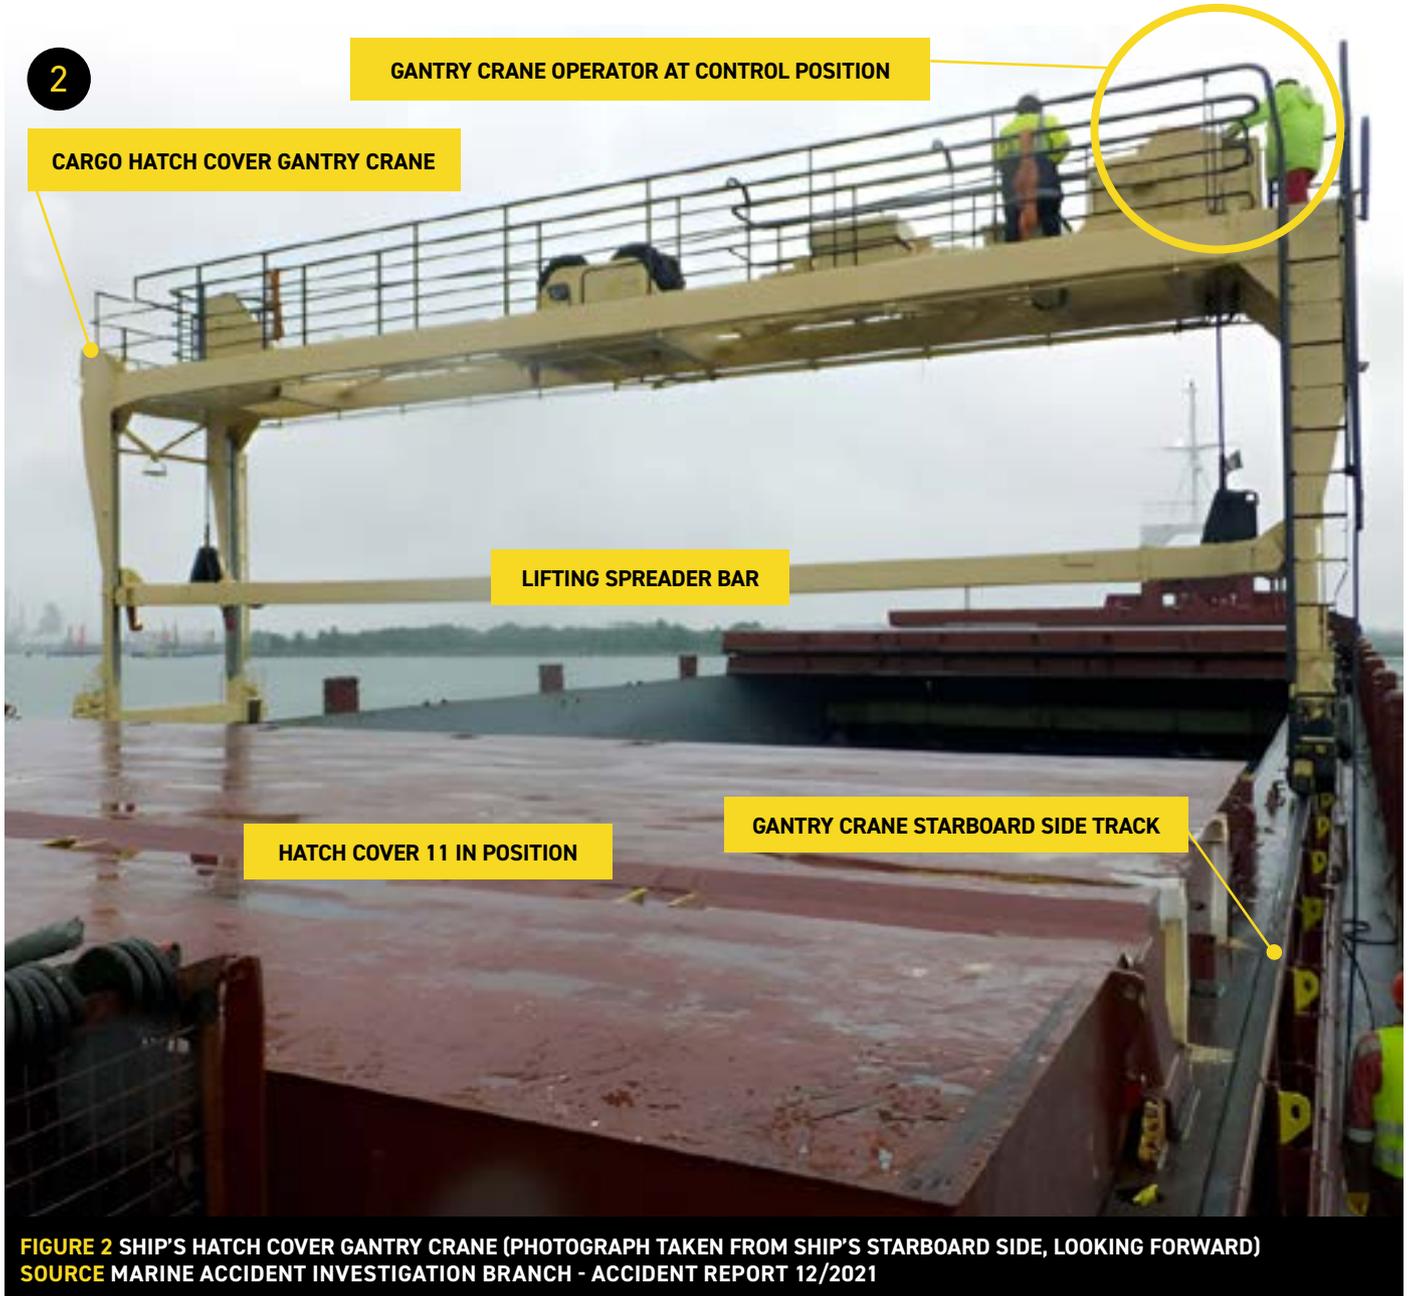
A general cargo ship moored starboard side to berth, at a bulk terminal, to unload its cargo of fine coke, also known as 'coke breeze'. The weather was cloudy, with light rain and a gentle breeze coming from the north. Between midnight and 0600 hours, the third officer on watch was operating the ship's gantry crane (Figure 2), to stack the hatch covers, following the cargo unloading plan (Figure 3).

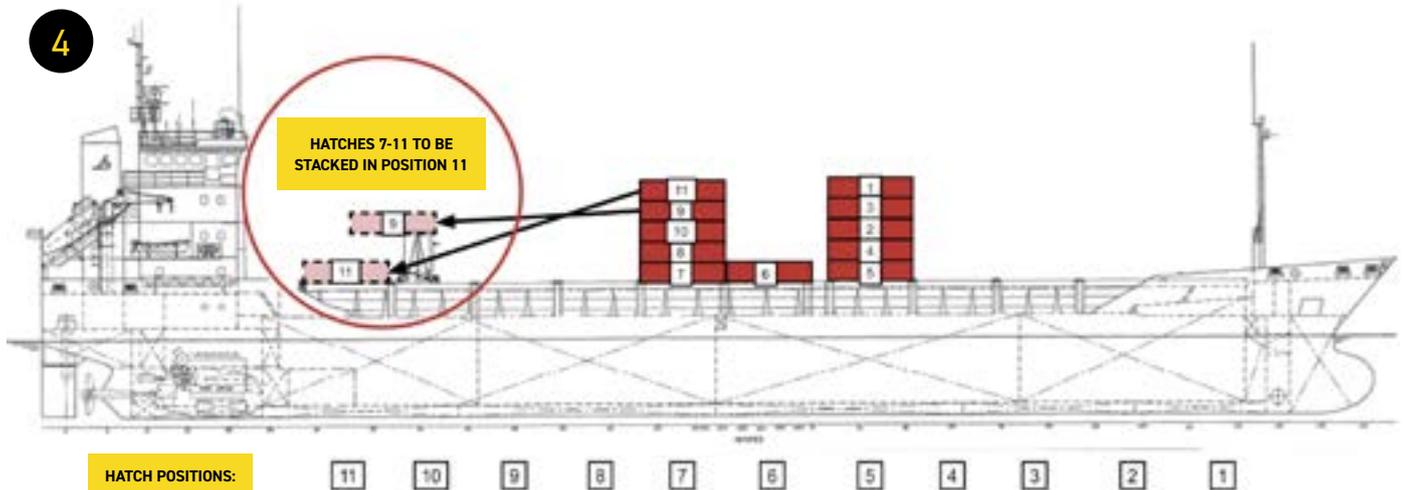
**FIGURE 4 HATCH CONFIGURATION BEFORE AND AT THE TIME OF THE ACCIDENT**  
**SOURCE MARINE ACCIDENT INVESTIGATION BRANCH - ACCIDENT REPORT 12/2021**

Shortly before 0900 hours, as the unloading of the aft part of the hold neared completion, the stevedore coordinator confirmed with the C/O that, once the front-end loader had been lifted into the hold by the shore crane, hatch covers 7 to 11 would be moved aft and stacked at the hatch cover 11 position. The transfer of the front-end loader into the hold was supervised by the coordinator, and once completed, the C/O made his way to the ship's gantry crane, while the stevedore coordinator proceeded towards the forward end of the hold via the port walkway.

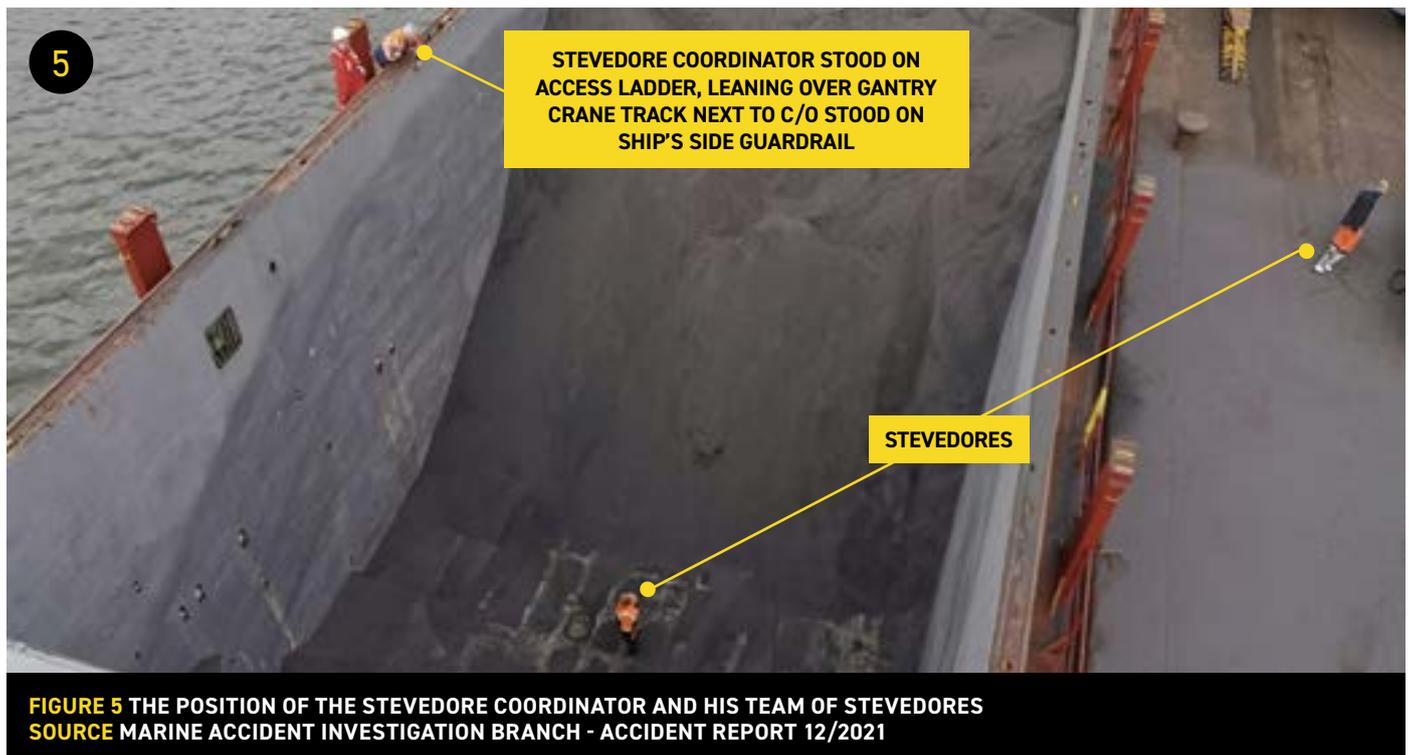
The stevedore coordinator directed the shoreside crane operator from the ship's port side walkway using a handheld radio. To oversee the operation, he climbed the ship's fixed ladders and leaned over the top of the 2m high hatch coaming to view the progress inside the cargo hold (Figure 5). Meanwhile, the C/O and an able-bodied seaman (AB) remained on board with the C/O monitoring cargo operations and the ship's stability, while the AB maintained security at the gangway to monitor mooring lines and fendering.

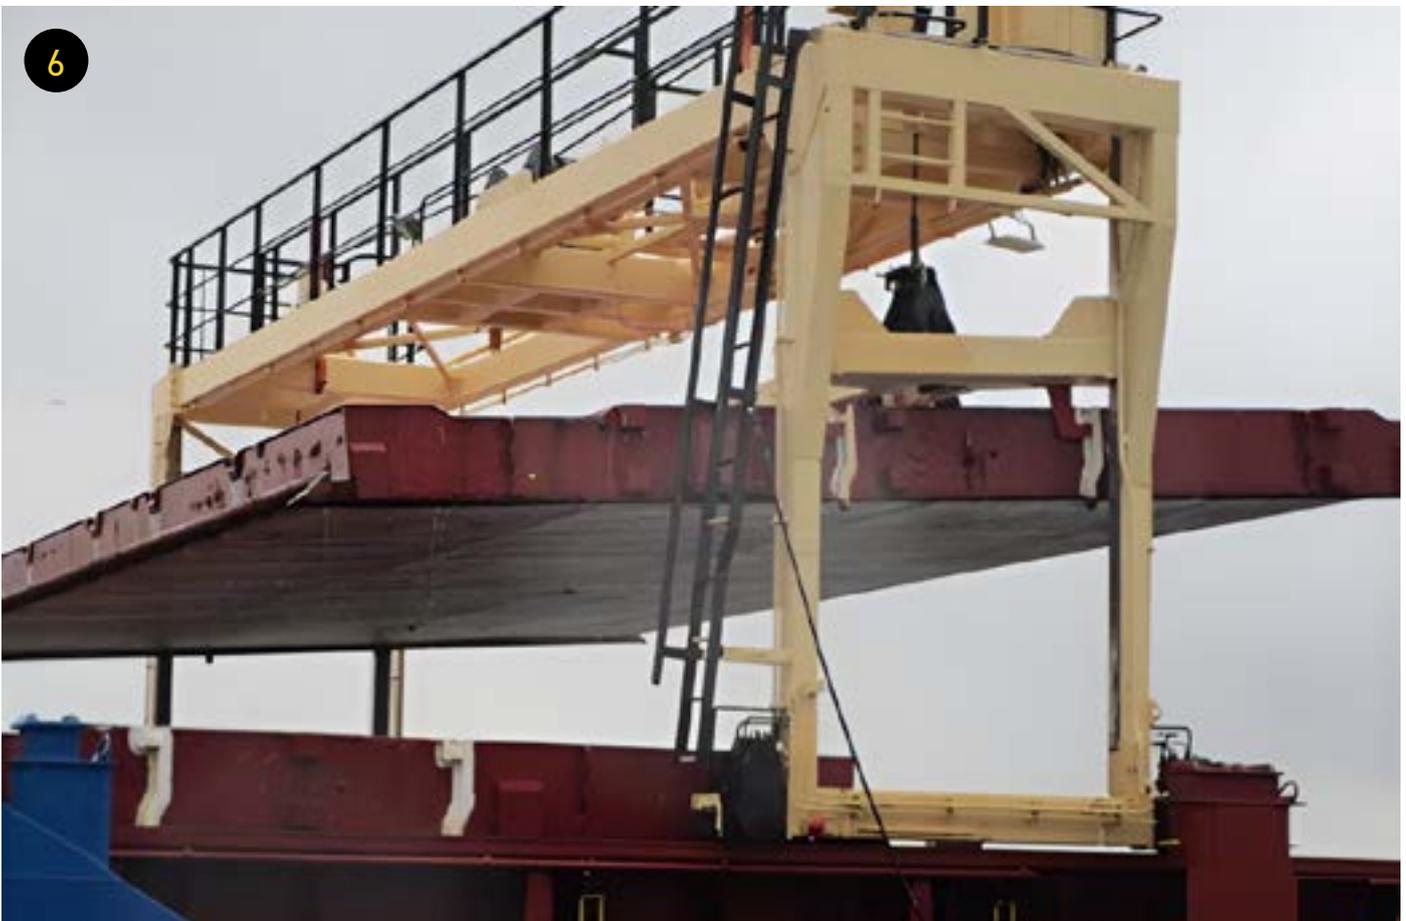
Around 0900 hours, while the C/O was moving the gantry crane over hatch cover position 10, it abruptly stopped (Figure 6). At this point still uncertain of the cause, the C/O was alerted by the stevedore foreman who was boarding the ship. The foreman spotted the stevedore coordinator's head above hatch cover 11 on the port side. Realising an accident had occurred, they both hurried to the portside aft walkway, where they found the stevedore coordinator trapped between the aft leg of the gantry crane and hatch cover 11, with a gap of approximately 130mm (Figure 7). It should be noted that when the hatch cover was suspended, the stevedore coordinator remained obscured and could not be seen by the C/O.

**FIGURE 6** GANTRY CRANE (IN ACCIDENT POSITION) WITH HATCH COVER 9 SUSPENDED  
**SOURCE** MARINE ACCIDENT INVESTIGATION BRANCH - ACCIDENT REPORT 12/2021

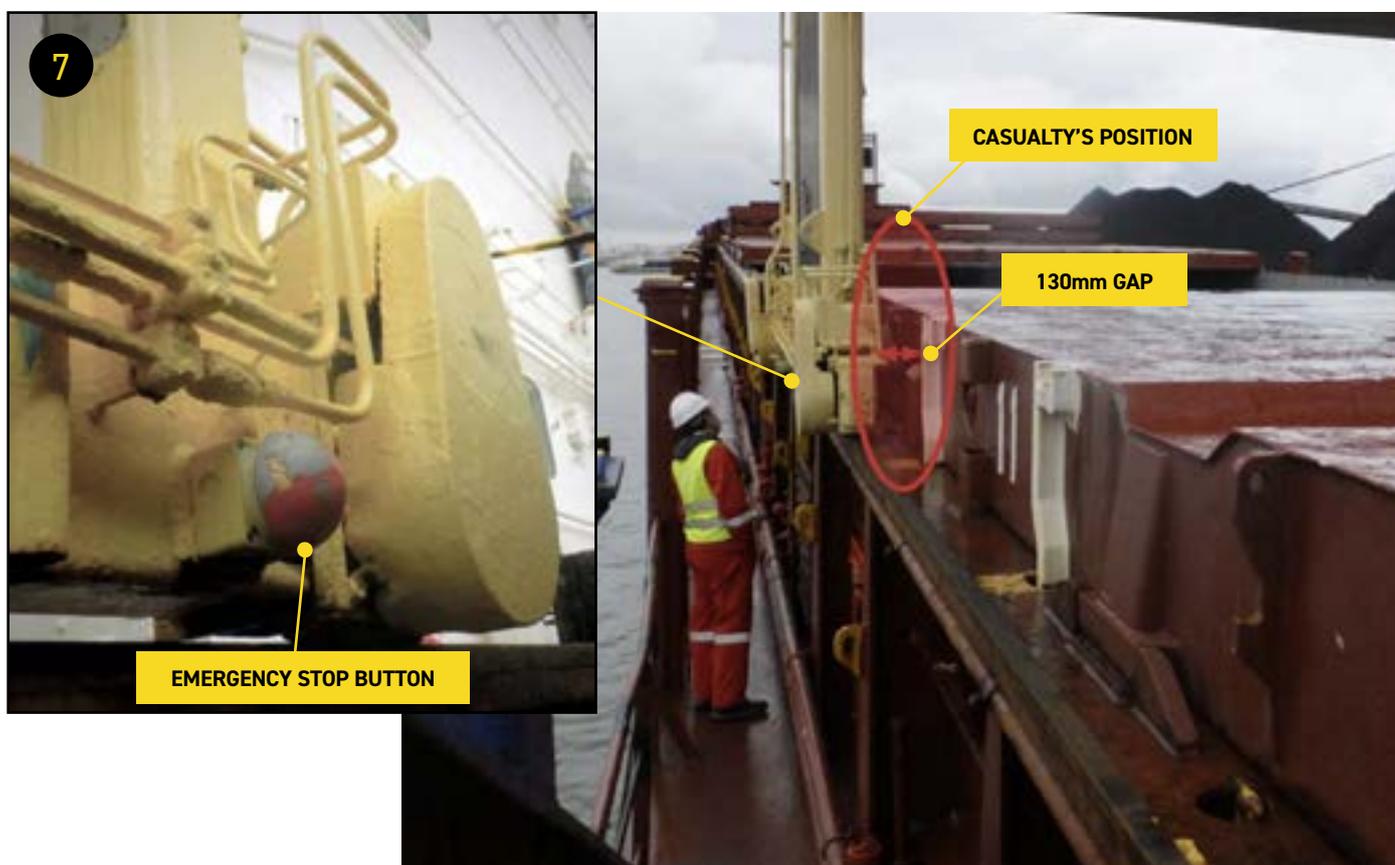
Tragically, the stevedore coordinator sustained severe injuries and was pronounced dead at the scene by the terminal's emergency services.

**FIGURE 7** VIEW OF LOCATION WHERE STEVEDORE COORDINATOR WAS DISCOVERED  
**SOURCE** MARINE ACCIDENT INVESTIGATION BRANCH - ACCIDENT REPORT 12/2021

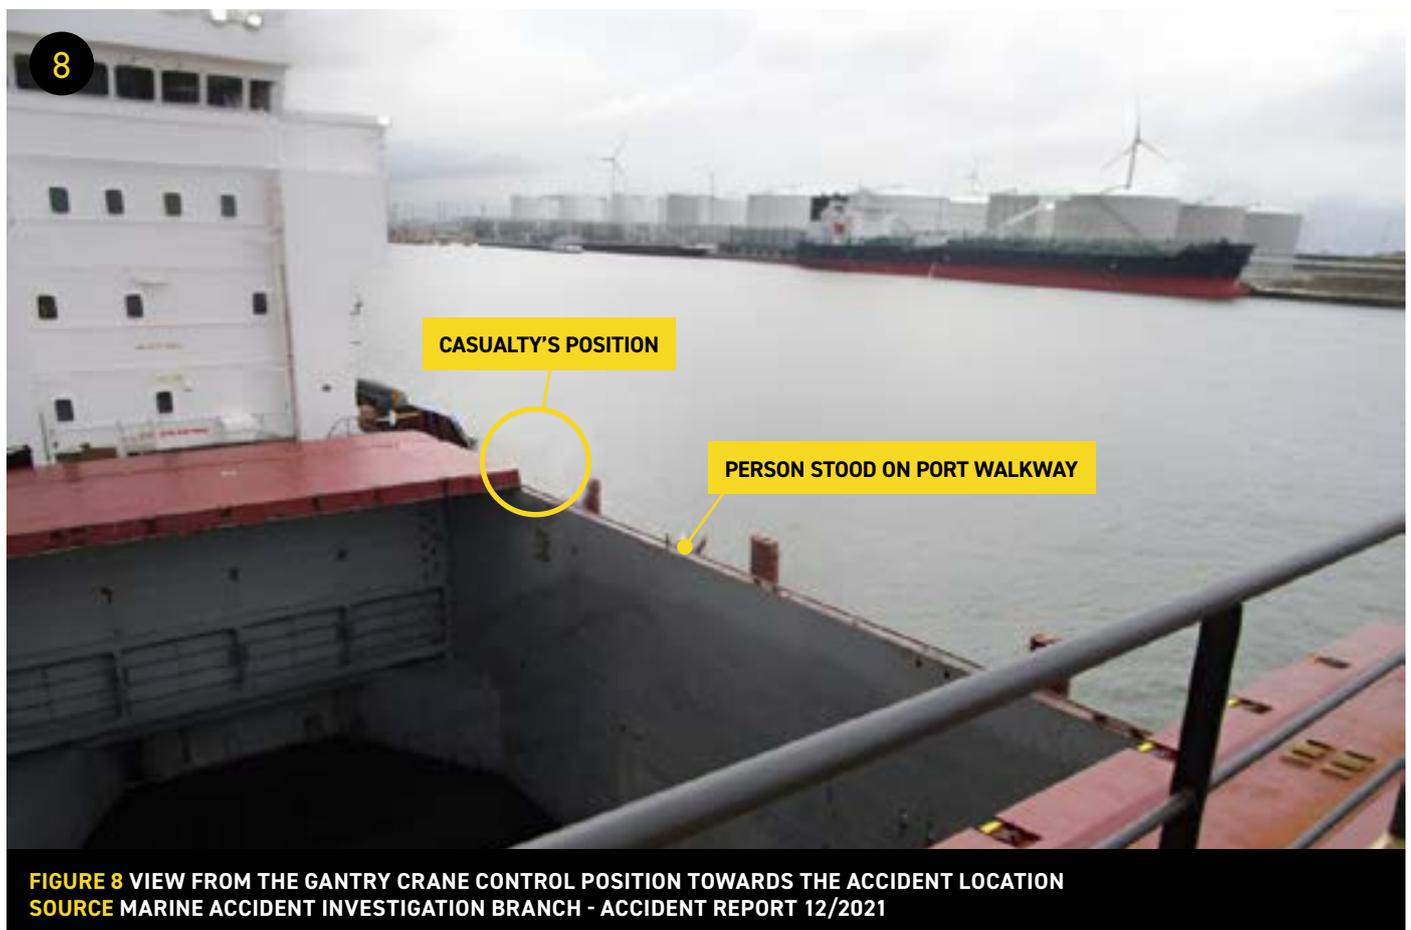
At the start of the operation to move hatch cover 9, there was a clear line of sight from the gantry crane's control position to the area where the stevedore coordinator was later crushed (Figure 8). However, as the gantry crane approached hatch cover position 10, visibility of the crush site became obscured by the suspended hatch cover. The distance from the starting position to where the crane structure aligned with hatch cover 11, where the coordinator was trapped, was about 20 meters. From the post-accident report, a reconstruction of the accident shows that it takes approximately 45 seconds for the crane to travel from hatch cover 7 to hatch cover 11, with the crush site becoming obscured from the crane's control position for the final 20 seconds of travel.

The company had a documented procedure within its Safety Management System (SMS) that should have prevented such an incident. It was specified that a minimum of two personnel were required for lifting operations, at least one crew member was to act as a lookout or banksman for the crane operator. Had this procedure been followed, it is very likely that the stevedore would have been seen by the crew and the crane stopped or the person asked to move clear before a risk of entrapment occurred.

The crane path was fixed and predictable. The lifting plan should have been discussed with the stevedores, and a reminder made that there were areas that the crane operator would be unable to see whilst the crane was in motion. A safe area for stevedores to remain whilst lifting operations were taking place should have been agreed between all parties.
