ASPHYXIATION IN CARGO HOLD DUE TO OXYGEN DEPLETION

AN UNEXPECTED INCIDENT OCCURRED ON BOARD A BULK CARRIER NEARING THE COMPLETION OF LOADING CORN CARGO, CAUSING TWO FUMIGATION CONTRACTORS TO ASPHYXIATE AND RESULTING IN THE DEATH OF ONE CONTRACTOR. BEFORE THE INCIDENT, THE CARGO HOLDS HAD BEEN CLOSED FOR SIX DAYS, LEADING TO DEPLETED OXYGEN LEVELS INSIDE.

BRITANNIA COMMENTARY ON INCIDENT

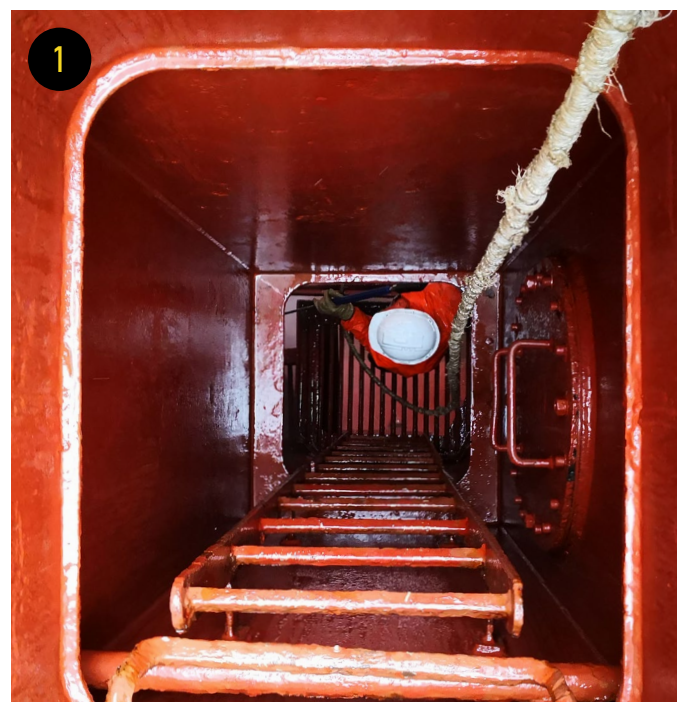
On 21 December 2021, as loading neared completion, 21 fumigation contractors boarded at 0948. While their equipment was being loaded using the ship's crane, a team of four contractors prepared to fumigate cargo hold four. At 1212, two workers entered the booby hatch of hold four with gas masks and a phosphine gas detector. Shortly afterwards, worker A emerged onto deck feeling breathless and noticed that worker B had fallen over within the cargo hold. He re-entered to assist.

Other team members, realising the danger, attempted to help but quickly retreated due to breathlessness. One team member then informed the ship's crew at the gangway. At 1217, the officer of the watch alerted the master, who then called for an enclosed space rescue via the public address system. The chief officer, upon hearing the call, rushed to the booby hatch. Upon seeing the two collapsed workers inside the hold, he donned an emergency escape breathing device (EEBD) and entered the hold, retrieving worker A at 1222. He re-entered (still wearing the EEBD) and, using a rope, retrieved worker B onto the deck.

FIGURE 1 BOTTOM OF THE LADDER WHERE CASUALTY WAS FOUND

As per Section 10.5 of Resolution A.1050(27), grain cargoes (e.g. corn) can cause oxygen depletion. Corn kernels absorb oxygen and excrete carbon dioxide, which can cause oxygen depletion in a cargo hold that is closed for a long time. The Occupational Safety and Health Administration (OSHA) considers any atmosphere with an oxygen content below 19.5% by volume to be oxygen-deficient and immediately dangerous to life or health. After the incident, tests of the atmosphere in cargo hold 4 showed an oxygen content of 2.6% by volume.

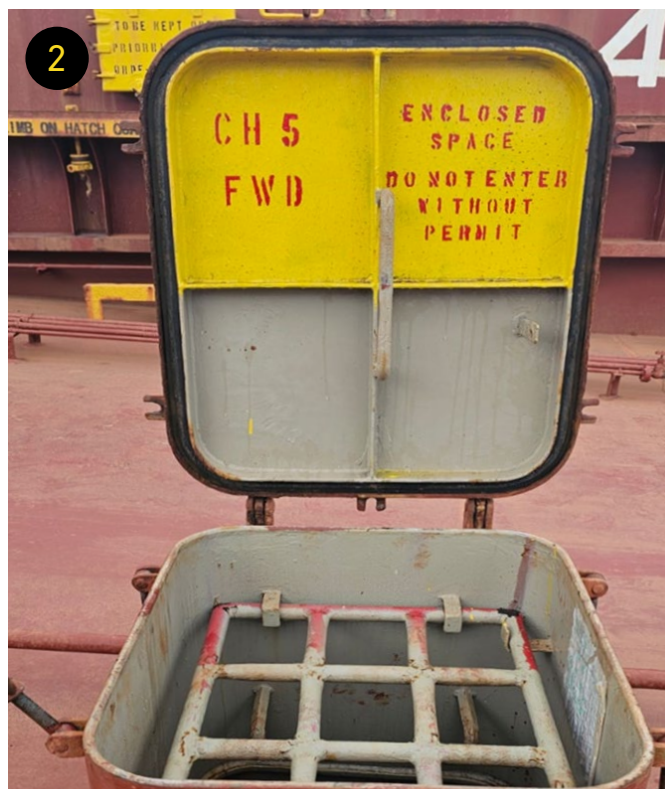
The cargo hold had been shut for six days, and the oxygen in the hold had been depleted by the corn cargo. Therefore, the cargo hold should have been considered an enclosed space. The involved parties did not recognise the danger of the cargo hold, loaded with grain and closed for a long time, so they did not consider it an enclosed space. Entry into an enclosed space should only occur after the ship's master authorises it and completes the entry permit system. Although the booby hatch for accessing the hold could be locked to prevent unauthorised entry, it was not locked, possibly because the final loading was incomplete, and they did not anticipate oxygen depletion or unauthorised entry. Since 21 fumigation contractors boarded the ship, the crew could not monitor every action of the contractors.

FIGURE 2 EXAMPLE OF WARNINGS ON BOOBY HATCHES

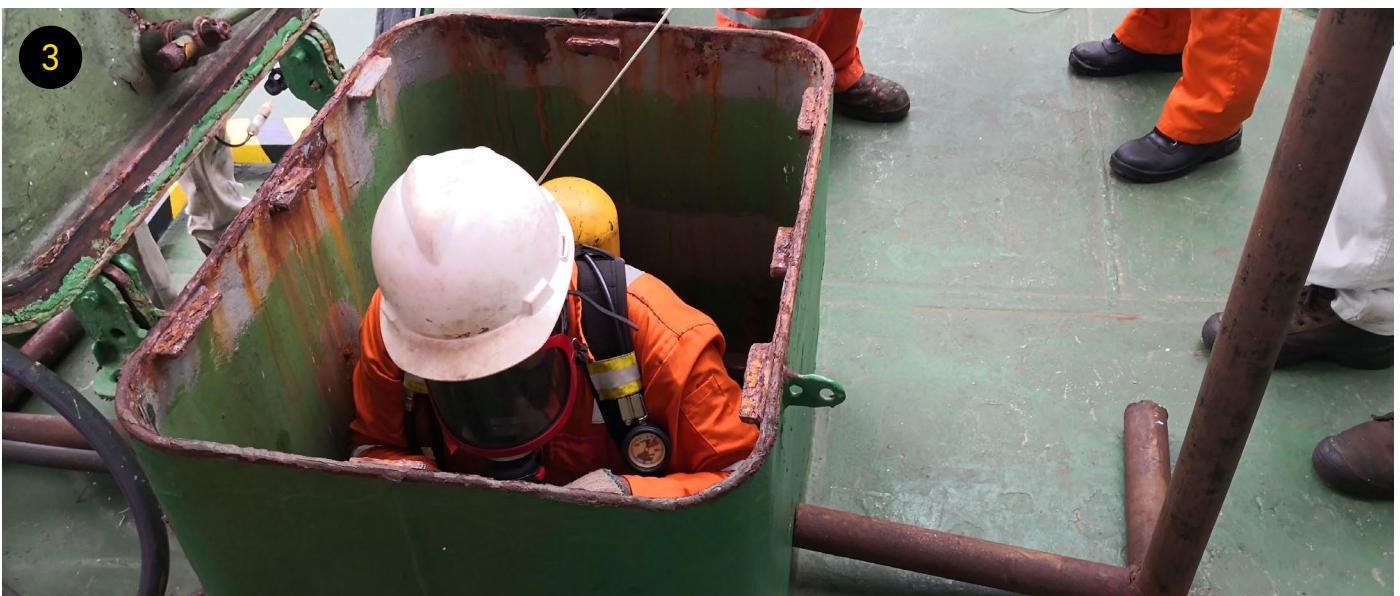
Enclosed space incidents regularly involve a person entering or re-entering a dangerous space to rescue a fallen colleague, and then subsequently becoming unwell and also requiring rescue. Worker A's attempt to help his colleague cost him his life. The chief officer's action to rescue contractors was brave, and he managed to save the life of one worker, but he jeopardised his own safety. As per paragraph 8.5 of Resolution A.1050(27), 'only properly trained and equipped personnel should perform rescue operations in enclosed spaces.' The chief officer was not properly equipped to enter the space for rescue as the EEBD worn by him supplies only 10-15 minutes of air and is designed to be used for escape from a compartment with a hazardous atmosphere. It should not be used for fighting fires, entering oxygen-deficient voids or tanks, or worn by firefighters. Instead, a self-contained breathing apparatus (SCBA) should be used.

FIGURE 3 CORRECT WAY OF ENCLOSED SPACE RESCUE

The circumstances that led to this incident and the shortcomings in the rescue operation highlight the need for continuous and ongoing training on enclosed space entry, emphasising the points from IMO 'Resolution A.1050(27)'. SOLAS Ch III regulation 19 states, 'crew members with enclosed space entry or rescue responsibilities shall participate in an enclosed space entry and rescue drill to be held on board the ship at least once every two months.' Regular enclosed space rescue drills should be conducted in a safe and realistic manner. The master should conduct drills in all enclosed spaces on the ship to practice and address the specific procedures and equipment needed for each space.
