ASPHYXIATION IN CARGO HOLD DUE TO OXYGEN DEPLETION

AN UNEXPECTED INCIDENT OCCURRED ON BOARD A BULK CARRIER NEARING THE COMPLETION OF LOADING CORN CARGO, CAUSING TWO FUMIGATION CONTRACTORS TO ASPHYXIATE AND RESULTING THE DEATH OF ONE CONTRACTOR. BEFORE THE INCIDENT, THE CARGO HOLDS HAD BEEN CLOSED FOR SIX DAYS, LEADING TO DEPLETED OXYGEN LEVELS INSIDE.

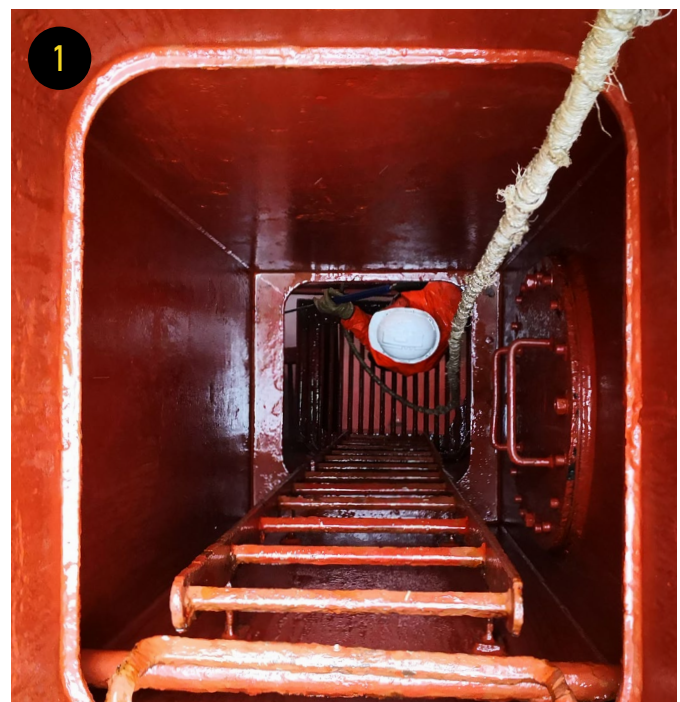
On 21 December 2021, as loading neared completion, 21 fumigation contractors boarded at 0948. While their equipment was being loaded using the ship's crane, a team of four contractors prepared to fumigate cargo hold four. At 1212, two workers entered the booby hatch of hold four with gas masks and a phosphine gas detector. Shortly afterwards, worker A emerged onto deck feeling breathless and noticed that worker B had fallen over within the cargo hold. He re-entered to assist.

Other team members, realising the danger, attempted to help but quickly retreated due to breathlessness. One team member then informed the ship's crew at the gangway. At 1217, the officer of the watch alerted the master, who then called for an enclosed space rescue via the public address system. The chief officer, upon hearing the call, rushed to the booby hatch. Upon seeing the two collapsed workers inside the hold, he donned an emergency escape breathing device (EEBD) and entered the hold, retrieving worker A at 1222. He re-entered (still wearing the EEBD) and, using a rope, retrieved worker B onto the deck.

FIGURE 1 BOTTOM OF THE LADDER WHERE CASUALTY WAS FOUND

As per Section 10.5 of Resolution A.1050(27), grain cargoes (e.g. corn) can cause oxygen depletion. Corn kernels absorb oxygen and excrete carbon dioxide, which can cause oxygen depletion in a cargo hold that is closed for a long time. The Occupational Safety and Health Administration (OSHA) considers any atmosphere with an oxygen content below 19.5% by volume to be oxygen-deficient and immediately dangerous to life or health. After the incident, tests of the atmosphere in cargo hold 4 showed an oxygen content of 2.6% by volume.

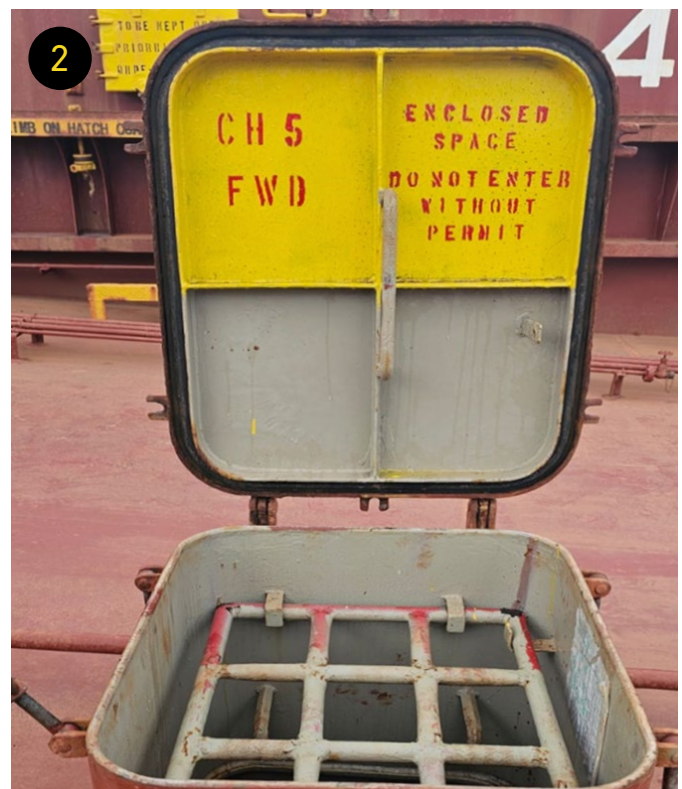
The cargo hold had been shut for six days, and the oxygen in the hold had been depleted by the corn cargo. Therefore, the cargo hold should have been considered an enclosed space. The involved parties did not recognise the danger of the cargo hold, loaded with grain and closed for a long time, so they did not consider it an enclosed space. Entry into an enclosed space should only occur after the ship's master authorises it and completes the entry permit system. Although the booby hatch for accessing the hold could be locked to prevent unauthorised entry, it was not locked, possibly because the final loading was incomplete, and they did not anticipate oxygen depletion or unauthorised entry. Since 21 fumigation contractors boarded the ship, the crew could not monitor every action of the contractors.

FIGURE 2 EXAMPLE OF WARNINGS ON BOOBY HATCHES

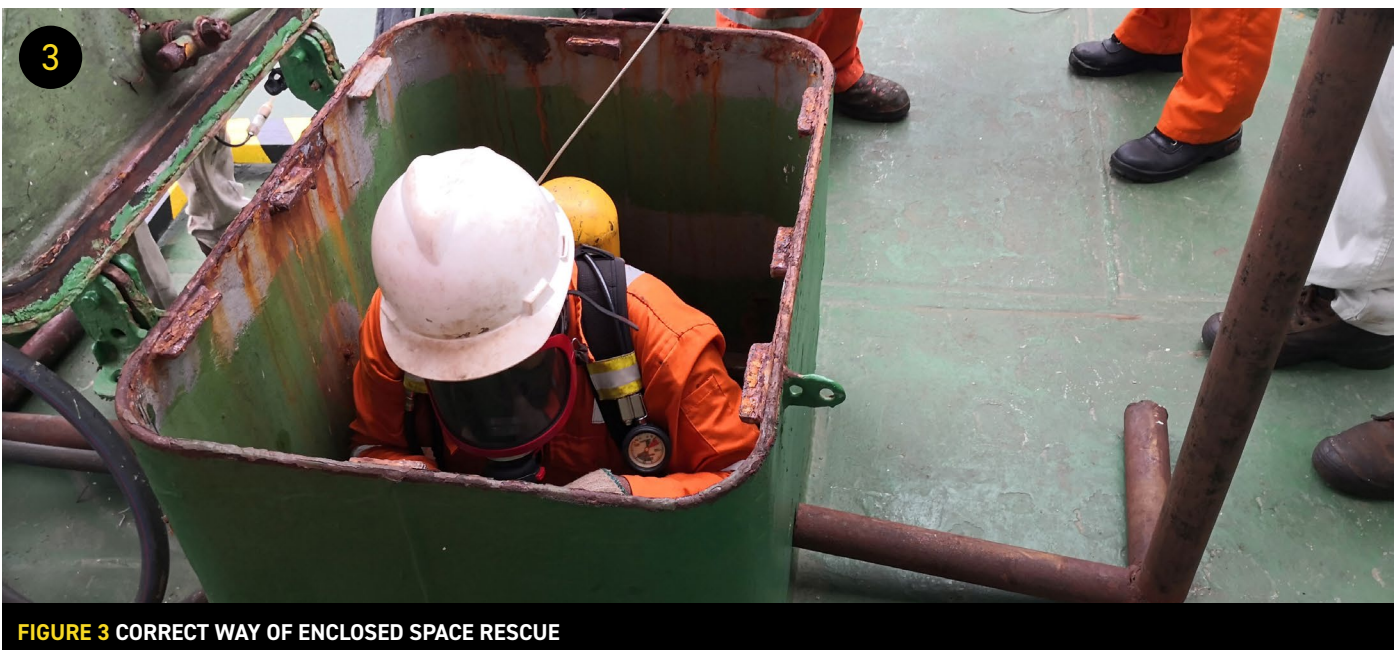
Enclosed space incidents regularly involve a person entering or re-entering a dangerous space to rescue a fallen colleague, and then subsequently becoming unwell and also requiring rescue. Worker A's attempt to help his colleague cost him his life. The chief officer's action to rescue contractors was brave, and he managed to save the life of one worker, but he jeopardised his own safety. As per paragraph 8.5 of Resolution A.1050(27), 'only properly trained and equipped personnel should perform rescue operations in enclosed spaces.' The chief officer was not properly equipped to enter the space for rescue as the EEBD worn by him supplies only 10-15 minutes of air and is designed to be used for escape from a compartment with a hazardous atmosphere. It should not be used for fighting fires, entering oxygen-deficient voids or tanks, or worn by firefighters. Instead, a self-contained breathing apparatus (SCBA) should be used.

FIGURE 3 CORRECT WAY OF ENCLOSED SPACE RESCUE

The circumstances that led to this incident and the shortcomings in the rescue operation highlight the need for continuous and ongoing training on enclosed space entry, emphasising the points from IMO 'Resolution A.1050(27)'. SOLAS Ch III regulation 19 states, 'crew members with enclosed space entry or rescue responsibilities shall participate in an enclosed space entry and rescue drill to be held on board the ship at least once every two months.' Regular enclosed space rescue drills should be conducted in a safe and realistic manner. The master should conduct drills in all enclosed spaces on the ship to practice and address the specific procedures and equipment needed for each space.
