INJURY AND EXTENSIVE DAMAGE DUE TO CABIN FIRE

A FIRE OCCURRED ONBOARD A 2,565 GT GENERAL CARGO SHIP, CAUSING EXTENSIVE DAMAGE AND INJURING ONE CREW MEMBER. FORTUNATELY, NO LIVES WERE LOST.

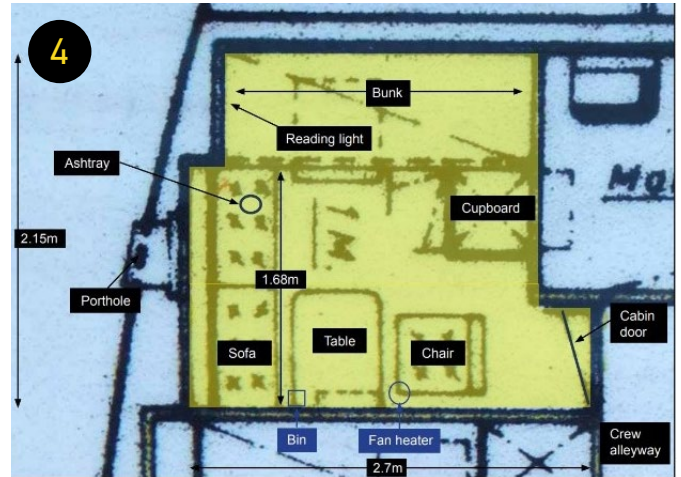
FIGURE 4 LAYOUT OF AB2'S CABIN

The crew member (AB2) opened the porthole in his cabin, a common practice onboard due to the ship's unreliable and noisy ventilation system, which often drew dust into the cabins. He then spent some time drinking beer (approximately 6-8 units of alcohol) and smoking cigarettes, continuing these activities after getting into bed. It is presumed that a lit cigarette fell onto the adjacent sofa, which was made of highly flammable synthetic materials. A fire quickly spread in the confined, material-rich environment of the cabin. During the subsequent investigation, items such as papers, lighters, and a plastic container of paint thinner were reported to have been present.

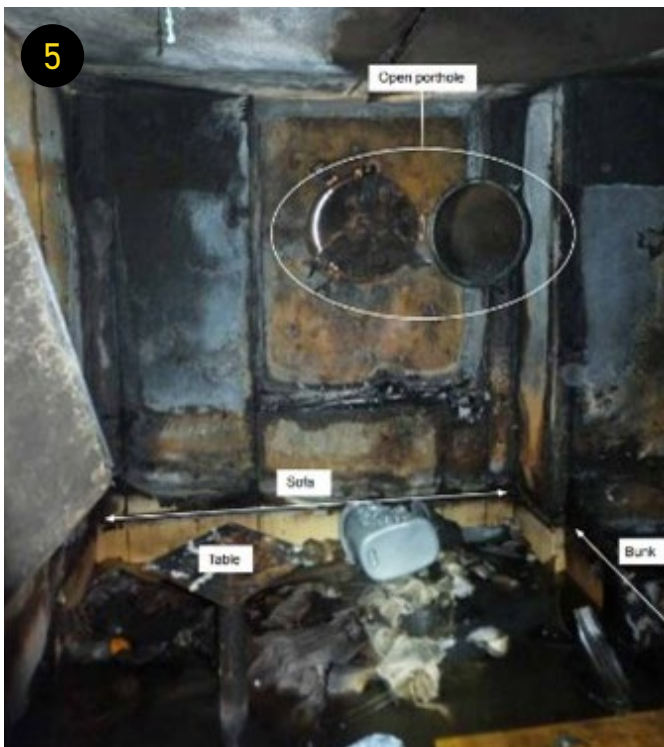
FIGURE 5 AB2'S FIRE-DAMAGED CABIN

It is unknown if the crew routinely smoked in bed, but the crew member had exceeded the company's specified limit of 4 units of alcohol per day. It is probable that alcohol consumption influenced his decision to smoke in bed and almost certainly contributed to him falling asleep with a lit cigarette.

The open porthole delayed the buildup of smoke in the cabin, however, it also helped the fire grow by drawing in oxygen from outside. This, combined with the crew member rushing out and not properly closing the door behind him (another source of oxygen), further fuelled the fire.
