ALLISION WITH PIER AND DRY DOCK BY CAR CARRIER

INCIDENT CASE STUDY

No.28 | SEPTEMBER 2025

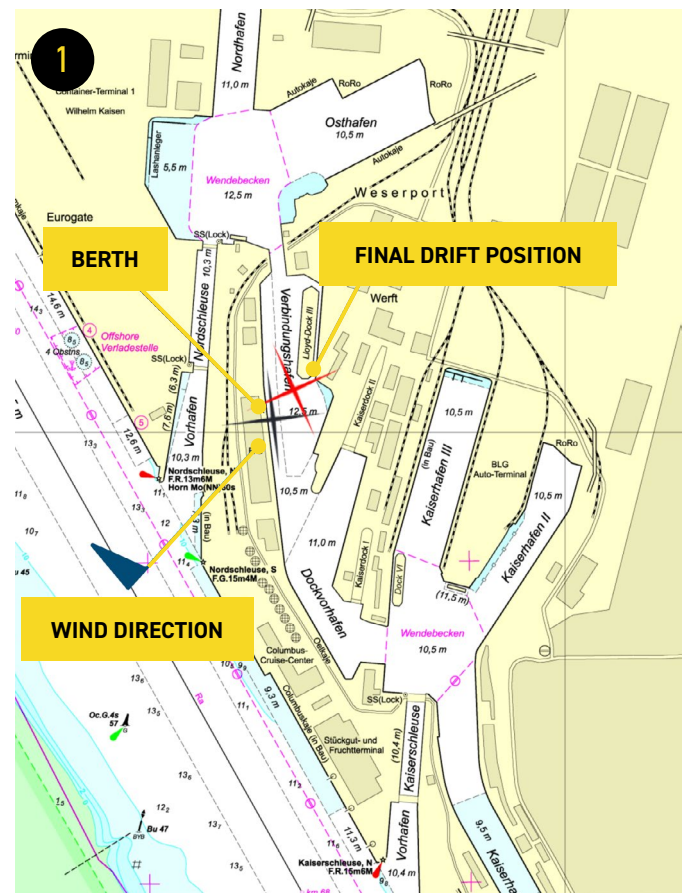
The head lines parted first, followed by the failure of a shore bollard cover with a spring line attached. The ship began drifting in a north-easterly direction towards the adjacent dockyard, around 120 m away on the opposite side of the waterway. Eight minutes after all lines parted, two tugs arrived. Despite their efforts, the ship's bulbous bow struck two floating pontoons at the dockyard, before the drifting ship contacted a floating dock within the dockyard and became trapped against it and the dockyard quay.

FIGURE 1 SCENE OF THE ACCIDENT, NAVIGATIONAL CHART NORTH SEA, GERMAN COAST - BREMERHAVEN
SOURCE BUNDESSTELLE FÜR SEEUNFALLUNTERSUCHUNG (BSU) SUMMARY INVESTIGATION REPORT 95/21
