## **BENZENE VAPOUR FATALITY FOLLOWING UNAUTHORISED TANK ENTRY**

ON 20 JANUARY 2024, WHILE A SHIP WAS UNDERWAY AFTER DISCHARGING BENZENE, A CREW MEMBER ENTERED A CARGO TANK BEFORE ENCLOSED-SPACE ENTRY PROCEDURES HAD BEEN AUTHORISED AND BEFORE CONFIRMING THE ATMOSPHERE WAS SAFE. HE WAS LATER FOUND COLLAPSED AT THE BOTTOM OF THE TANK AND, DESPITE RESCUE EFFORTS, DID NOT SURVIVE. THE INVESTIGATION REPORT CONCLUDED WITH THE PRESUMPTION THAT RESIDUAL BENZENE VAPOURS AND OXYGEN-DEFICIENT ATMOSPHERE WITHIN THE TANK WERE THE PRIMARY FACTORS LEADING TO HIS RAPID INCAPACITATION AND SUBSEQUENT FATALITY.

No.29 | NOVEMBER 2025

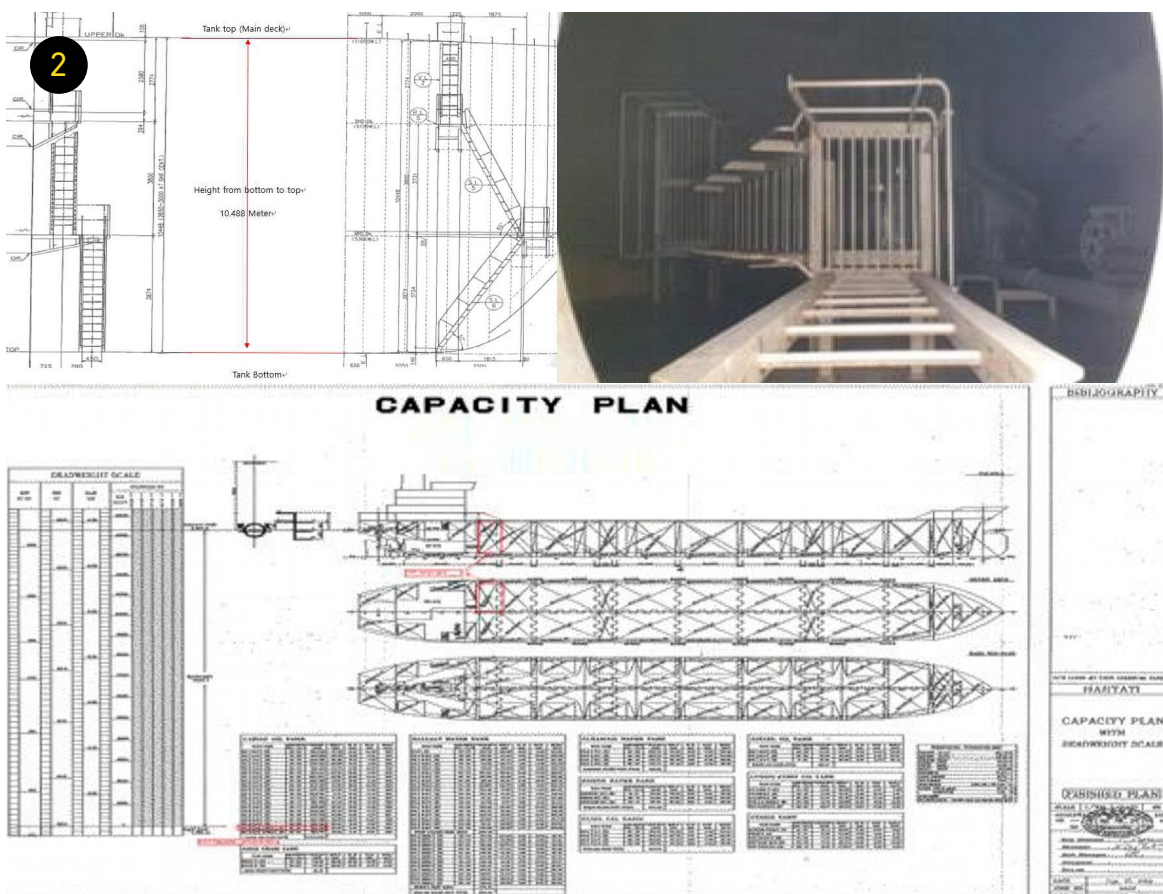
Around 1035 hrs, the bosun, who was walking across the deck, looked down into cargo tank 10 Port. Seeing the OS lying collapsed on the tank bottom, the bosun immediately raised the alarm. The bridge informed the master, and shipboard emergency response commenced.

**FIGURE 2 HATCH AND LOCATION OF CARGO TANK**  
**SOURCE KMST MSI REPORT 2024-002**

The subsequent autopsy identified traumatic injury consistent with a fall onto a hard surface, including cervical spinal fracture – meaning the atmosphere incapacitated the OS before they had reached the bottom. Benzene was detected in the OS's cardiovascular system. Based on this, and the fact that the tank bottom was only accessible by ladder, it was determined that the OS had entered the tank of their own volition, inhaled residual benzene vapours, collapsed inside the tank and fell, sustaining fatal injury. The tank atmosphere had not been tested and confirmed safe prior to entry, and the filter-type mask worn by the OS was not suitable or approved for protection against benzene vapours or oxygen-deficient atmospheres.

As an additional layer of protection, physical barriers or temporary guards over hatches may be considered to prevent premature access to spaces that have not yet been declared safe for entry. This simple measure reinforces the procedural status of the space, reduces ambiguity, and provides an immediate physical reminder that the tank remains "closed", and reduces the likelihood of someone stepping into a tank "just to check" or to prepare equipment before controls are fully in place.

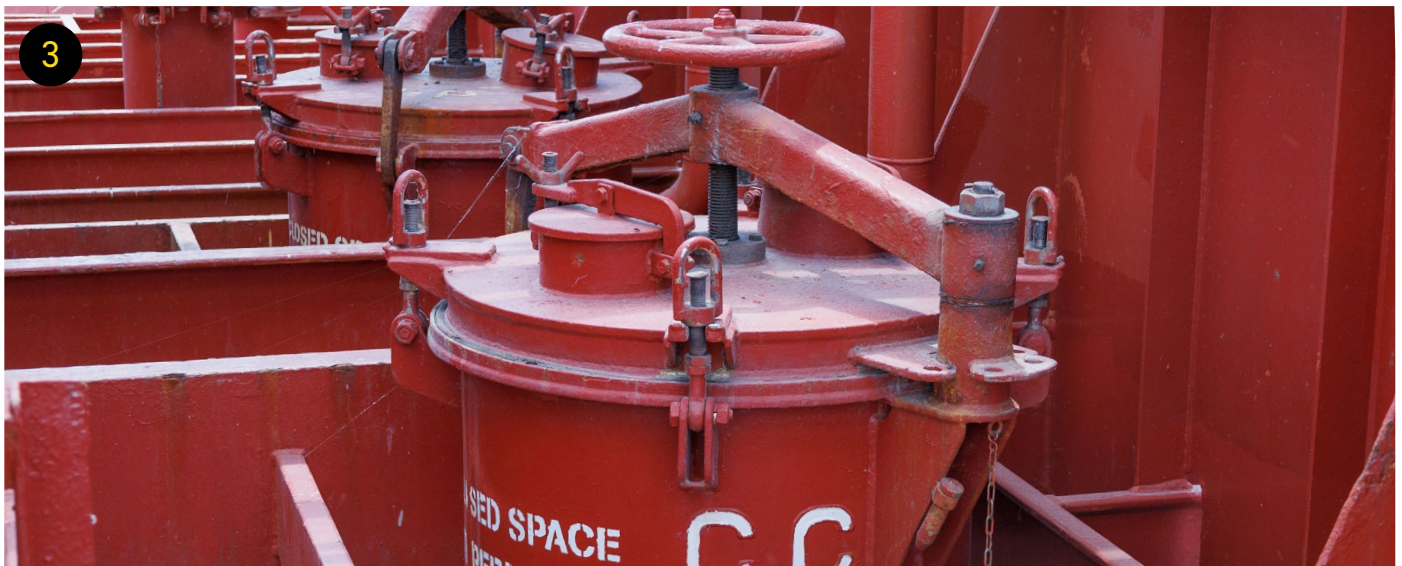
This event developed rapidly and at a point where the tank had not yet been formally cleared for entry. Until an enclosed space permit is issued, a cargo tank must be treated as hazardous, regardless of whether the hatch is open, a fan is running, or the tank has been recently washed.

**FIGURE 3** TYPICAL CARGO TANK ENTRANCE HATCH OF TANKER

The purpose of the permit process is to confirm, through measured data and recorded gas testing, that it is safe to proceed. Tanks may look harmless from above yet can still harbour atmospheres that can quickly incapacitate or kill without warning. Therefore, visual appearance from the deck level cannot be relied upon; the atmosphere within a tank can remain dangerous even when it seems inactive or benign.

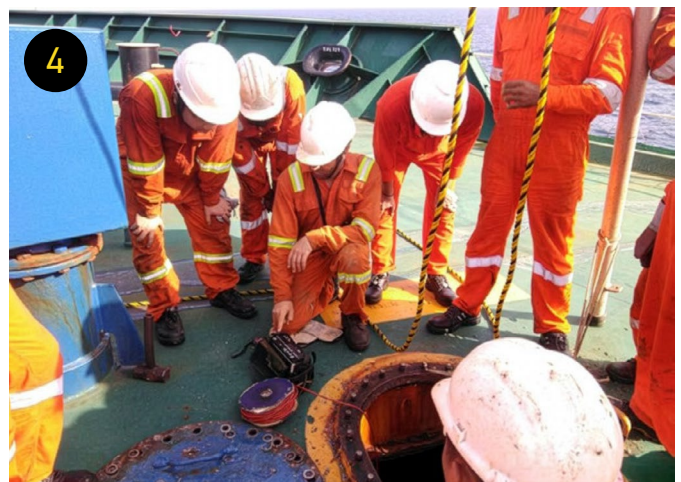
In the hours leading up to the incident, a "strong" odour was reported. Reliance on smell is fundamentally unreliable; the human nose desensitises quickly to certain smells, and many dangerous vapours are either odourless or only detectable by smell at concentrations already above hazardous limits.

Tank atmospheres cannot be safely assessed by intuition, visual checks, open hatches, or ventilation alone. Even recently washed tanks may still contain vapour pockets or oxygen-deficient zones. Entry conditions must therefore be verified using calibrated instruments, with readings recorded and compared against defined tolerances, before anyone enters the space.

Also, reagent tubes or type-specific gas detectors should be used where applicable. It is important that tests are conducted for the specific hazards present – in this case, benzene – so that the analysis reflects the actual risk rather than a general hydrocarbon test. Selecting the right detection method is part of ensuring atmosphere testing is meaningful, not merely procedural.

**FIGURE 4 REGULAR TRAINING IN TANK ATMOSPHERE TESTING IS RECOMMENDED**
