ENGINE ROOM FIRE ON A BULK CARRIER ON LAKE ERIE

THIS CASE STUDY IS DRAWN FROM THE TRANSPORTATION SAFETY BOARD OF CANADA'S MARINE TRANSPORTATION SAFETY INVESTIGATION REPORT M23C0104.

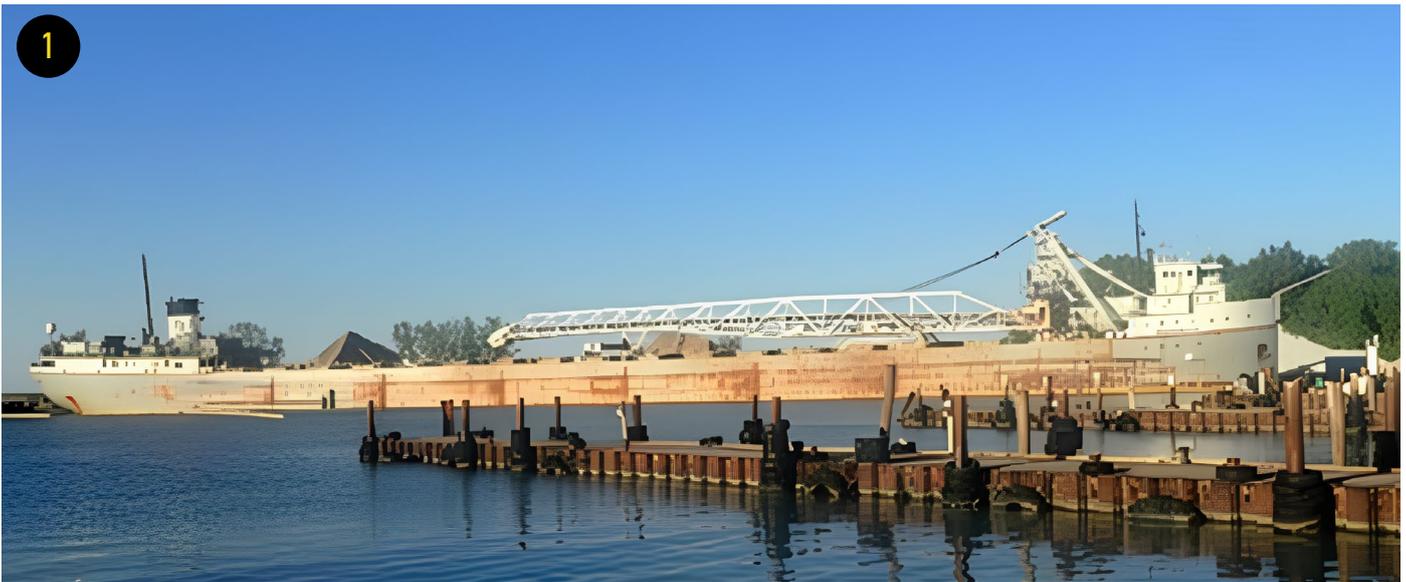
FIGURE 1 VIEW OF VESSEL, SHORTLY AFTER THE FIRE
SOURCE TSB

The ship was eventually taken under tow to Kingsville, Ontario, where authorities carried out inspections. No injuries to the crew were reported, and no pollution was detected from fuel or cargo. Despite this, the ship's engine room was found to be substantially damaged.

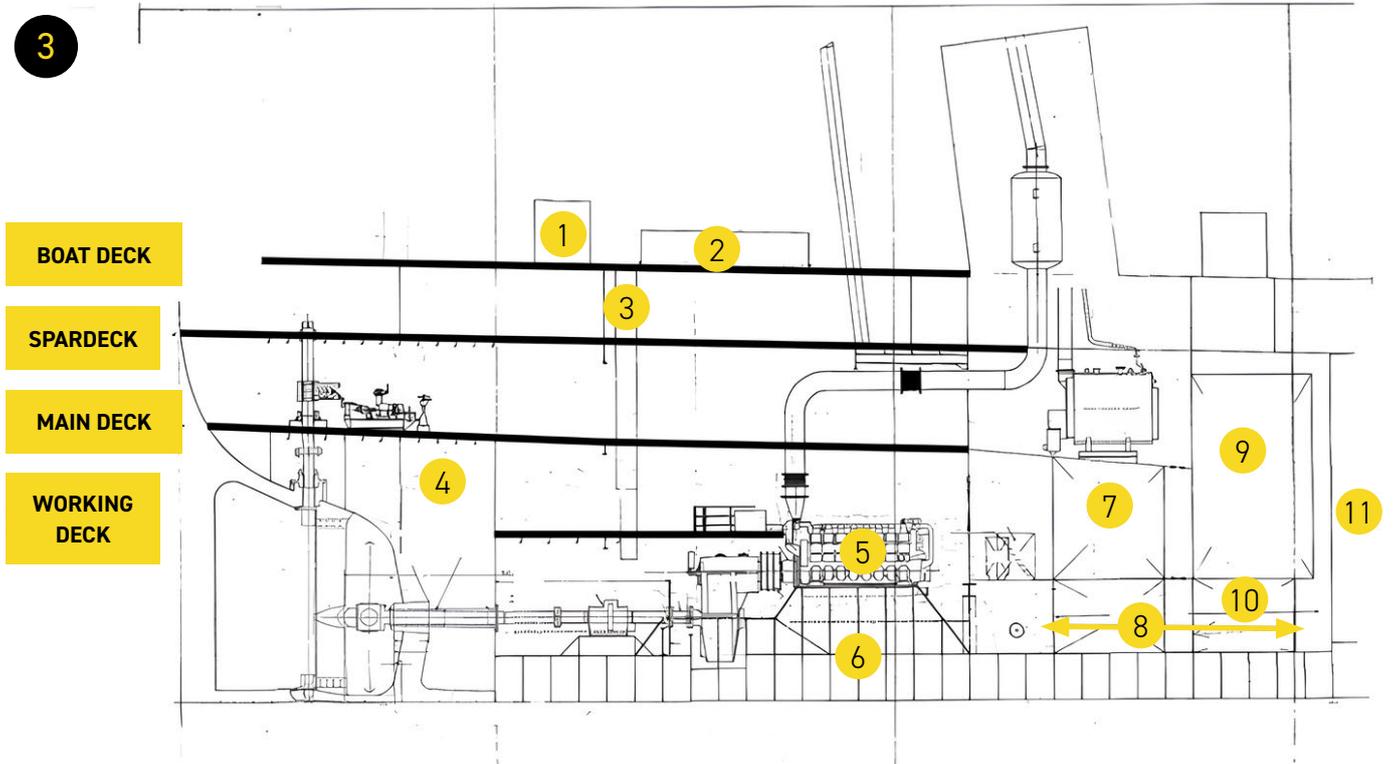
The engineers could not reach the engine room skylight to close it manually due to the heat and smoke from the fire, and the remote control was inaccessible, being located within the engine room. Despite the skylight and some portholes within the engine room still being open, the master ordered that the ship's fixed CO₂ firefighting system be activated.

FIGURE 3 PROFILE VIEW OF THE STRUCTURE
SOURCE TSB, BASED ON MACHINERY ARRANGEMENT DRAWINGS

Open portholes, vents, and a skylight hatch at the time of the fire allowed fresh air to enter the space. This both fed the flames and delayed effective sealing. Prompt closure of ventilation openings is a key element of machinery space fire control, with delays in securing these openings contributing to the severity of the fire.

Where ventilation within the engine room is lacking, it may be acceptable to have open port holes, fire doors, and skylights, but these must be able to be closed remotely from a safe position or be fitted with a fail-safe arrangement.

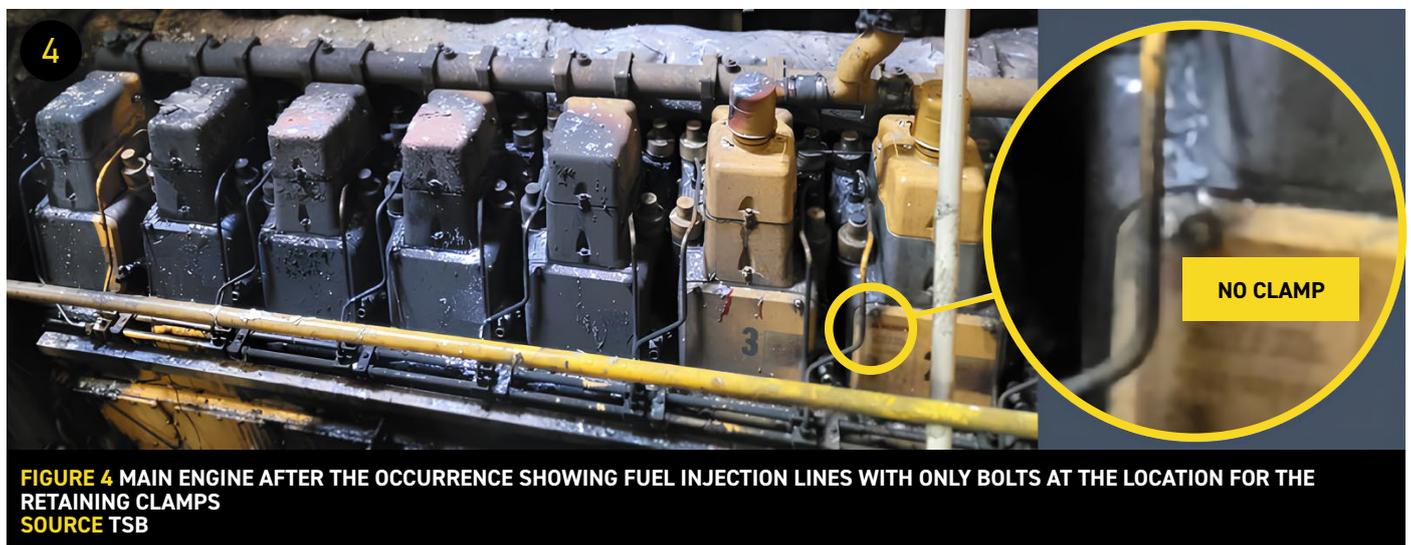
The fire originated at the top of the main engine and spread rapidly through the machinery space. The immediate cause was traced to a loosened fuel injection return line connection on one of the cylinders, which allowed pressurised diesel fuel to spray onto hot engine surfaces. The problem was exacerbated by missing retaining clamps on the fuel lines, poor vibration control, and deteriorated exhaust insulation.

The fuel line retaining clamps were likely removed during fuel line maintenance at an earlier date and not replaced. This lack of securing contributed to the increased vibration of the fuel lines. Numerous observable leaks had occurred since the fuel line maintenance; however, no internal investigation was conducted into why the leaks kept happening.

The importance of maintenance in both preventing and in tackling fires is clear. Critical but inexpensive components, such as fuel line retaining clamps, correctly torqued fittings, and properly installed insulation, serve as key safety barriers. However, when these same components are not maintained properly, or are not replaced after maintenance, major barriers to a catastrophic incident are removed.

Ensuring that a ship's planned maintenance system tasks match the manufacturer's instructions is important. This should include any task-specific instructions, and/or the need to replace components after removal for access or maintenance. Regardless of how busy the ship's schedule, maintenance must be prioritised.

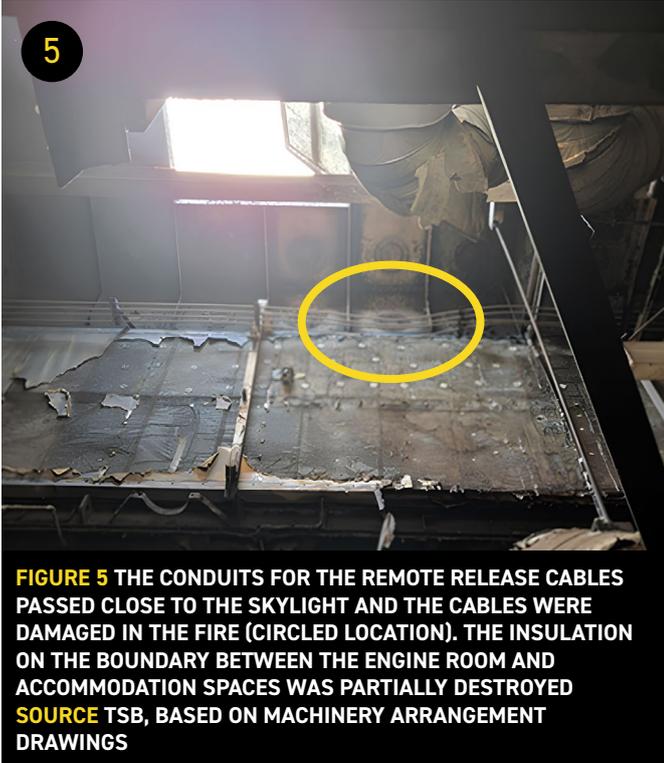
The remote release cables for the CO₂ system were located in an exposed position in the engine room and had been damaged by the fire, resulting in the cables failing when attempted to use. A subsequent manual release of the CO₂ locally, resulted in the loss of all CO₂. This highlights a poor design and lack of training.

A CO₂-fixed firefighting system is the last line of defence. It must work when called upon. Remote release cables were routed through the engine room near the skylight and were subsequently heat-damaged, causing them to part when pulled. We would therefore recommend that the path and condition of remote release cables for any fixed firefighting system is regularly checked and assessed for usability during an emergency.
