### ACCIDENTAL RELEASE OF A LIFEBOAT

A REFRIGERATED CARGO SHIP HAD BERTHED IN SOUTHAMPTON TO DISCHARGE A CARGO OF FRUIT. ON THE DAY OF ARRIVAL THE LOCAL PORT STATE AUTHORITIES HAD BOARDED THE SHIP IN ORDER TO CONDUCT A PORT STATE CONTROL (PSC) INSPECTION, WHICH INCLUDED A LIFEBOAT DRILL. WHILE SECURING THE LIFEBOAT AFTER THE DRILL, THE SHIP'S BOSUN SUSTAINED MINOR INJURIES AS THE FORWARD END OF THE LIFEBOAT FELL FROM ITS DAVIT DUE TO IT NOT BEING CORRECTLY RESET WHEN IT WAS HOISTED FROM THE WATER (**FIGURE 1**).

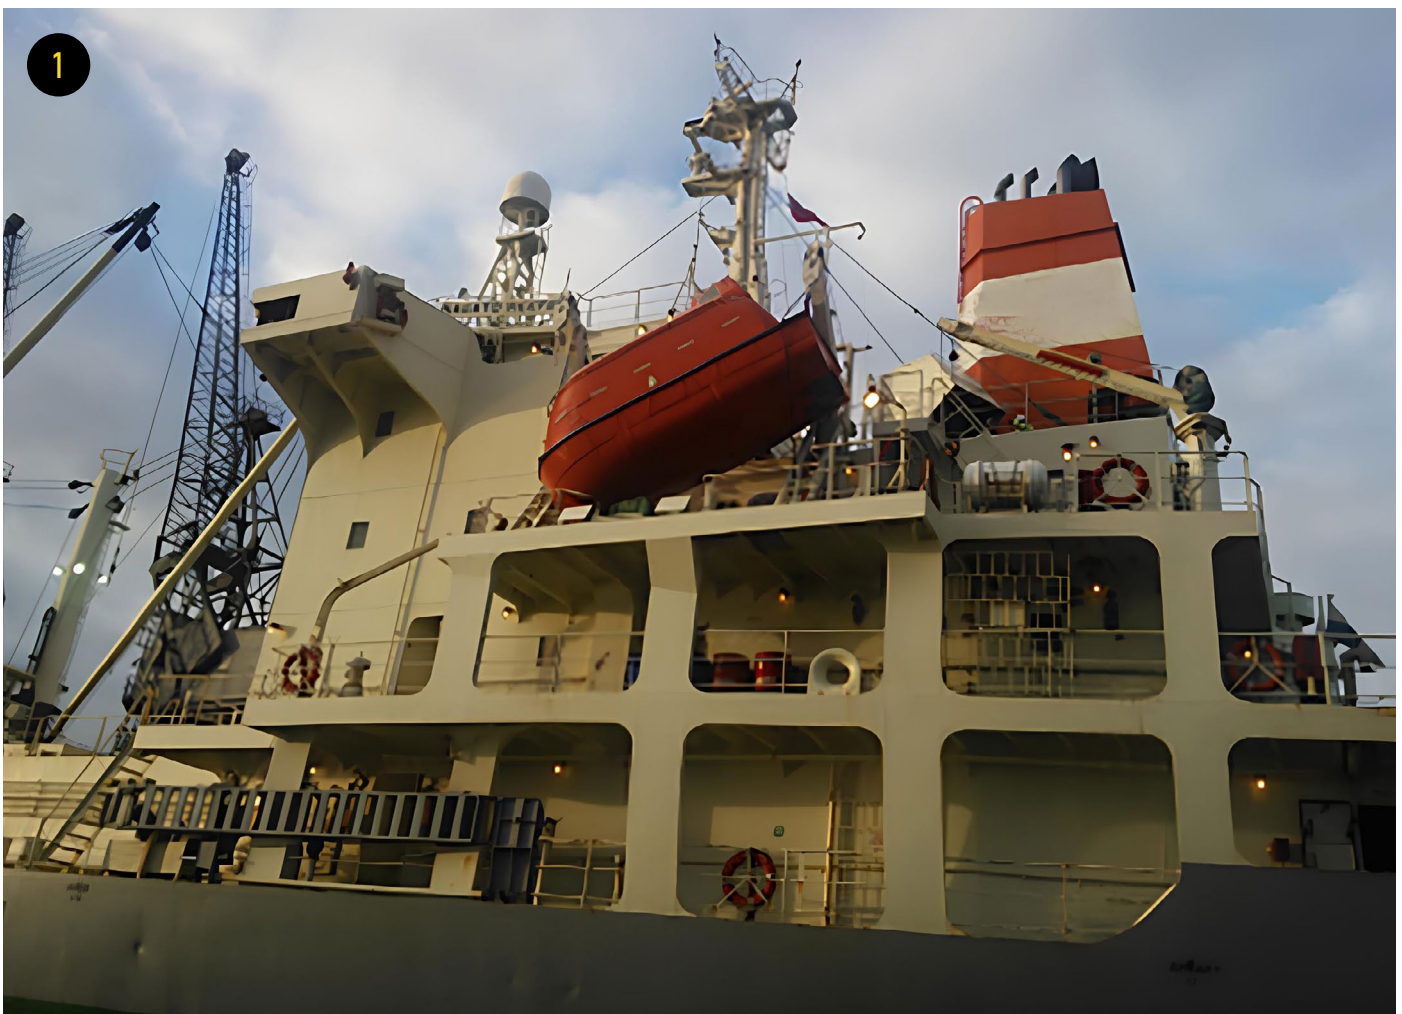
**FIGURE 1** PORT SIDE LIFEBOAT AFTER THE INCIDENT  
**SOURCE** MARITIME ACCIDENT INVESTIGATION BRANCH

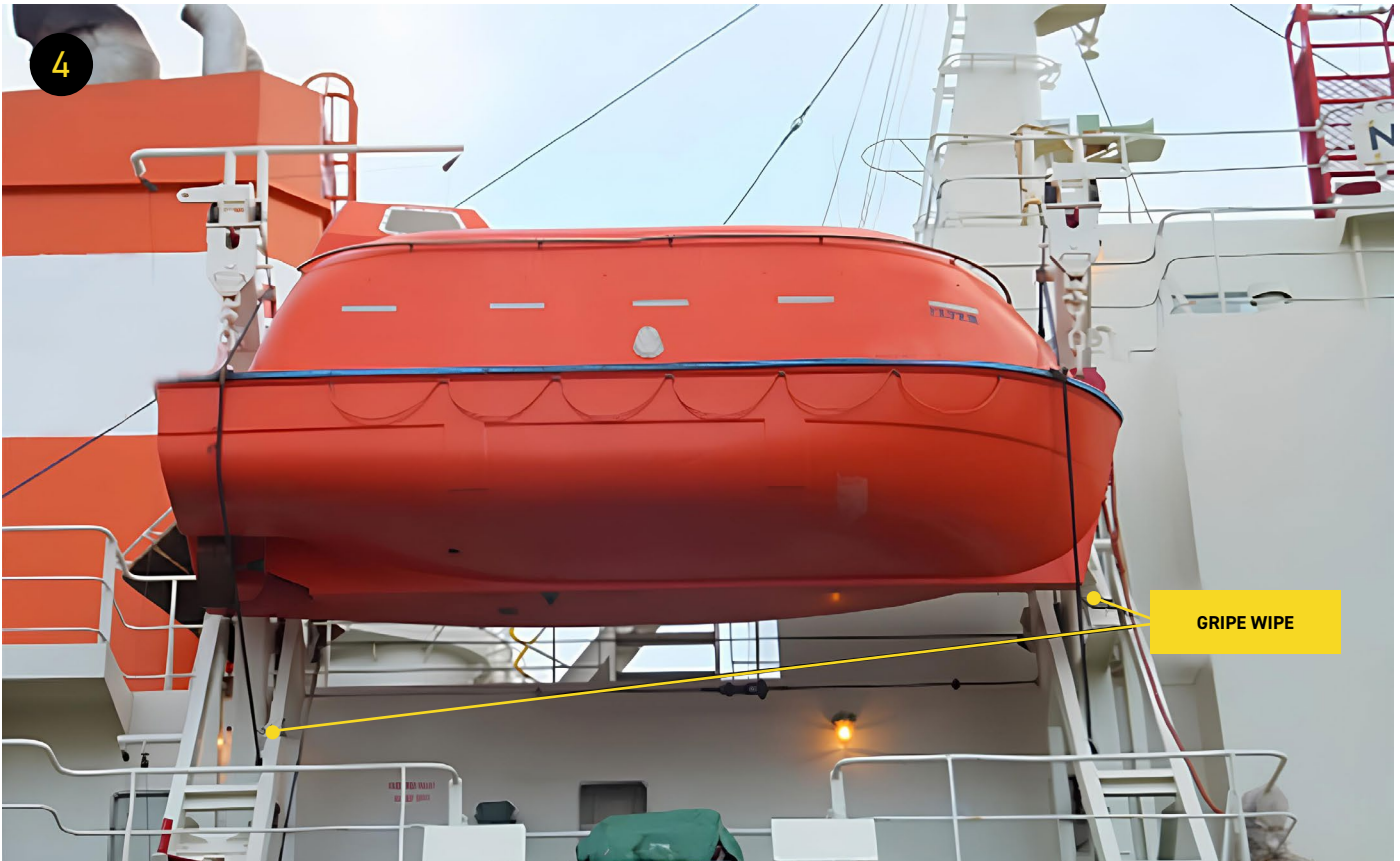
**FIGURE 4** GRIBE WIRES (ON STARBOARD LIFEBOAT)  
**SOURCE** MARITIME ACCIDENT INVESTIGATION BRANCH

After the break the C/O instructed the ship's bosun and two crewmen to secure the lifeboat. The two crewmen boarded the lifeboat to assist in positioning the gripe wires forward and aft. The bosun instructed the men in the boat not to release the FPDs until he had connected the gripes to the davit arms (**FIGURE 4**). The aft gripe had been secured and the bosun was connecting the forward gripe when the C/O came to the lifeboat and instructed the men in the boat to release both FPDs. As soon as the forward FPD shackle pin was removed, the hook opened and the forward end of the boat fell onto the handrails on the deck below (**FIGURE 4**), striking and injuring the bosun as it fell.
