RISK WATCH

Restricted visibility – chief officer's neglect

An example of a collision in restricted visibility is provided in an investigation report recently issued by the British Marine Accident Investigation Branch of the Maritime and Coastguard Agency (MAIB).

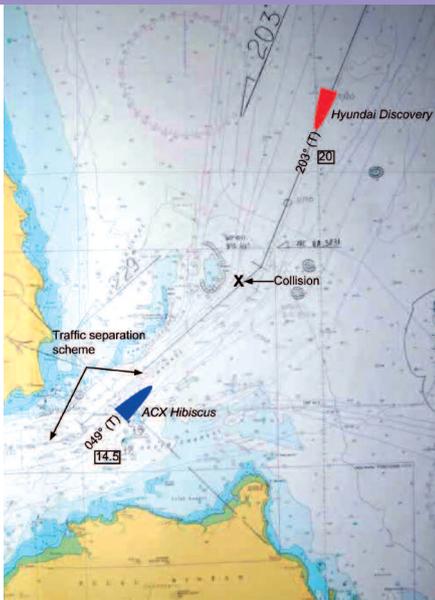
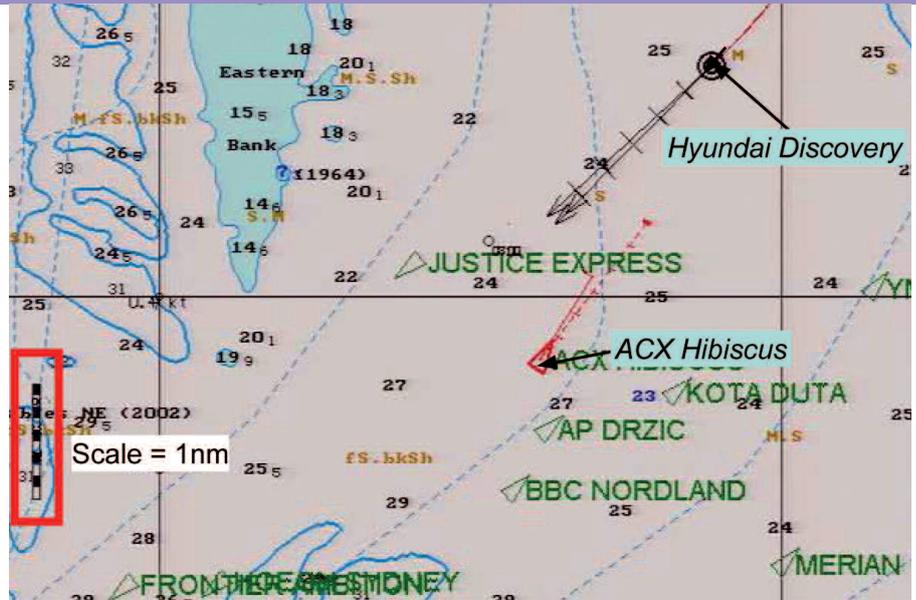
Position of ACX HIBISCUS and HYUNDAI DISCOVERY at 0751:30

At around 0750 ACX's third officer arrived on the bridge ready to take over the watch. At 0751:30 ACX's chief officer started to turn the ship incrementally to port onto the next planned track of 350°. It was reported that the third officer looked at the radar display and found that radar targets were not seen due to clutter and that he informed the chief officer about the situation.

At 0752, with about 2.2nm distance between the ships, HD's chief officer noticed the radar trail of ACX change direction, indicating that ACX was altering its course to port, towards his ship. He immediately checked the AIS information on the ECS and confirmed that the ship turning to port was ACX. At 0753:15, and again at 0753:30, the chief officer called ACX by VHF radio.

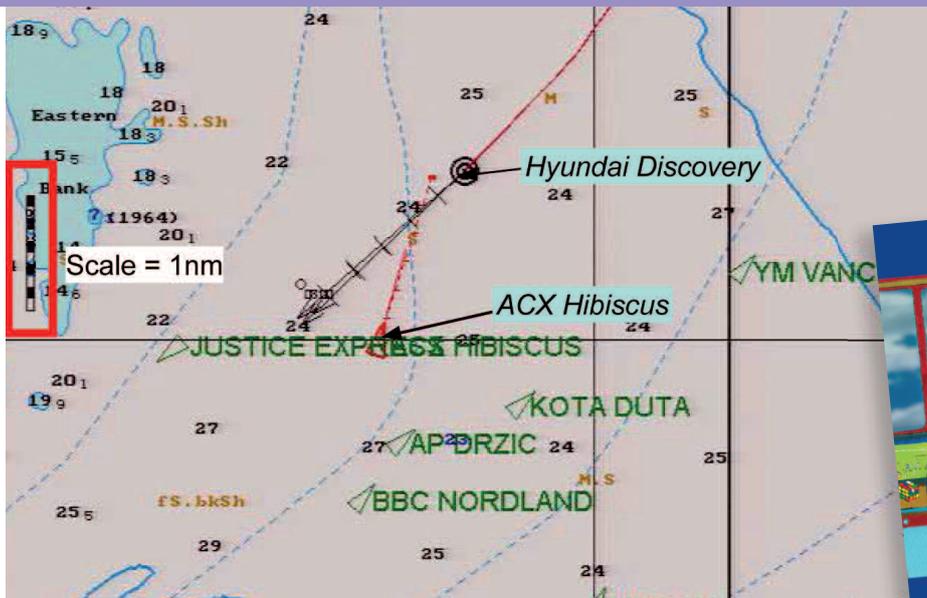
Position of ACX HIBISCUS and HYUNDAI DISCOVERY at 0753:30

At 0754:00 HD's chief officer asked ACX's third officer: 'Why are you altering course to port side?' The response from ACX was unclear, but it was apparent that the third officer said that his ship was turning to the north. HD's chief officer continued: 'Do not cross my bow ... the visibility is zero you must alter course to starboard!'. At 0754:20 HD's chief officer told ACX's third officer to alter course to starboard and create a minimum CPA of 3 cables. He then asked: 'The visibility is zero, what are you doing?'

At 0754:34 ACX's third officer replied that: 'We are altering course to the north now'. The chief officer continued to turn ACX to port, passing a heading of 017°.

to maintain the same courses and speeds as during the accident. It showed that if *HD's* chief officer had turned hard to starboard immediately after he had observed *ACX's* alteration of course to port, *HD* would have passed clear ahead of *ACX* by 4 cables.

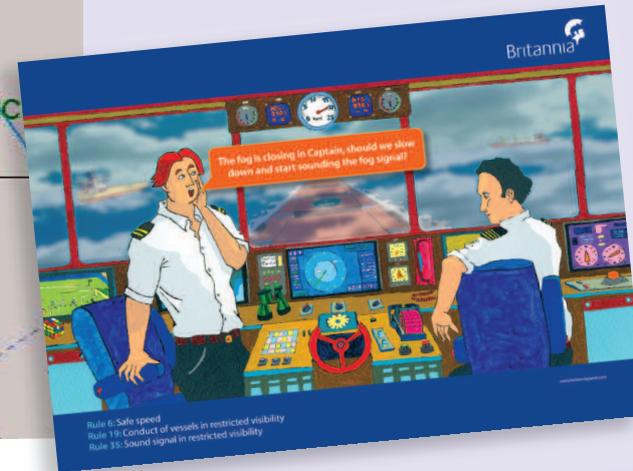
Collision regulation posters: COLREGs rules 6, 19 and 35

The scene played out in the poster depicts busy traffic with visibility reducing. This is a sizeable ship proceeding at 19 knots in close proximity to other ships in deteriorating weather conditions. There is an immediate need to reduce the speed and take into consideration all the factors outlined in rule 6. There is also a requirement to prepare the engines for possible manoeuvring and to start sounding the fog signal (rules 19 and 35).

The rules provide clear and concise instructions to make early and substantial action to avoid collision.

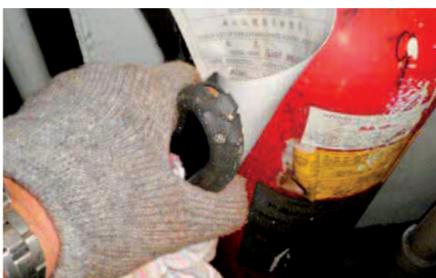
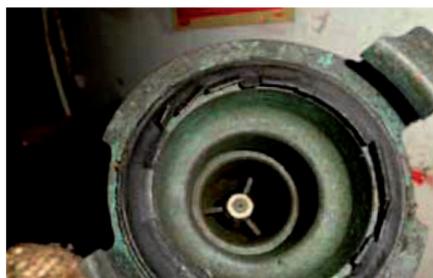
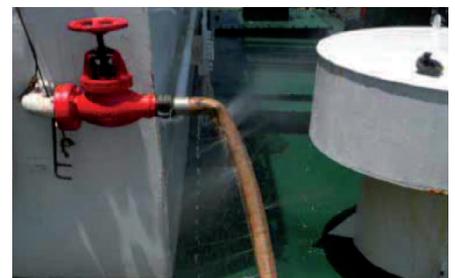
Whilst there are always exceptions, it is unusual for these officers to be adequately trained to properly and effectively service all safety equipment on board a particular ship. It is customary for the new joining officer to get a handover from the officer being relieved. This should be written down and, if there is sufficient time, should include a brief walk through and perhaps the location of spare parts should be pointed out. There is a requirement to review the manufacturer's documentation in order to verify the recorded weight of the fire extinguishers, or to be able to decide whether the plastic cap of the extinguisher is degraded to the extent that it may need replacement. However, this requirement is unfortunately not often fulfilled, as demonstrated by a sample of pictures from recent survey reports.
