Chemical Burns

BACKGROUND

- A 12,162 GT chemical tanker was anchored at a roadstead in the lower reaches of a river and was in ballast condition.
- The crew were preparing its tanks for loading a cargo of 50% sodium hydroxide solution (caustic soda) in ten of the ship's twelve cargo tanks.
- The tanker had previously carried RBD (refined, bleached, deodorised) palm stearin in six of the tanks, including tank no.1 port, along with crude palm oil, coconut oil and biodiesel in the other tanks.
- The tanker had only been operating for four-months and the same crew had been on board throughout this period.
- In the days preceding the incident, the crew made various attempts to prepare the ship's tanks for the new cargo. However they were each time rejected by the attending tank inspector.

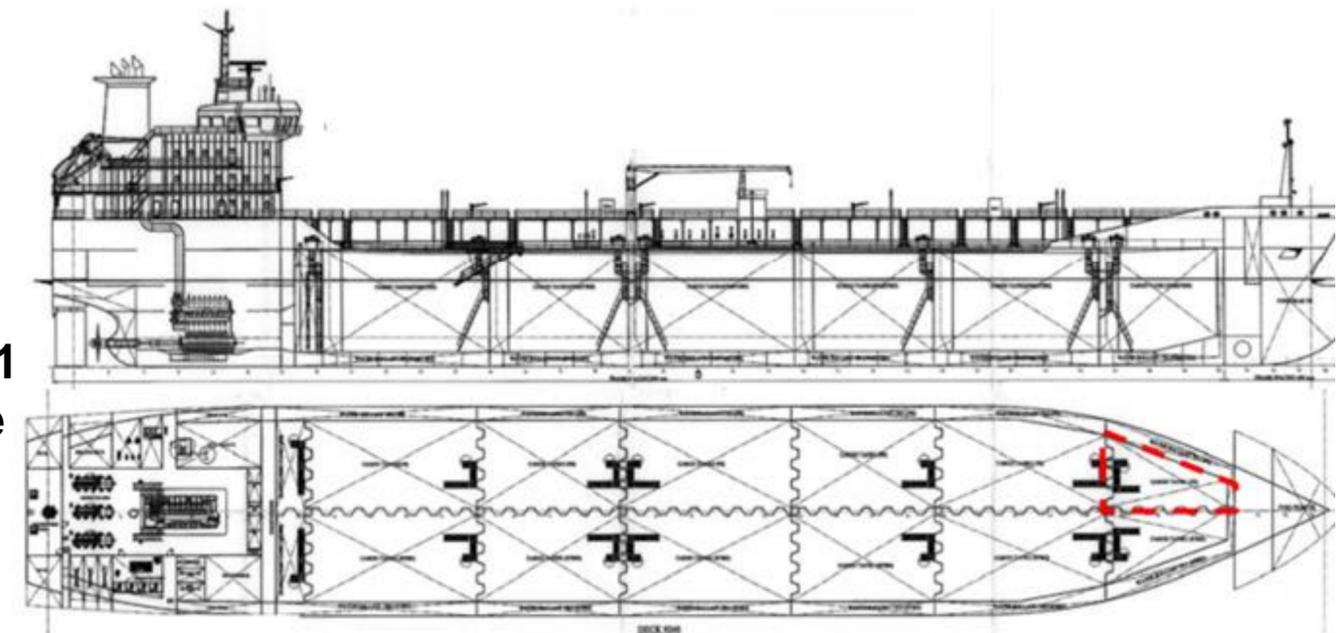
General arrangement plan showing the location of tank no.1 port in red.

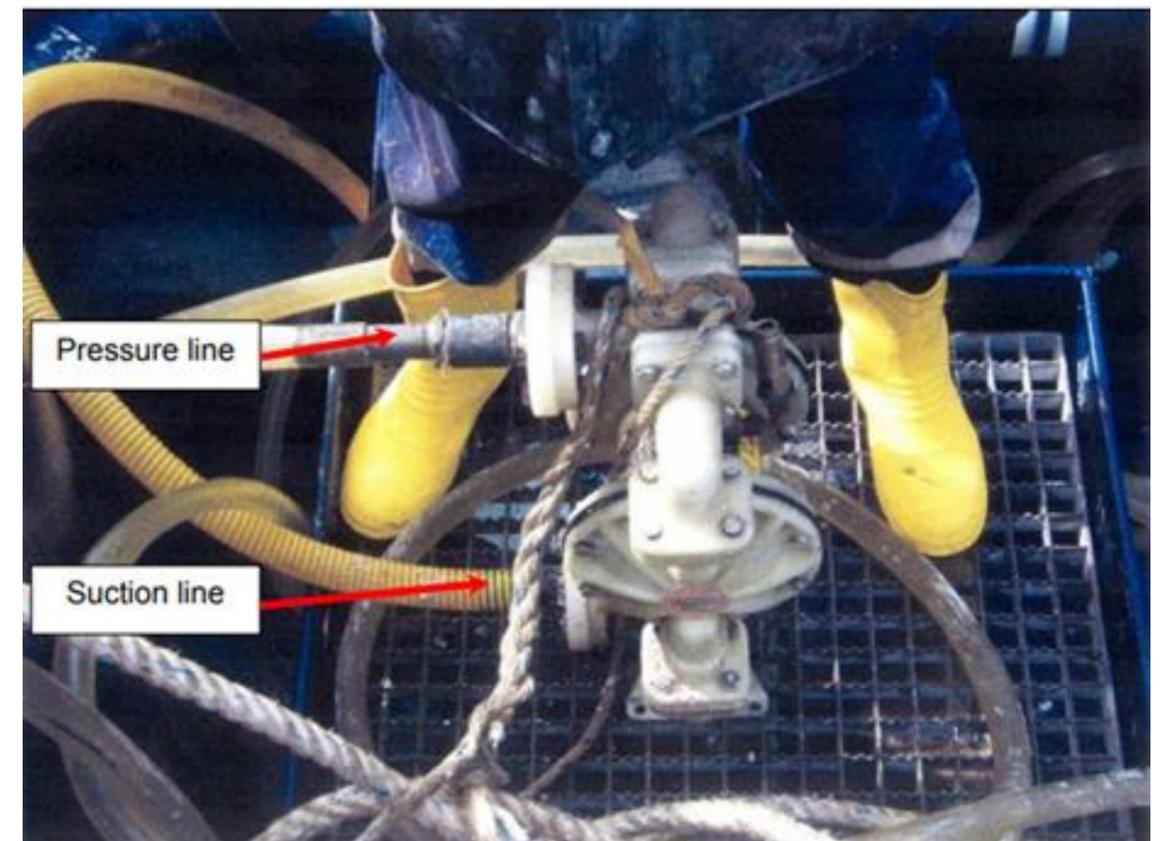
- The cleaning required two crew members to enter tank no. 1 port and remove the residues of the caustic soda that had been used as a cargo sample using a mobile pump.
- For this a polypropylene pneumatic driven pump with a pumping capacity of 520 l/min at a maximum working pressure of 8 bar (Figure 2) was prepared.
- Meanwhile a tank cleaning team consisting of the 3/O and an ordinary seaman (O/S) donned Personal Protective Equipment (PPE)
- The PPE consisted of a cotton overall, a rubberised jacket, safety boots, protective gloves, goggles and a safety helmet.

Pump used on the day of the incident.

- **Training** – The crew demonstrated a lack of training and capability both in preparing the tanks for the cargo and safely handling the cargo.
- **Condition of equipment** – It remains uncertain whether a case of material fatigue caused the clamp to part. Nonetheless, all equipment should always be inspected prior to use to ensure it is fit for purpose.

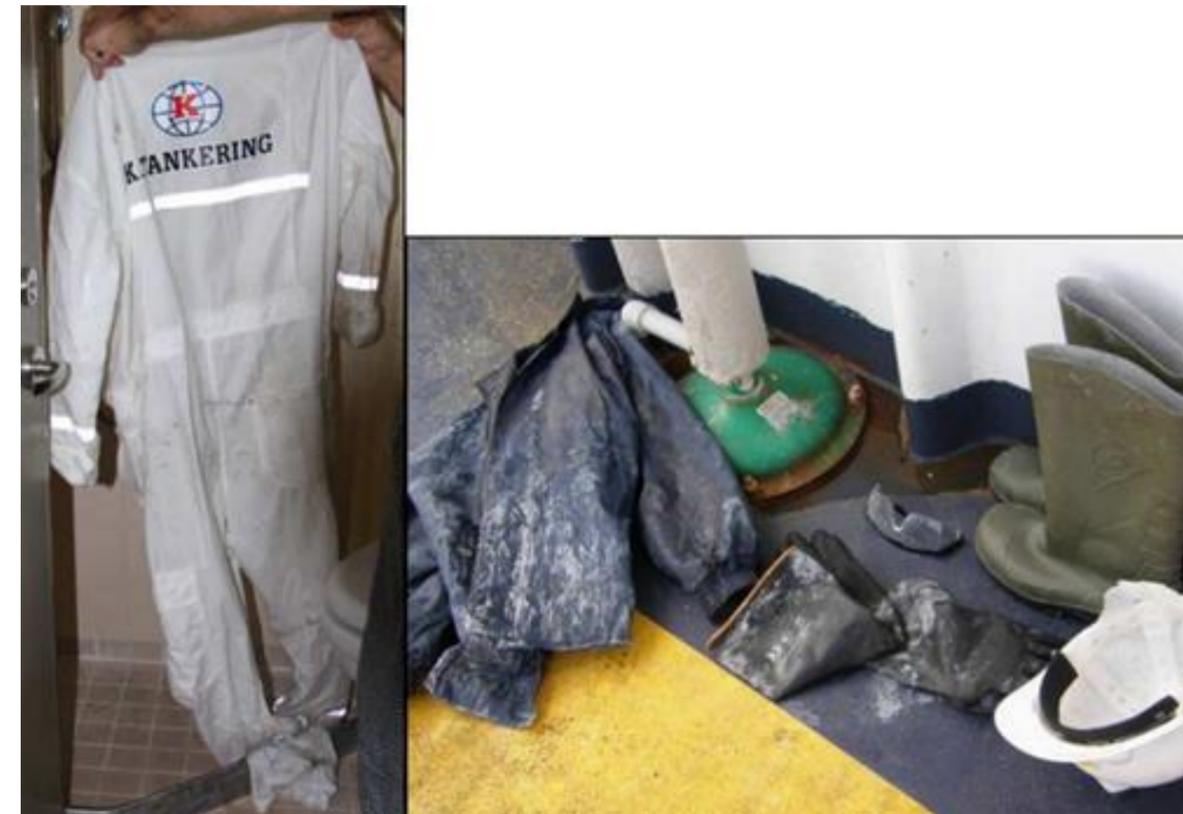
Personal Protective equipment worn by the 3/O at the time of the incident.

- **PPE** – The PPE worn by the 3/O at the time of the incident were a suitable standard for handling caustic soda.
- **Preparation** – A tank cleaning plan based on a thorough risk assessment was not available following the incident and the investigation concluded that these documents had not been prepared.

- **Intervention** – Although the master and bosun were present as the cleaning team entered the cargo tank, neither of them took any actions with regard to the inadequate PPE being worn by the 3/O and O/S. An effective Stop Work Authority programme would have prevented the incident.

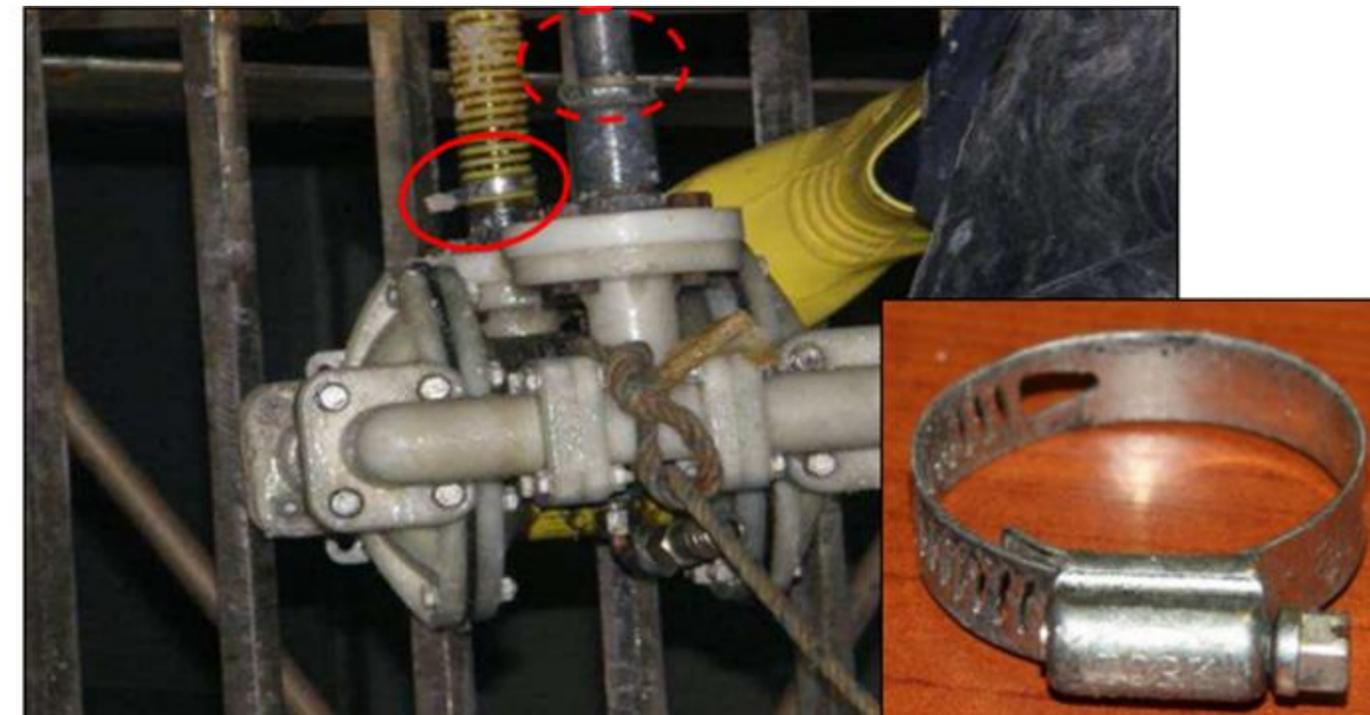
- As the tank cleaning team entered cargo tank no. 1 port on its port side. The bosun was located at the coaming of the entry hatch to the cargo tank and
- The master was located at the forward part of the vessel near the tank entrance.
- While the caustic soda was being pumped out from inside the tank, the hose clamp securing the pressure hose to the pump parted.
- This resulted in caustic soda being released into the cargo tank.
- The 3/O was spattered with caustic soda, with a small quantity entering his eyes.
- The O/S requested assistance using his portable radio. The 3/O was safely escorted out of the cargo tank and onto the deck.

Remaining hose clamp on the suction line and a sample clamp.
Source: Federal Bureau of Maritime Casualty Investigation (BSU)
