Scaffolding fall causes serious injuries

BACKGROUND

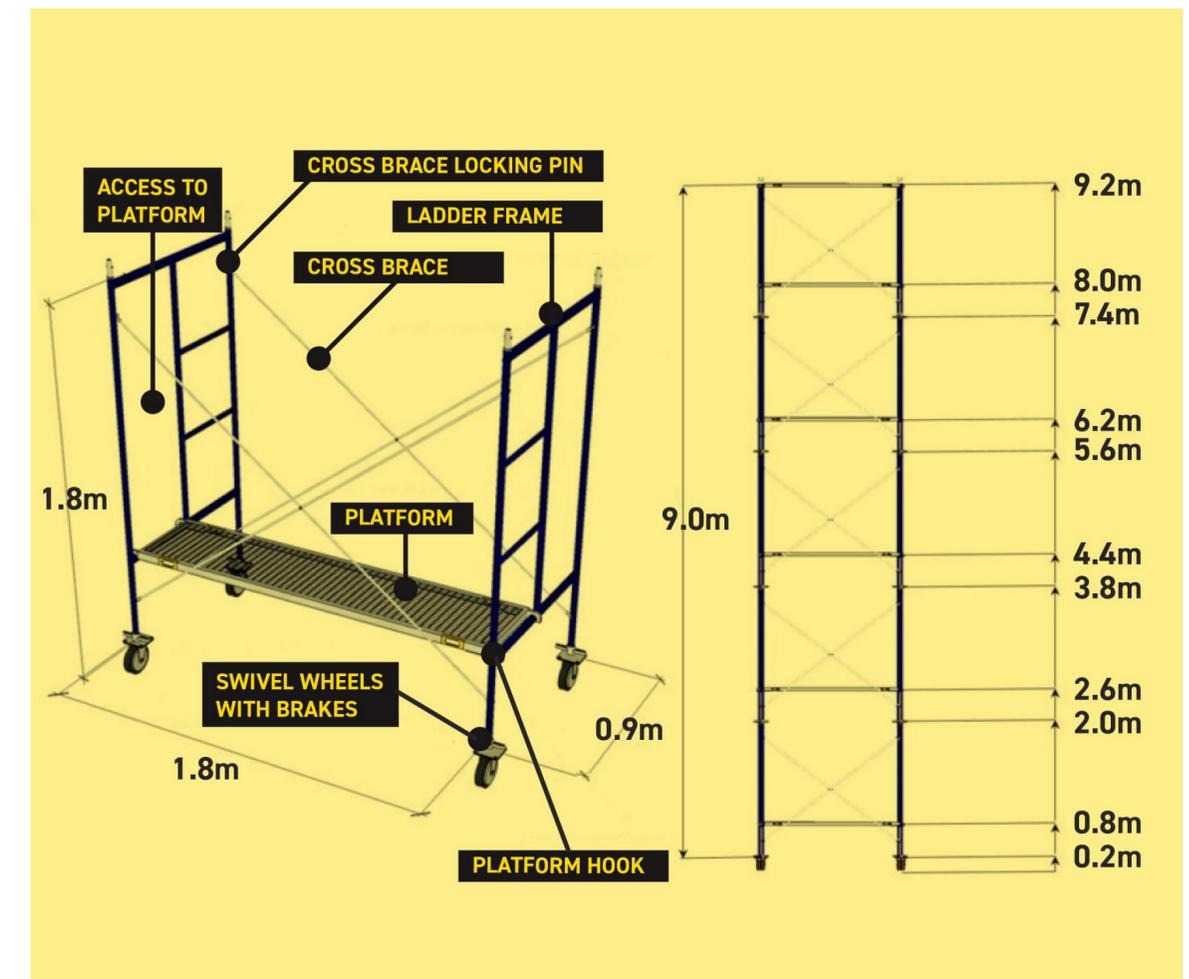
Scaffold construction components and dimensions

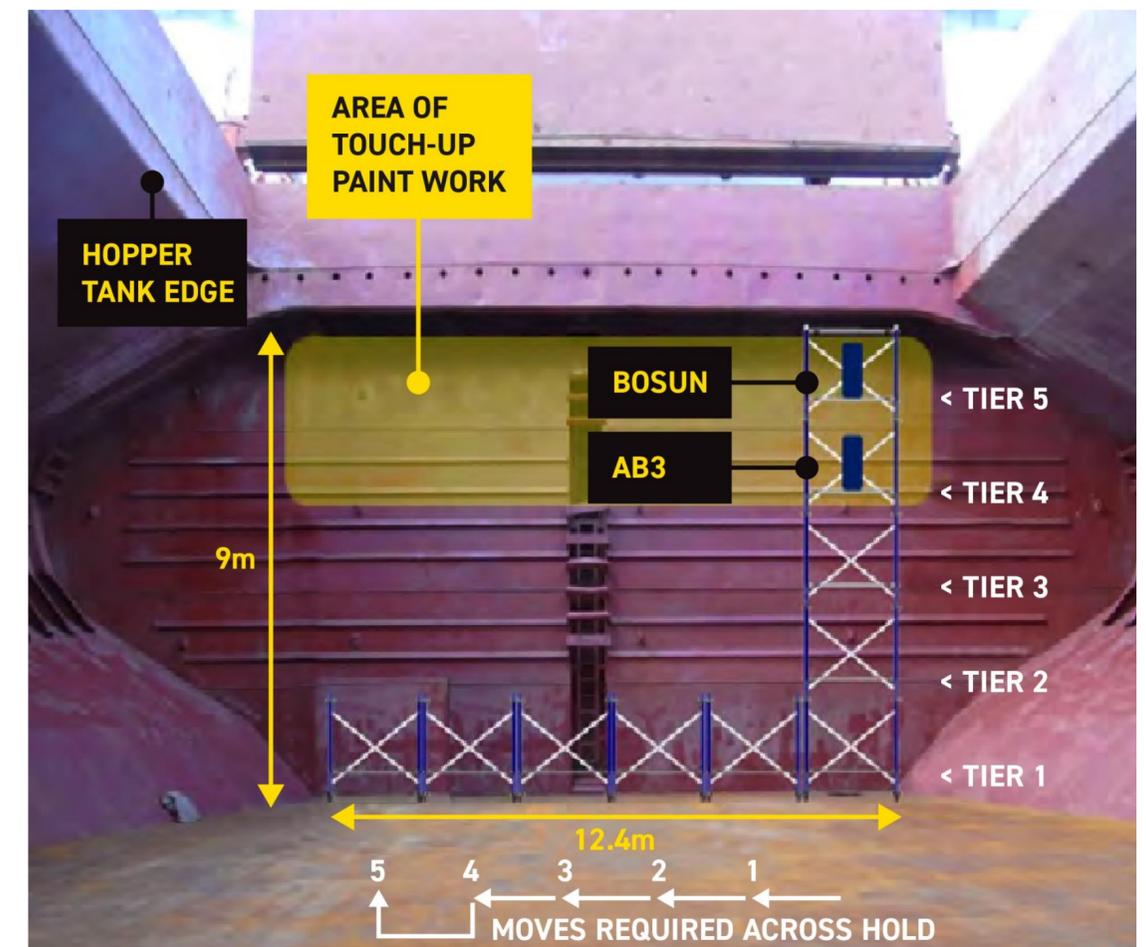
- The scaffold tower was assembled and equipment prepared.
- As before, the bosun and AB3 painted from the scaffold tower and the remaining crew members assisted.
- A similar work sequence to the morning was followed. However, this time, the bosun and AB3 remained on the tower while the OS and cadet repositioned the scaffolding.
- The bosun was on tier five, about 8 m above the deck, and AB3 was one tier below, facing aft, about 6m above the deck.
- Unlike in the morning, neither the bosun nor AB3 wore safety harnesses or used safety lines.
- The work proceeded from port to starboard across the hold, with the scaffolding moved five times.

Hold No.4 showing the scaffold tower moves and the of crew member positions on the tower viewed from forward
