RISK WATCH

Collision case studies

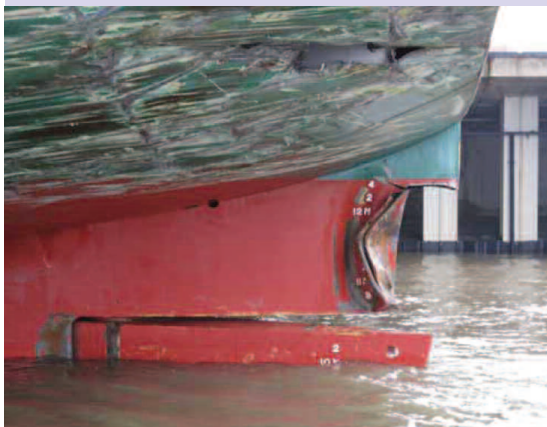
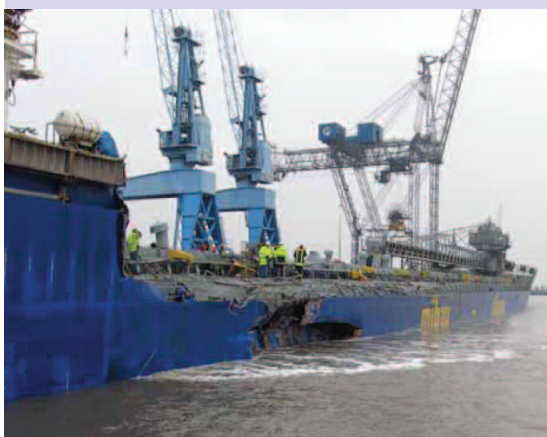
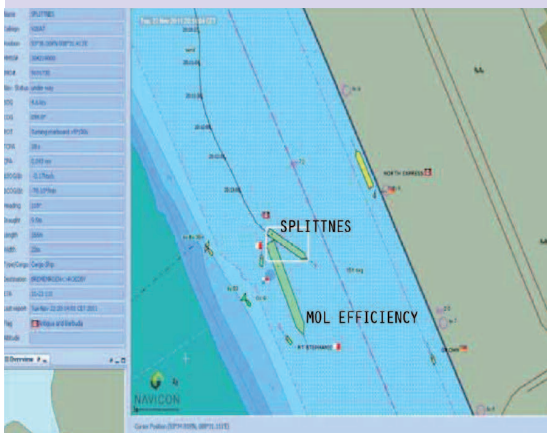
CASE STUDY 2

On 22 November 2011 *SPLITTNES* was proceeding up river (R. Weser, Bremen) behind *MOL EFFICIENCY (ME)* with a flood tide and low visibility due to fog. Several times between 1956 and 2006 the Blexen Radar Station advised that *ME* would stop and turn in order to berth and several times *SPLITTNES* acknowledged and stated they were stopping to await the turn of *ME*. At 2006 the two ships were 2.2 nautical miles apart and *SPLITTNES* was doing 6.12 knots and *ME* was doing 0.5 knots astern. At 2005 *SPLITTNES* had turned slightly to starboard using rudder and bow thrusters so as to sit in behind *ME* and also to stay clear of the downstream bound ship. At 2009 the pilot of the *ME* suggested *SPLITTNES* ought to pass them before they turned and *SPLITTNES* agreed.

SPLITTNES came ahead and to port but failed to complete the manoeuvre before her stern contacted hard with the stern of *ME*. Crucially, at the time *ME* was doing 2 knots astern (in order to keep herself in the turning circle) thus significantly reducing the distance and time that *SPLITTNES* had to complete the newly agreed overtaking.

- **Communicate clearly and effectively any observations on the ship's progress and contribute to any decision made by the team**
- **Assertive error spotting by the team should be encouraged to combat complacency or distraction**
- **Look out of the window as often as possible**
